## TIMBERED ROOFS AND CEILINGS OF THE *PALATINA CHAPEL* IN PALERMO

### 1. The history of monument and its timbered roofs and ceilings

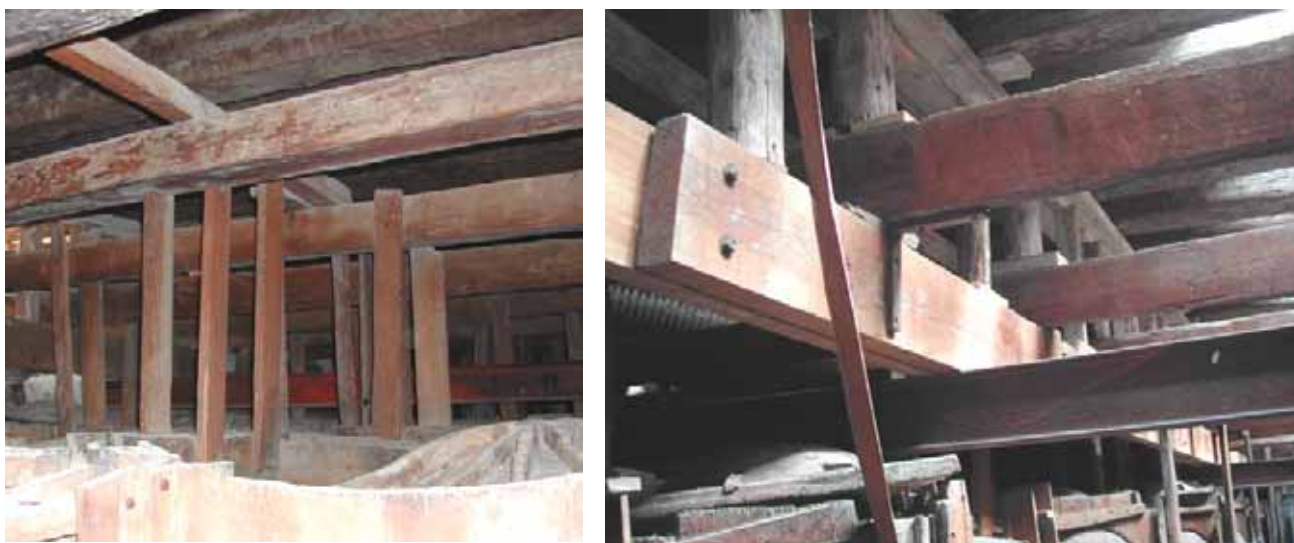
The ceiling today is supported by a system of 22 hemi-squared wooden beams (having each one approximately a section of 10,5x13cm); these beams are sustained by 2 wooden beams (*rompitratte*), constituted everyone by a couple of beams (about 20x5,5cm), mutually connected with filleted bar and bolts, that are supported once more by 4 steel beam (*NP16*, presenting an **I** section). The two wooden and the four steel beams are datable to the reinforcing intervention effected in 1939 by F. Valenti assisted by M. Guiotto, represented by G. Pignato in 1941. The hemi-squared wooden beams, set into perimetric masonries, they look more ancient; vertical wooden boards are connected with nails to these beams (wooden tie beam, called from the XVI century “*appenditori*”) and to the structures of *muqarnas* Norman ceiling above described, having the function to support the heaviest or damaged parts. The evident constructive difference between the ceiling system and these vertical wooden boards of support, the use of not medieval nails, together with the considerations already exposed about the translation of

coverage beam-floor, all these conditions show that the *muqarnas* ceiling constructive system was originally a self-carried structure and that only after numerous and stratified interventions some auxiliary elements of reinforcement were added, with the consequent translation of coverage beam-floor level.

**Fig. 5** – The articulated system that support the *muqarnas* ceiling, constituted by hemi-squared wooden beam with wooden tie rods and reinforcing wooden beams (*rompitratte*), NP16 steel beams.

The following year, the same technician consolidated the frame that support nave ceiling, inserting squared pitch pine beams (as we said before, the so-called “*rompitratte*” wooden beams), and in that occasion were also acted restorations of pictorial patinas at intrados and structural consolidations of ceiling.

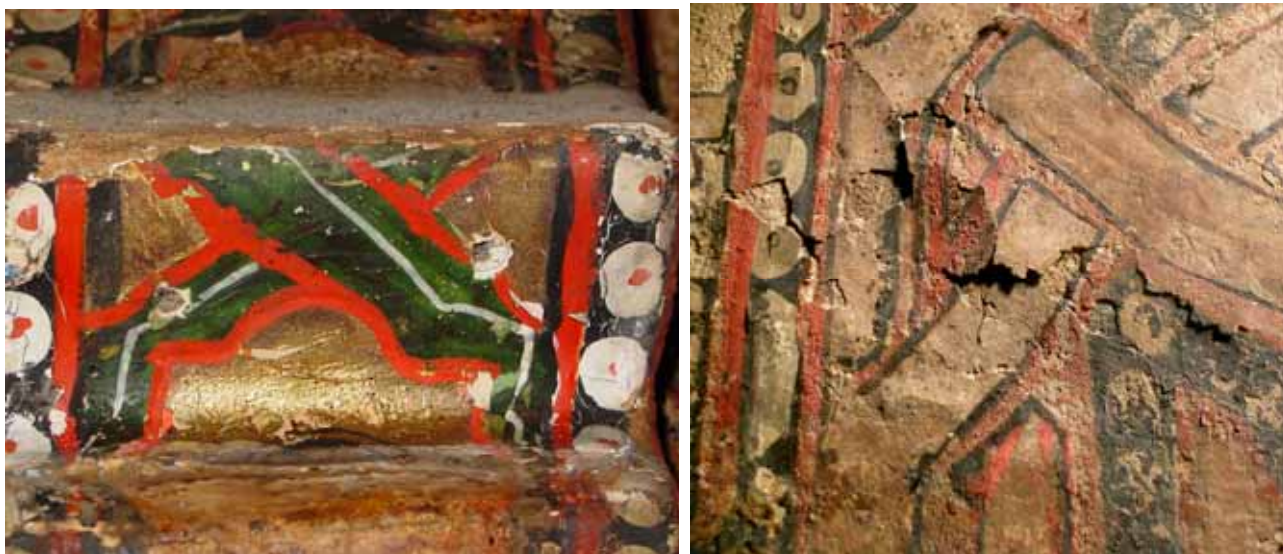
After some researches by the I.C.R. archives, it results that during the restoration effected in 1948-53, a lot of white shellac was purchased. In a long list of materials bought for restorations, nevertheless it was also gum-arabic; **c)** defects of pictorial film adhesion: we notice in different zones particularly serious liftings of pictorial film, especially in correspondence of walls; **d)** defects in the adhesion of preparatory pictorial layers: layer separations are present, both between the gypsum preparatory layers and the glue one, and - more in depth - between the first one of these and the wooden support; **e)** falls of pictorial film: it represents a diffused phenomenon - often happened, surely already in ancient epoch - how we could notice for the numerous and most different remaking of painted parts; **f)** falls of preparatory layers: the diffused presence of dashes, a very diffused technique of pictorial reinstatement of surface, surely used by I.C.R., it testifies the gravity of decay phenomenon, already during repairs acted in 1948-1953.

**Fig. 6** – An original part of pictorial decoration, saved by the overhanging of protective and consolidation products and liftings of pictorial film.

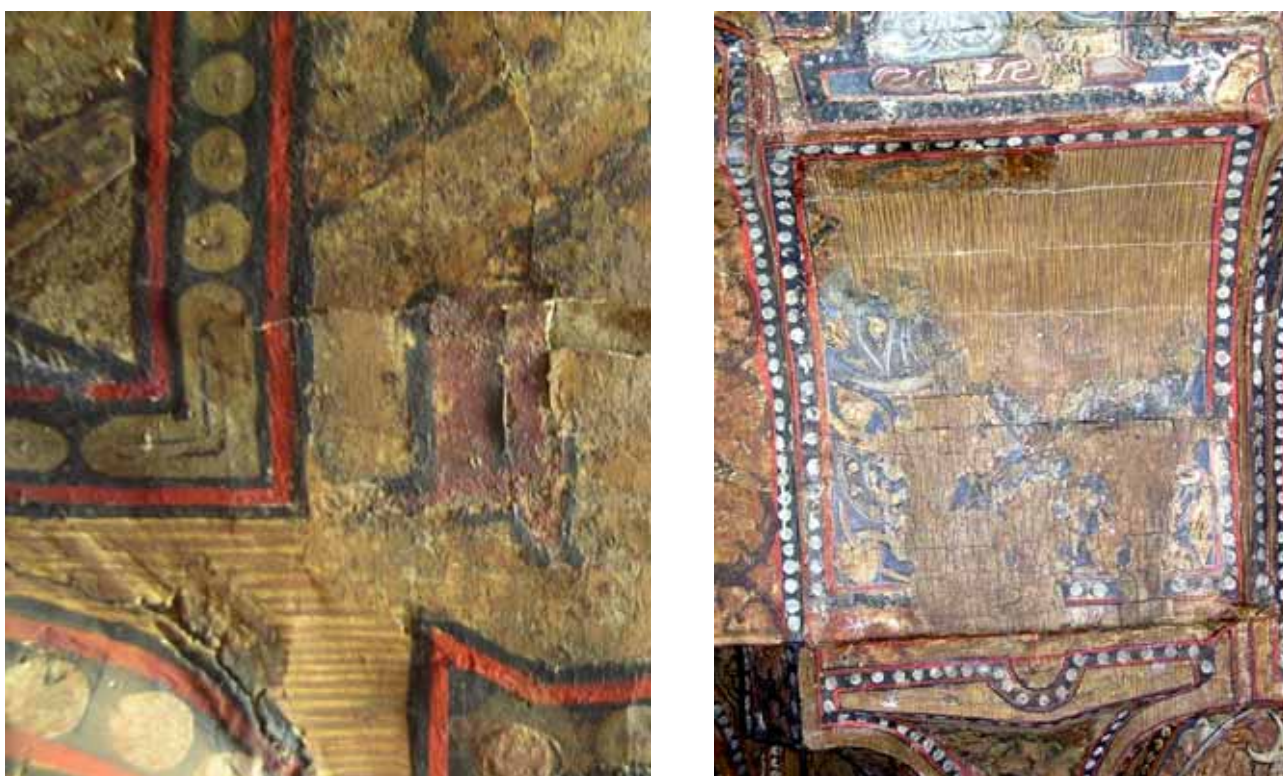
**Fig. 7** – Liftings of preparatory layers and absence of the same preparatory layers e/o of colour, with integrations using the dash technique with chromatic decomposition (*rigatino*).

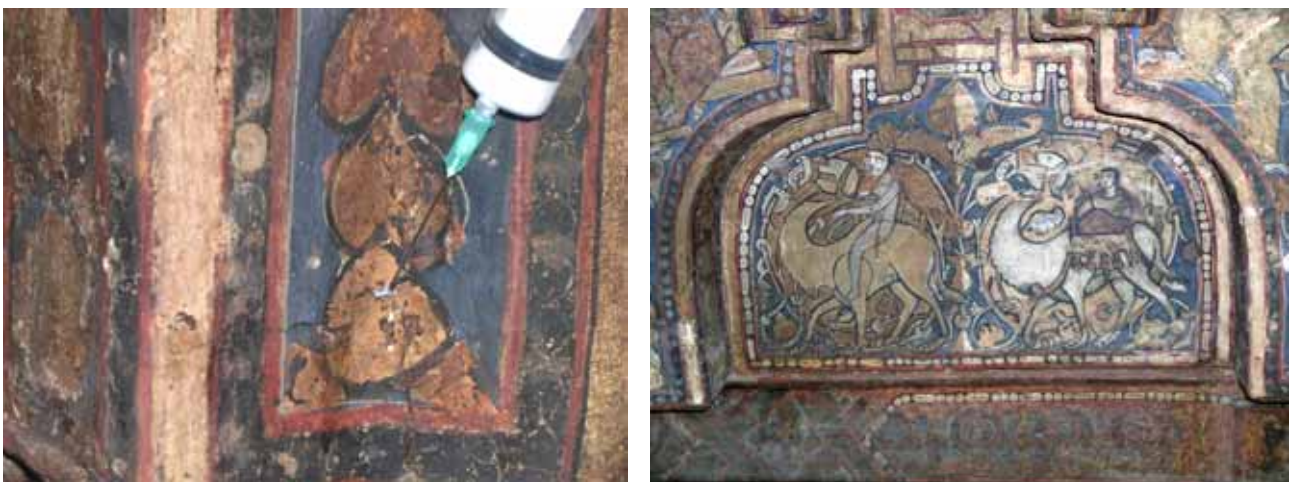
**Fig. 8** – Re-adhesion of preparatory strata and cleaning tests.

Restorations start after the preliminary diagnostic phase, initially as test phase and then, following micro-chemical analyses, as phase of verification and interventions. In different zones of ceilings, consolidation tests are executed with various predominantly organic materials. We notice that pictorial surface (pictorial film and preparatory layers) resulted very reactive to watery solutions both for consolidation that for cleaning. Discarded the use of an acrylic resin put in solution, resulting ineffective and difficult for its application in a punctual and circumscribed use, it was decided to proceed with greater concentrations of acrylic resin in emulsion for recover lifting of pictorial film and, more in depth, with the so-called *colletta* (traditional recipe with animal glue) for the elimination of adhesion

defects in preparatory layers, dehydrating quickly the interested zone through thermocautery and using easily evaporable alcoholic solutions.

As we said, the ceiling appears darkened and “out”, as regards its original colours: the substances used in old maintenance e/o restoration interventions, as well as superficial deposits like dusts, greasy dusts, smoke, etc..., all these conditions altered deeply the original chromatism. It’s possible to easily enough localize the remaking of pictorial film, both with “dash technique” both these that imitate the original ones, generally realized with water-colours and therefore in any moment - if necessary – removable; appears necessary also to individualize the more opportune operational methodology for eliminate, or however to lighten, that general brown tone that so much darkened painted surface. Besides, the micro-analytic investigations confirmed what empirically deduced by small cleaning tests: on the surface of ceiling we notice gum-arabic and, partly, also animal glue, clearly referable to products used for the application of fixed/revivifying/protective products. Various intervention systems have been tested using different products or mixtures of products, departing from principle that the use of organic substances as fixed/revivifying/protective products for repairing pictorial surface, generally were removed with watery solutions; vice-versa, the evident water incompatibility of preparatory layer containing gypsum makes unadvisable the use of watery soaking mixtures, and for these reasons a punctual cleaning technique has been therefore debugging with solutions easily evaporable and controllable, applied both through Japanese paper and absorbent cotton.
