Chiiori: Survey and Analysis of Structural Problems Facing a Traditional Japanese Farmhouse

Conway Carter

University of Hawaii at Manoa, School of Architecture

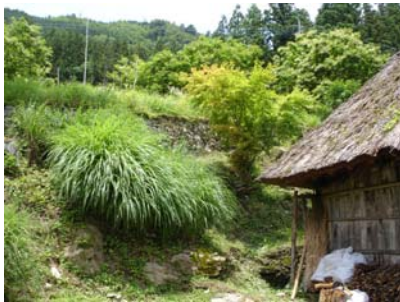
Figure 6. North slope

The soil on the site is mostly clay, with a surface layer of semi-decomposed organic material. This organic material is heaviest on the north side, where surface runoff deposits it in a shallow depression behind the house. However, it does not appear that this material continues to move beneath the house, since the organic matter of the soil there seems to have a different composition. Most likely, the material beneath the house originated from decaying straw mats left to rot inside of the house during its period of abandonment. Beneath the house, the soil on the east side is dense and stable. On the west side, where there is heavy water intrusion, the soil is loose and sinks easily under any weight. The surface of the ground here is marked with depressions which appear to be caused by erosion.

Regardless of whether the sinking ground is being caused by localized erosion or a large scale settling of the terrace, the solution to both problems is to divert the water currently running off the mountain and collecting behind the house. The area directly behind the house should be re-graded to encourage drainage over the surface towards the east. Special attention should be paid to the area beneath the bathroom deck, which could block organic matter and prevent the flow of water. A more reliable solution would be to install a drainage pipe in a trench of gravel fill.

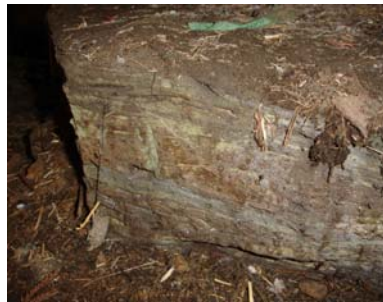
Figure 7. Saturated rock

bed. Phyllite, the stronger of the two, is used for the house's foundation stones, and is strong in compression perpendicular to foliated layers but prone to shearing along grains of mineral foliation. These phyllite foundation stones are fairly porous and tend to wick ground water upwards towards the house's wooden supports. In times of heavy rain, they can become so saturated that droplets of water squeeze out from between layers of mineral foliation. While intended to protect the wooden structure from water intrusion, the stones can in fact draw water towards the support posts during the rainy season.

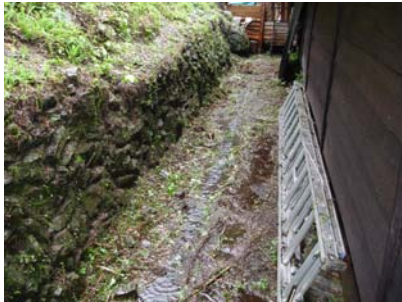
Figure 9. North side depression

Rainwater enters the site from the north, flowing down the slope of the mountain and onto the relatively flat terrace on which the house sits. On the north-west side of this terrace, a shallow depression traps water behind the house where it is forced to percolate through the soil, creating a subsurface flow of water. During the rainy season, even if the surface soil is relatively dry, the foundation stones in the north-west corner are often saturated with water. This appears to confirm the presence of a subsurface flow of water which can persist even days after a rainstorm. It also means that the bases of wooden columns are almost continually damp during these summer months.

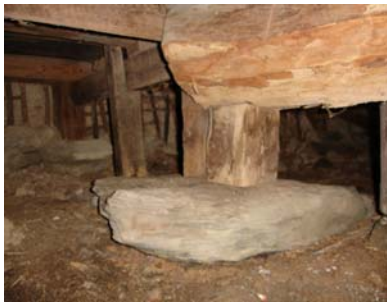
Figure 10. Foundation erosion

While the foundation stones on the north-west side of the house have the most contact with water, paradoxically their surrounding area shows few signs of erosion. In contrast, the stones beneath the south-west side of the house are relatively dry, yet the ground around them is heavily eroded. Most likely this is because water intrusion on the south side only tends to happen during heavy rains, loosening the ground through cycles of shrinking and swelling and then washing it away with sudden bursts of water. It is difficult to gauge whether the ground here is either sinking or being washed away by a horizontal flow, and where any lost material is being deposited.

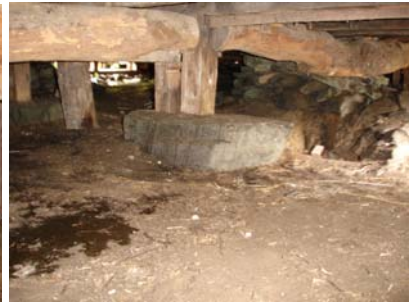
Figure 11. West Vs. East sides

Even during torrential rains, there is no evidence of water flow beneath the east side of the house. On the east side there is a vegetable storage pit, sunk approximately one meter beneath ground level, which did not show any signs of water intrusion even when puddles had formed two meters to the west. This can be partially explained by the slight downward slope of the ground behind the house on the north-east side, which drains water away from the house before it can penetrate the foundation. In contrast, the ground in front of the house on the south-west side often remains saturated for hours after a rainstorm, seeping out slowly through the stones of the retaining wall below. The subsurface flow of water on this west side, combined with water retaining clay soils, gives this area particularly poor drainage.

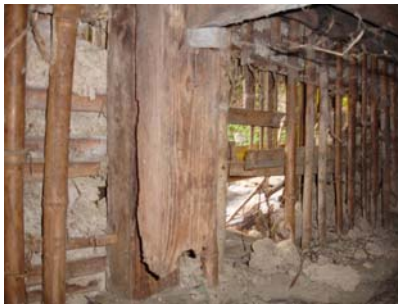
Figure 12. Exterior column base

On the north side of the house, the bases of all of the perimeter columns have been removed and replaced with new support posts in response to moisture damage. However, the original columns are not sufficiently restrained to their new column bases in the north-south direction, making them susceptible to rotation in this direction. Also, during repair work, almost all of the horizontal bracing connecting the north perimeter columns with the rest of the structure was severed. Presumably, the members had been weakened by moisture damage and were simply removed, but it is perplexing why this bracing was not replaced. The result is that the rigid structural frame is disconnected at this point, leaving the lower half of all north perimeter columns floating separately from the rest of the house.

While diverting water runoff will alleviate the rot of floor timbers, the amount of damage already suffered and their reduced structural capacity will require them to be replaced at some point in the future. When this is done, all free-standing braces should be removed and an experienced carpenter should evaluate and more securely brace any unstable sections. Similarly, if the exterior north wall is to be rebuilt, it is important that the horizontal braces connecting this wall to the interior structure be reconstructed.

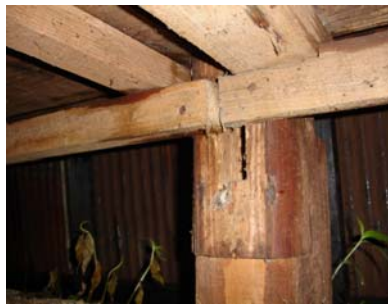
Figure 13. Unrestrained member

Clustered beneath the west side of the house, simple unrestrained buttresses were installed by repair workers to provide additional support for the floor structure. Some look precariously balanced, but are stable to the touch. If there is any vertical movement in the house structure, these new members have the potential to damage the frame by applying an upwards force in undesirable places. The buttresses were installed to compensate for a loss of structural capacity in the main floor beams caused by moisture damage. Predominantly on the west side of the house, the wood of these beams is flaky and crumbles to the touch in places, consistent with symptoms of dry rot.

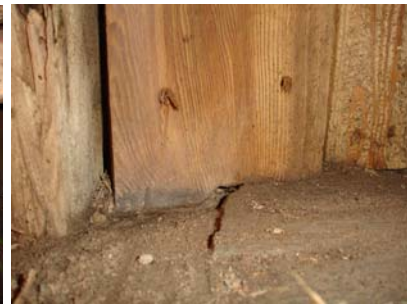
Figure 14. Column movement

Column bases rest directly on foundation stones with no horizontal restraint. Many of these columns exhibit some signs of movement at the base, either lateral or rotational. The lateral movement is evident in places where the column base was precisely cut to match the surface of its foundation stone, but has now shifted to reveal a small gap between the two. More common is rotational movement, usually only evident from a slight gap between the foundation stone and one side of the column base. In a few places where the column is resting on an irregularity in the foundation stone, the shear force at this point causes a small piece of the column to splinter along the grain.

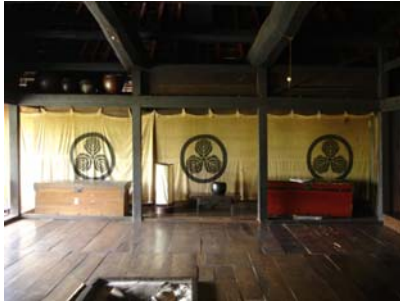
Figure 15. Column lean

The most noticeable structural defect of the house is the lean of almost all major structural columns by an average of two degrees towards the south. Some columns lean but remain straight while others bend while leaning. Those that bend tend to exhibit a convex curvature in the direction of the lean, with greater bending at the base of the column and less towards the top. Most also lean slightly in an east-west direction, generally leaning in toward the center of the house. The floors of the house generally follow this lean towards the south, but in a less uniform way than the columns. Some sections of the floor centered along the east west axis of the house are perfectly level, while the lean of others varies to more than twice the angle of the columns without any discernable pattern.

Due to the potential instability of the terrace itself, correcting the structural lean will have to be minimally invasive without the use of heavy equipment. This will be difficult and expensive, requiring the services of an experienced carpenter with specialized knowledge of traditional wooden construction. It cannot be stressed enough that the use of hydraulic jacks or any other such equipment has the potential of disrupting the retaining wall, causing massive structural collapse.

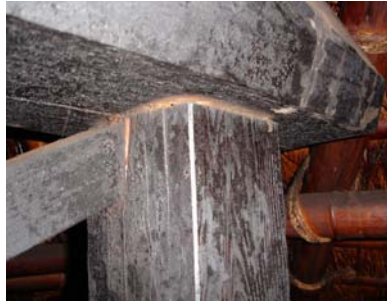
Figure 16. Stress cracks

In many of the large, north to south running beams which form the lower chords of the roof trusses, fresh stress cracks can be seen developing under much older cracks. While there are no new individual cracks, the old and new layers of the same crack can be seen by the clear division between the original crack blackened with soot, and the newly exposed fresh wood. Fresh stress cracks can also be seen where these same large, north to south running beams are joined to vertical columns, indicating extra stresses at these joints. While new cracking in the transverse beams is concentrated on the west side of the house, it does occur to some extent on nearly all of these beams. New cracking at the joints however, can only be seen on the west side of the house.

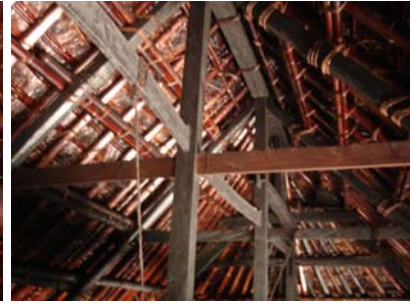
Figure 17. Warped braces

The thin wood members that provide horizontal bracing in the roof trusses have nearly all been either warped badly or replaced entirely. While this indicates movement of structural members, it is unclear if and how much the effects of this movement have been exaggerated by warping caused by moisture intrusion from leaks in the roof thatch. Also, the original mud and plaster walls which covered the north side of the house have been destroyed by years of water intrusion, and replaced with wood siding. The result of this moisture damage is that most of the horizontal braces tying this north wall into the main structural frame have rotted away and lost their structural capacity, much in the same way as the horizontal braces at the foundation level.

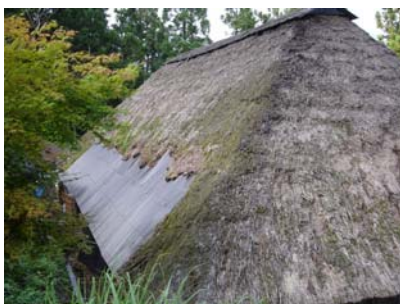
Figure 18. North Vs. West sides

The bulk of the damage to the thatch roof occurs on the north side, where a lack of sunlight creates damp conditions during the rainy season and a buildup of snow during winter months. Villagers report that snow levels can be two times as deep on the north as on the south side of the roof. During the winter of 2005, the peak levels of snow coverage were approximately one and a half meters on the north side and three quarters of a meter on the south side. The thatch is only eighteen years old, but shows damage more consistent with a roof three times its age. Primarily, this damage is the result of the house's abandonment since rethatching. A crucial part of maintaining a thatch roof is keeping wood fires constantly lit, as the heat helps to dry out the thatch and the smoke destroys any potential plant or fungal growth.

Simple maintenance will alleviate some of the deterioration suffered by the house. Hearth fires should be kept burning as often as possible to maintain the thatch roof, and during winter months snow should be gently cleared from the north side of the roof. It is important not to clear all of the snow, which could result in scraping and damaging the thatch bundles. The goal is simply to level the snow load between north and south sides of the roof.

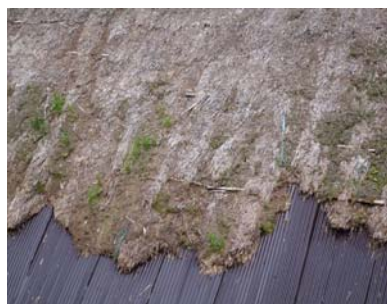
Figure 19. Exposed bamboo

On the north side, damage to the thatch is so severe that the bamboo cross pieces used to hold layers of thatch together have been exposed. Normally, these should be no less than five centimeters below the surface of the roof. Most likely, because fires were not constantly lit during previous winters, ice formed as snow melted and refroze, binding to the thatch and gradually stripping it from the surface of the roof. Damage to the north side of the roof has been so extensive that leaks have formed under this side of the house. In early 2006, metal sheeting was installed over the most heavily damaged areas. The edges of the sheets were first wedged under a portion of the thatch, then hammered upwards, to get as deeply beneath the thatch as possible. They were then covered with a protective coating of tar and the edges sealed with an epoxy foam.

At this point, damage to the roof is too severe to correct with maintenance alone. The north side of the roof has lost almost a quarter of its original thickness, exposing the internal bamboo cross pieces. The most severely damaged and decomposed areas of thatch were removed after a particularly heavy snowfall during the winter of 2005. Metal sheeting was installed to cover this area and prevent leaks, but this is only a temporary solution and may in fact be encouraging further moisture penetration. Quite simply, the roof must be rethatched soon.

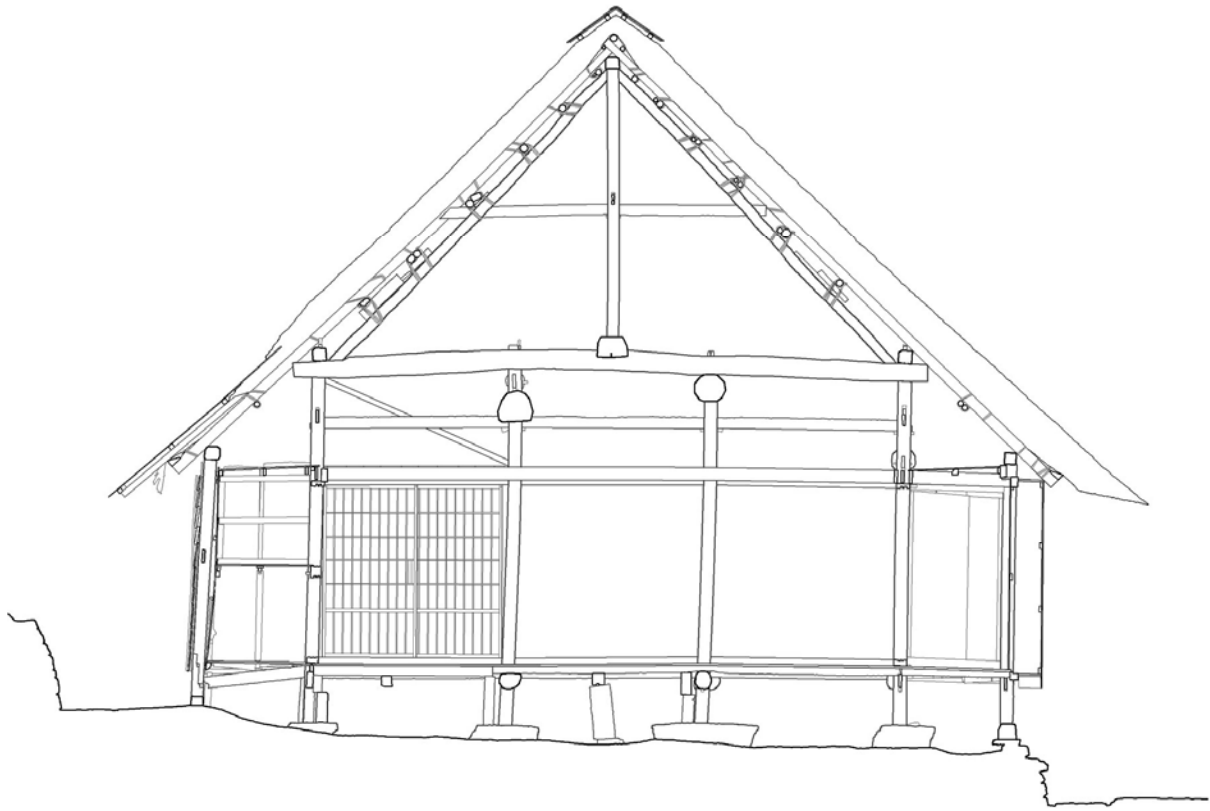
Figure 21. Column lean measurements

Due to the house's orientation, the north face of the roof remains in perpetual shade during winter months. This causes double the amount of snow to accumulate on the north face of the roof as on the sunny south face. As can be seen in section, the roof timbers supporting the thatch have deformed under the extra weight of the snow, causing crushing of some of the bamboo cross pieces. This is not a major problem, because the members effected are not part of the main structural core and could be easily replaced during the next rethatching of the roof. While there is little realistic danger of structural collapse, a record breaking snowfall could cause the local collapse of a small portion of the roof.

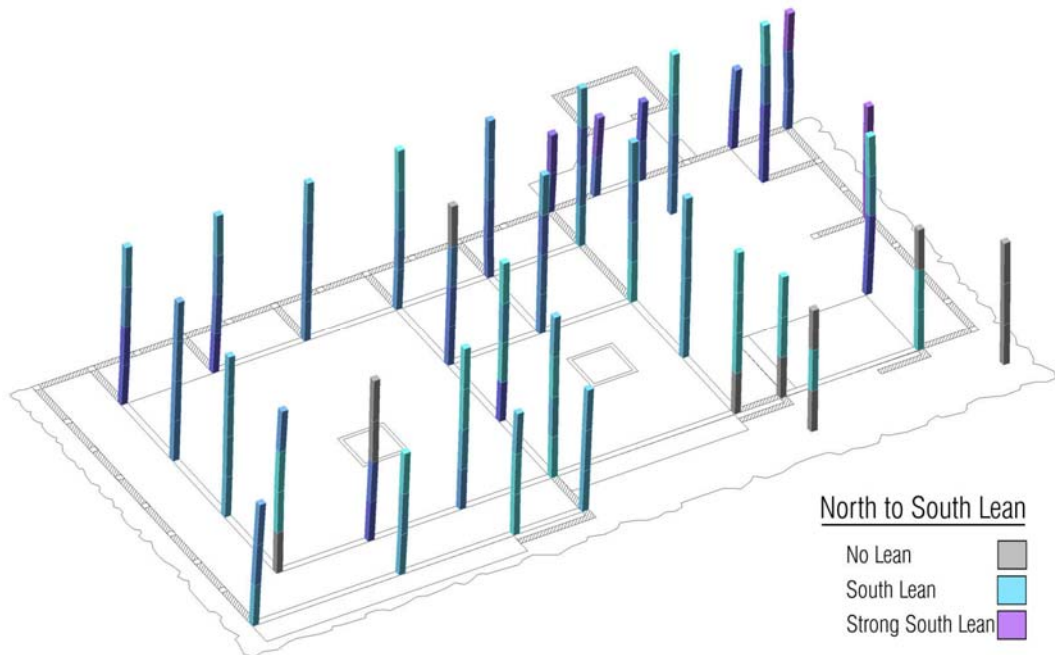
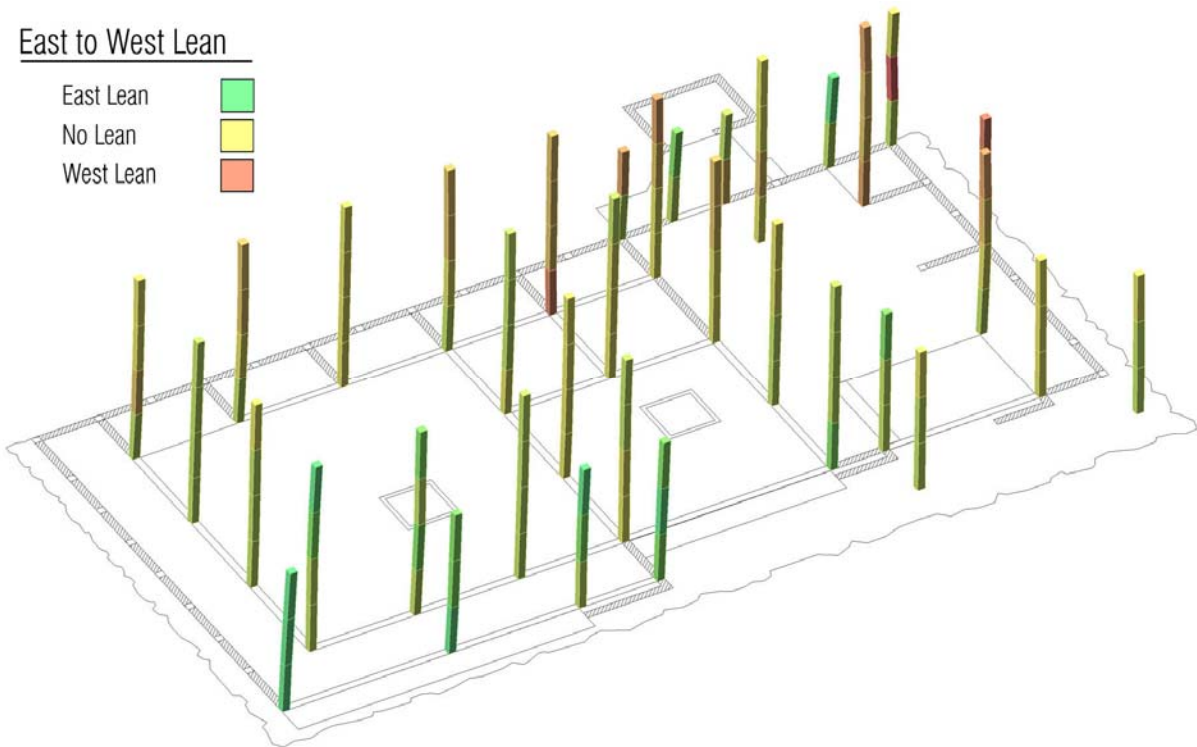
The north to south lean diagram reveals that while all columns are leaning to the south, those on the northern side of the house are leaning more severely than those on the southern side. The east to west lean diagram shows a similar clear pattern of movement, in this case the south-eastern most columns are leaning inwards to the west, and the north-western columns are leaning to the east, indicating that a torsional force is acting on the entire structure. While there are several localized irregularities, a distinct pattern emerges from the diagrams. In both cases, these results show the early stages of global structural failure. The joints holding the structure together have begun to slowly weaken, which will eventually cause the entire building to slowly collapse upon itself.

While the most obvious structural defect is the predominant north to south lean, the detailed column lean measurements indicate an additional counter-clockwise twisting of the structure. The column lean on this east to west axis, averaging at a half degree off the vertical, is less severe than on the north to south axis, which averages at two degrees off the vertical. However, this racking is troubling because it indicates a large scale weakening of the entire structure.

The column lean measurements indicate a heavier southern lean in columns on the north side of the house than those on the south side. However, if the house were viewed at an angle, correcting for its average lean, it would appear that the columns are leaning inwards subtly. Combined with the racking of the structure, this indicates that added stress is not only causing the house to lean, but is weakening its joints. With almost no diagonal bracing, these joints provide crucial stability to the wooden frame. It should be stressed that these effects are very minor at the moment, but if the overall lean of the house is not corrected and stress removed from the structure, there is a danger of gradual collapse.
