The Failure of the Timber Structures Caused by Incorrect Design-Execution of the Joints. Two Cases Study

Pier Paolo derinaldis, Gennaro Tampone*

University of Florence, Dept. of *Conservazione e Restauro dei Beni Architettonici, Collegio degli Ingegneri della Toscana**

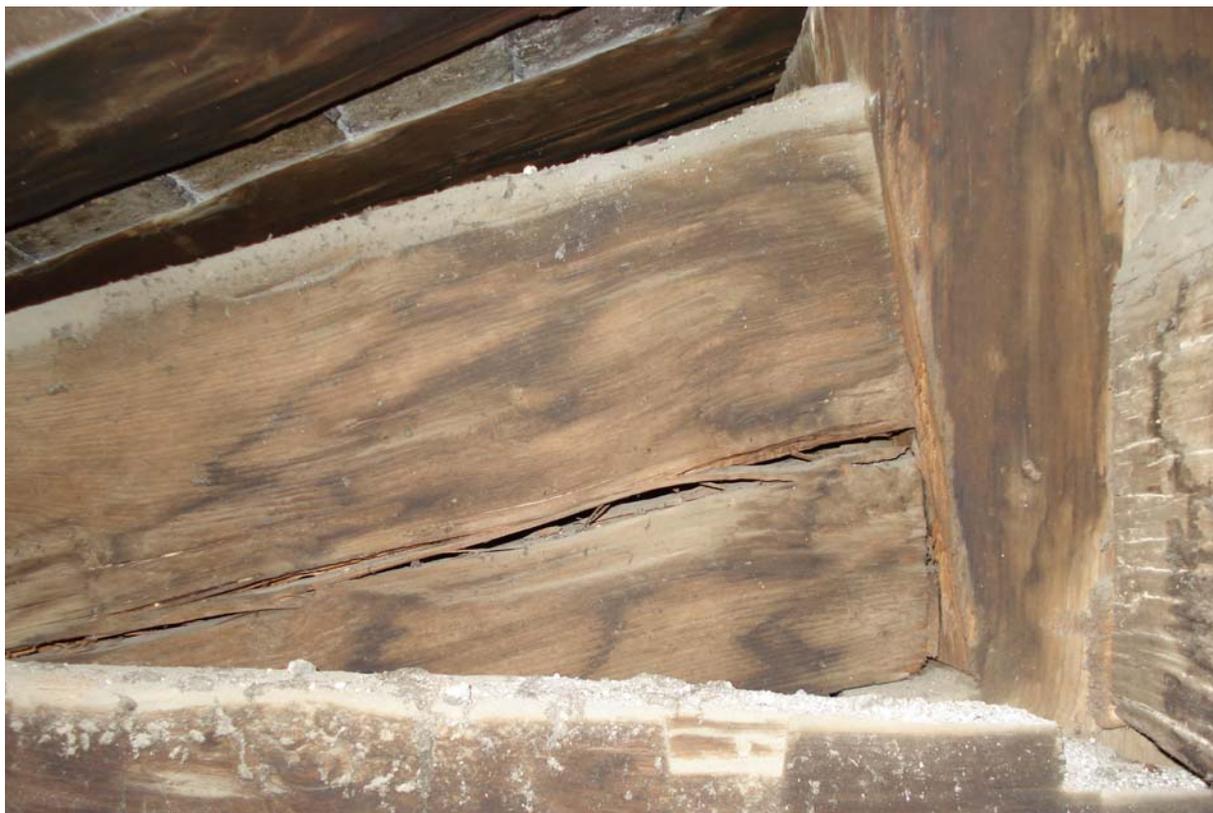
Figure 1. *Palazzo Altieri (Roma)*. Passing trough crack (splitting) of the rafter of a truss, placed on a previous shake, caused by wrong execution of the joint. In the picture it is evident that only the upper part of the end has close abutments, the inferior surfaces do not touch

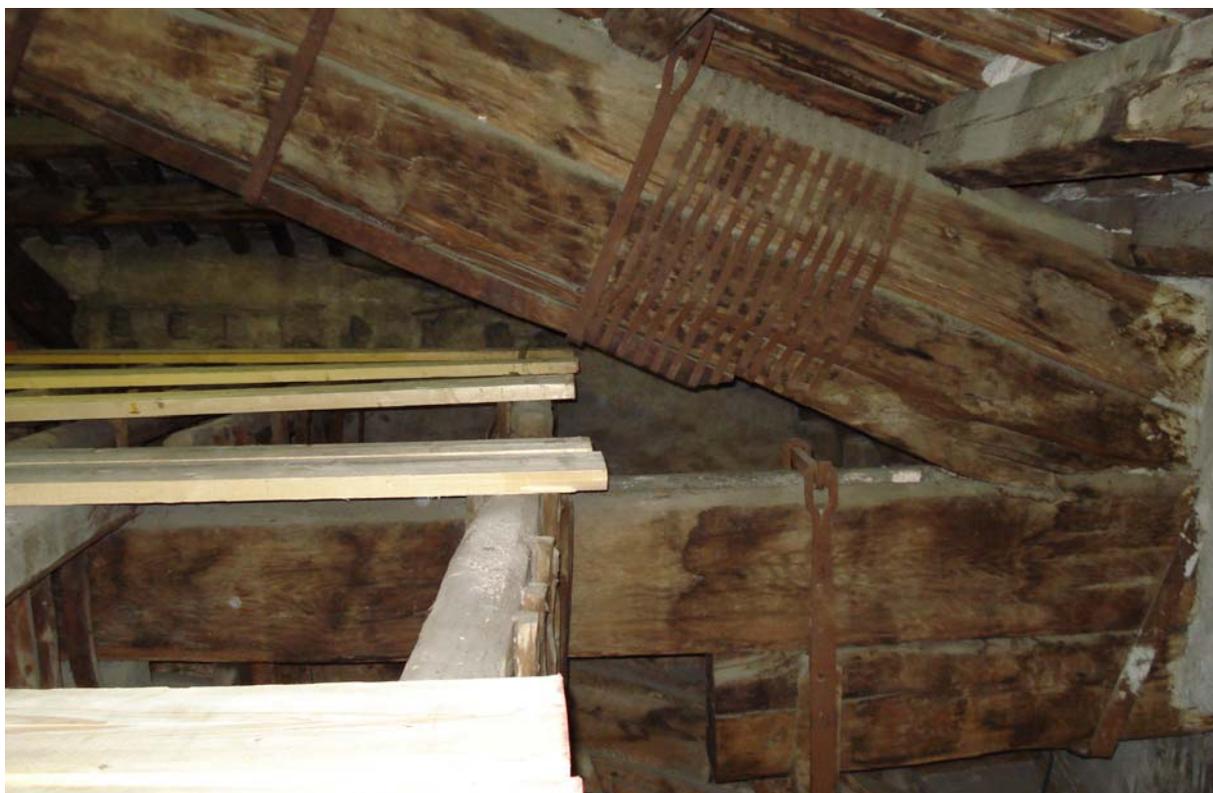
Figure 2. *Palazzo Altieri (Roma)*. Crack of the clog of the connection section of the rafter of a truss caused by insufficient sizing, wrong design. The presence of humidity stains allows the suspicion of decay of the wood caused by biotic attacks. Note the multiple splitting fissures along the fibres in the sections close to the indentation and the bending of the lower fibres bundles

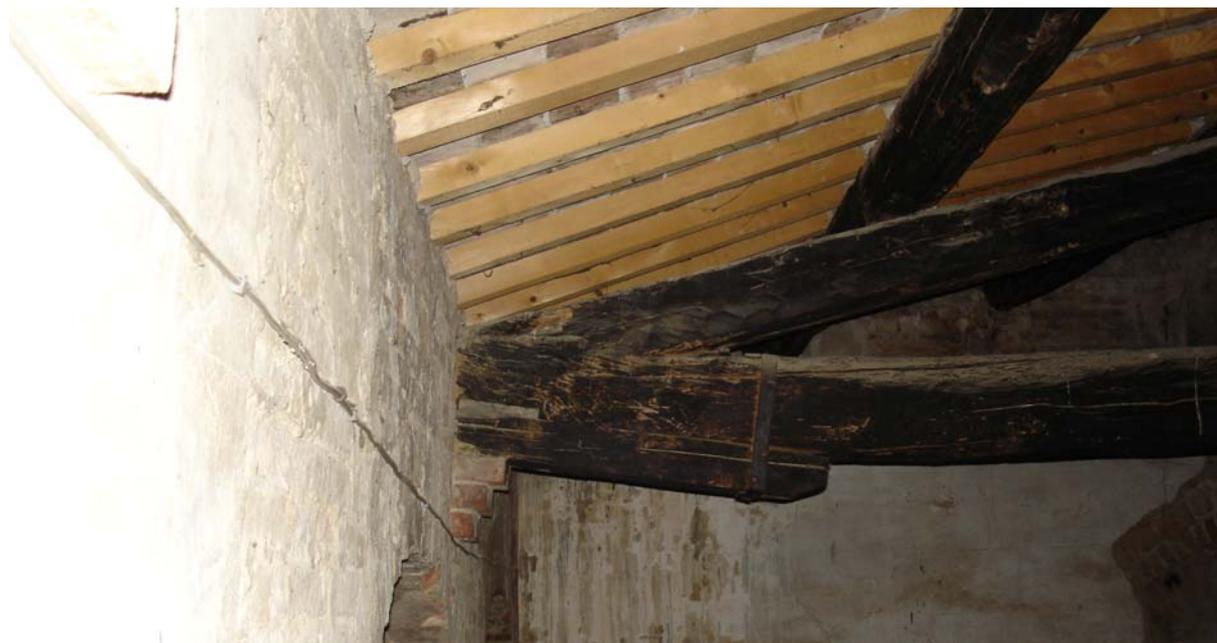
Consequently the exterior part of the chord is undergoes a bending stress produced by the vertical reaction of the bearing and by the vertical component of the interior stresses. The results of this incoherence is immediately perceived in a big deformation of the chord.

At the same time we can note a break in correspondence with the joint. This break causes the sliding of the rafter on the chord. This sliding is also caused by the bad quality of the wood which presents an irregularity and deviation of the grain.

The structural failure increases and starts a reiterative process, because the running of the rafter makes the king post touch the chord (the chord is stressed from bending moment).

Figure 3.Palazzo Vicariale of Certaldo. Severe deformation of the rafter of the truss of the roof of the Sala Vicariale in the sections under the clog, splitting of the rafter at the connection with the chord indentation, severe deformation and crack of the chord close to the collar tie, splitting of the ancon.

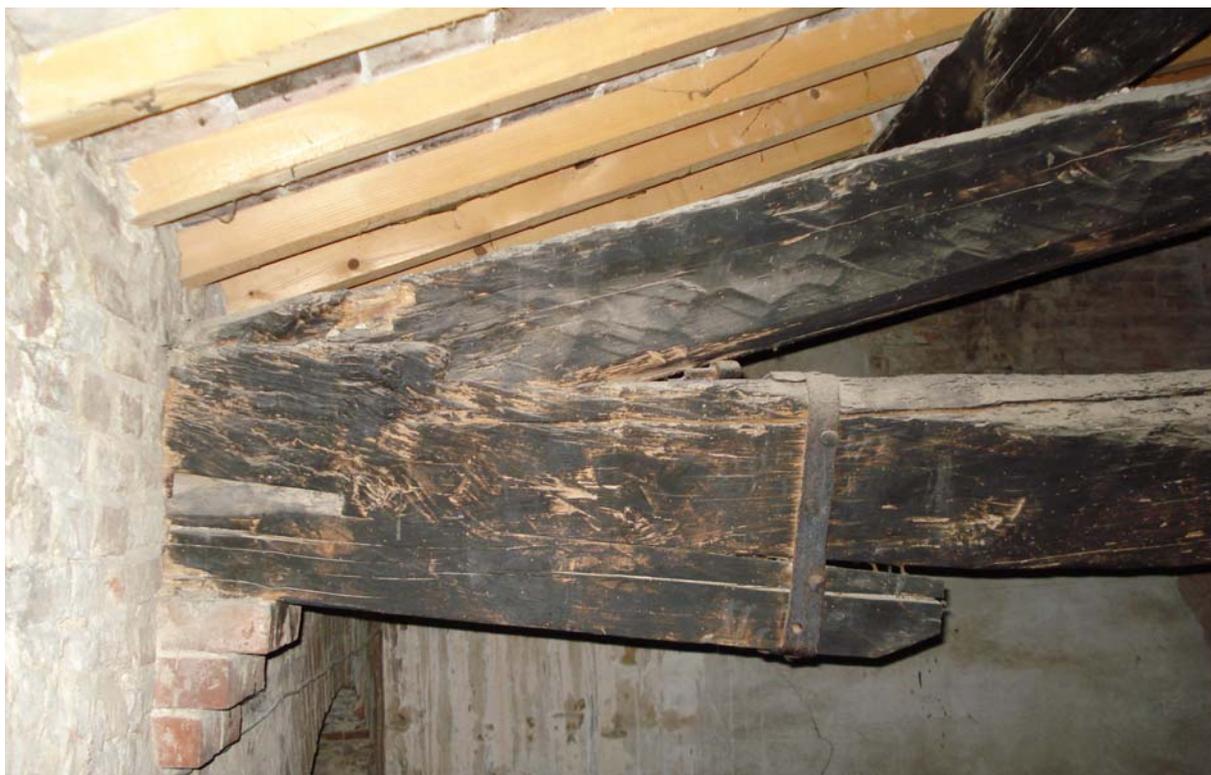
Figure 4. Palazzo Vicariale of Certaldo. All the failure scenario is caused by erroneous placing of the node of the truss on the wall with the indentation out of the support: the reaction of the load transmitted by the rafter on the chord and the reaction of the wall support produce a bending moment which, over the time, generated the deformation and the crack.

The timber ancon, the brick ancon and the collar tie are insufficient measures taken in a close past; the collar tie does not connect, as it should do, the three converging rods

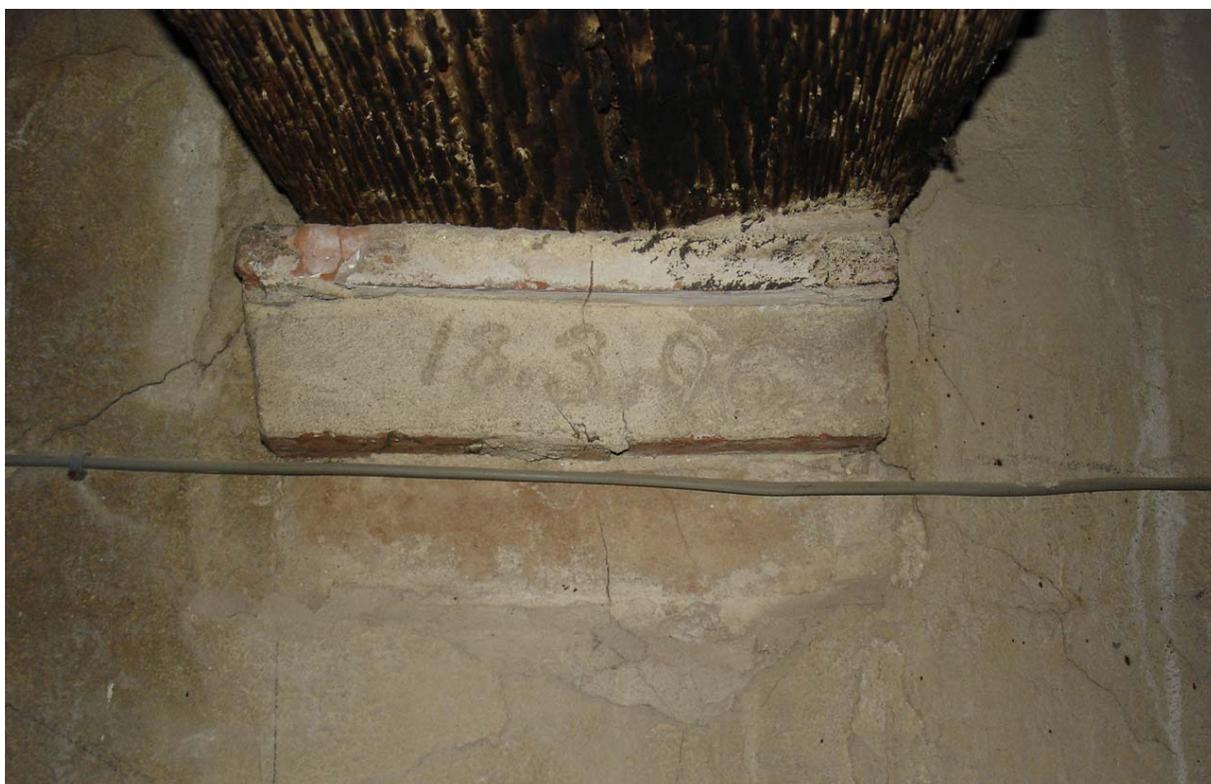
Figure 5. Palazzo Vicariale of Certaldo. Typical fissures and generalized cracks of the wall support of a truss, caused by excessive pressure on the edge of the masonry support following the deformation and rotation of the chord

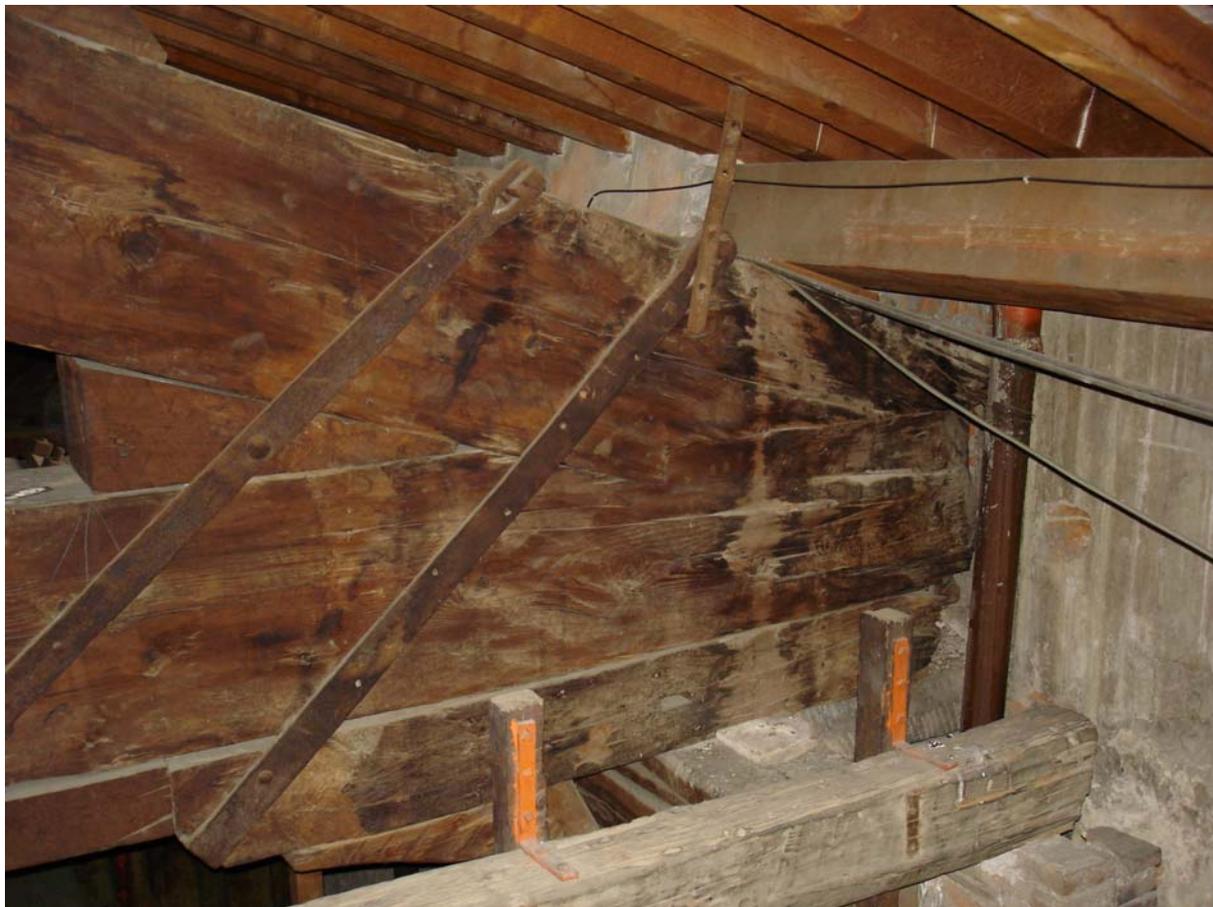
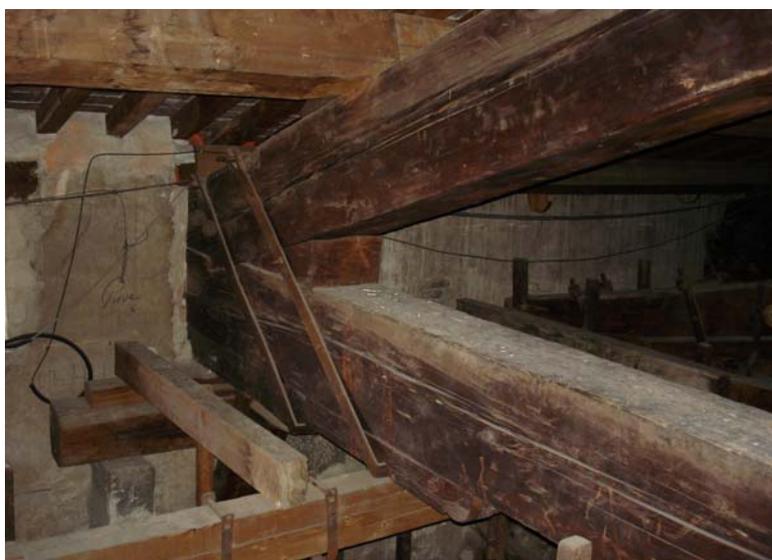
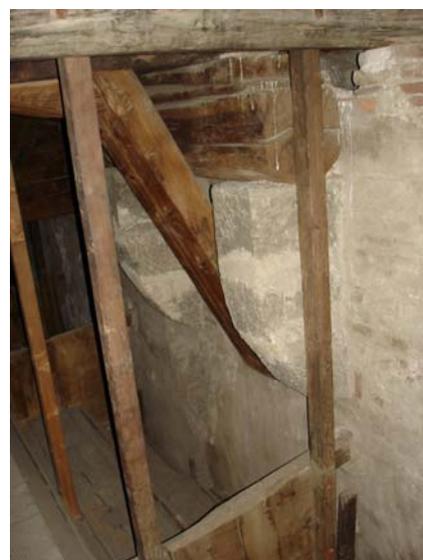
Figures 6,7,8. One of the Vasari's truss. Insertion of wooden strut, stone ancones and large wooden adjustment wedges, meant to obviate the inadequacy of the masonry support

A very significant example is the system designed by Giorgio Vasari for some trusses of the *Salone dei Cinquecento*. Here the increasing of the bearing surface is assured by the presence of two stone ancones where enormous timber wedges rest. These wedges are the regulation mechanism which assures the tighten between the stone ancones and the intrados of the truss bearing surface.

A timber strut placed exactly under the timber ancon of the truss provides an additional support and alleviates the timber wedges from the high concentration of the load.

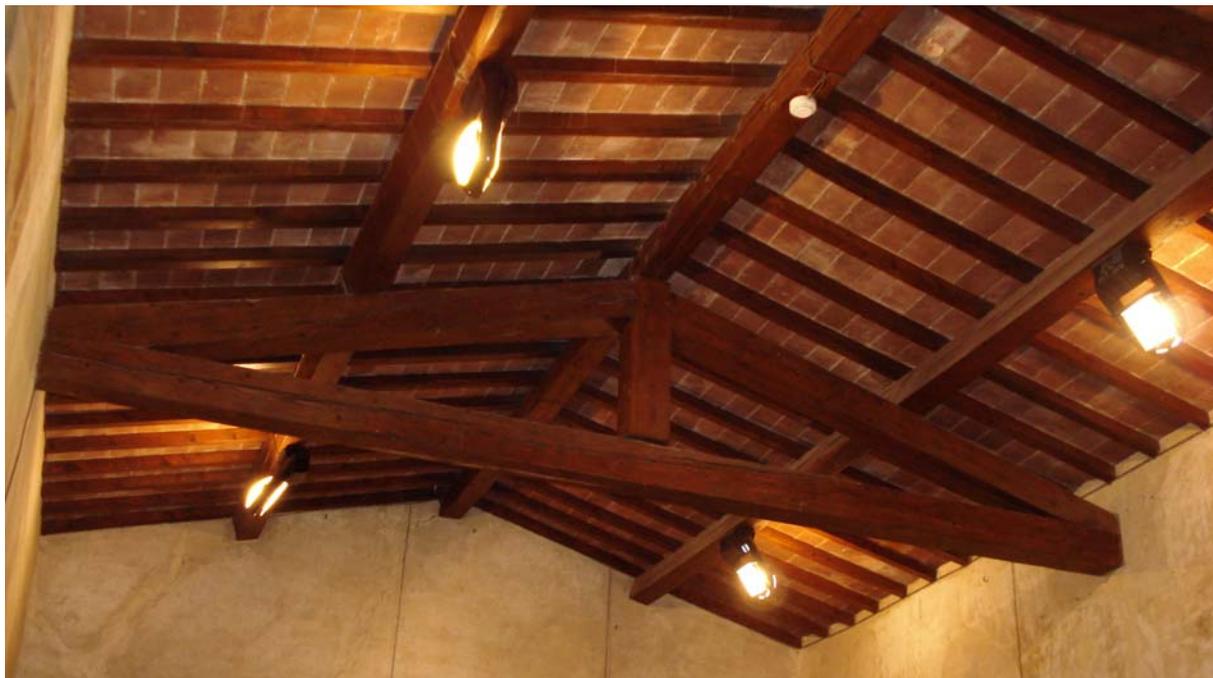
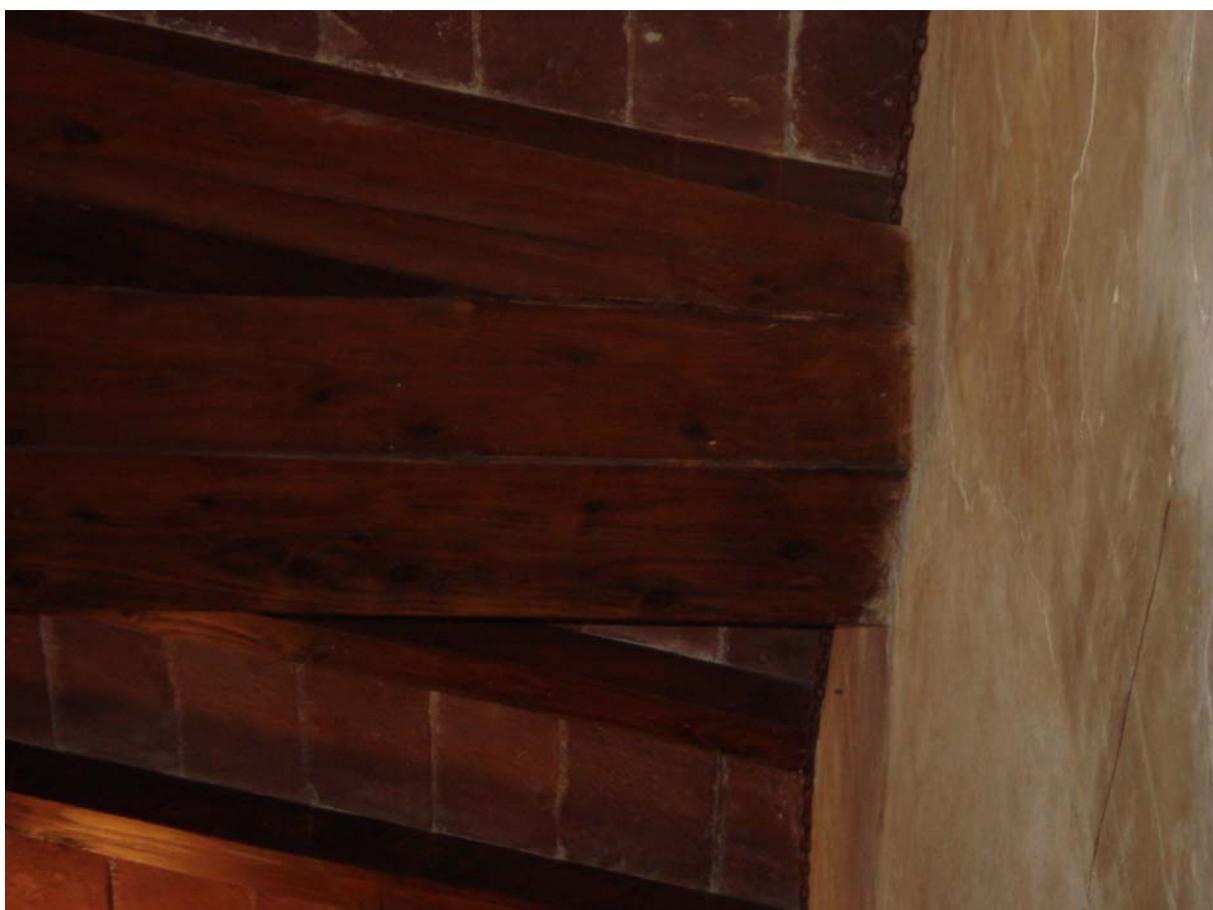
Common degradation caused by wrong design or execution can be found in the simple overlapped connections between rafter and chord.

The hand workers rely on the action that the masonry can offer to prevent the rafter from sliding on the chord.

In the case of a very thin masonry, the diaphragm that divides the woods from the exterior, could be extremely little and unable to support the stress.

Another hindrance to the sliding is the masonry weight on the rafter. Frequently, metallic ties are not present, while they would be useful since they block the sliding of the rafter on the chord.

Figures 9,10. Palazzo Vicariale of Certaldo. Connection by simple over position of the rafter on the chord in the main joint of one of the trusses

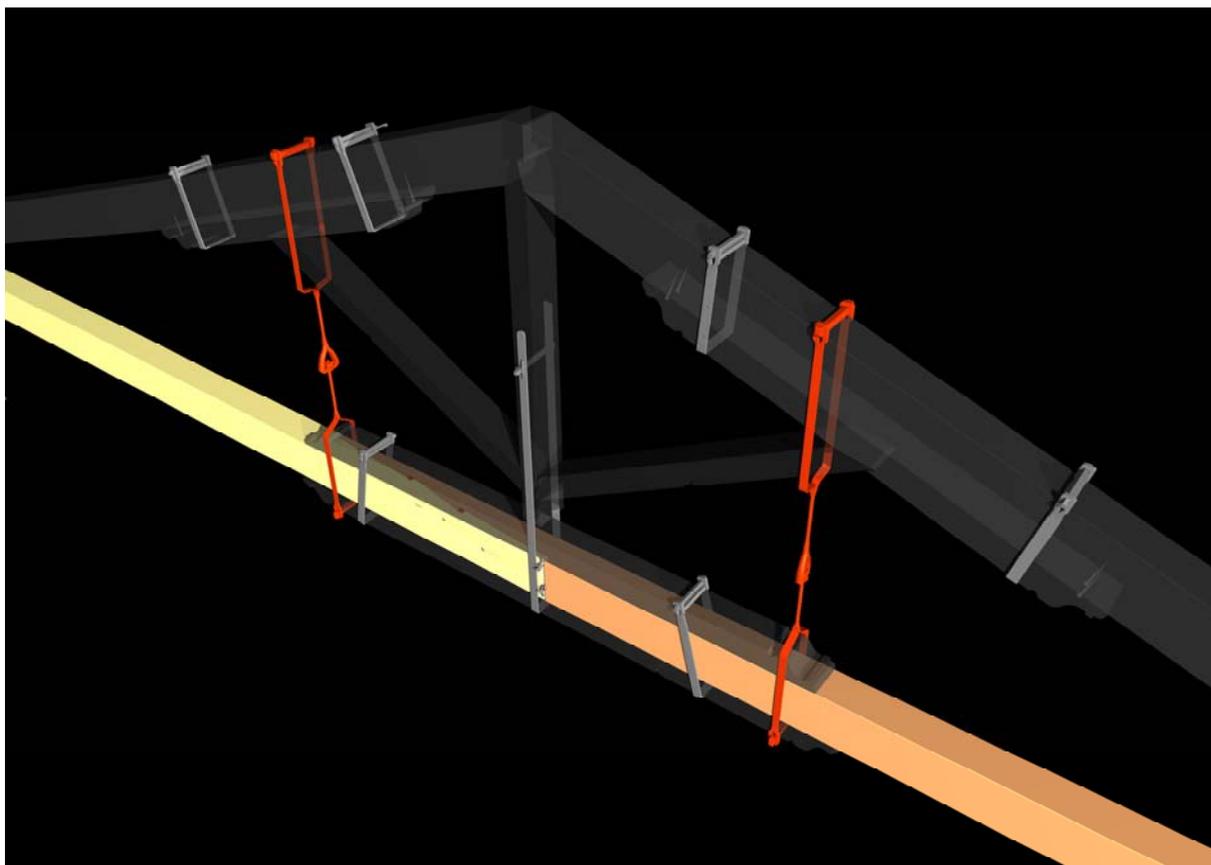
The cited truss is similar to the others except for the different length of the two component pieces, one is 15 m, the other 12, with a difference in weight of about 300 kg. The truss is not symmetric because the intermediate connection is not in the centre. The deformation is asymmetrical as well.

Figure 11. Vasari's truss, 3d model. The Jupiter's arrow connection is not put in the middle but sideways. Only by means of the two iron suspenders (red in the figure), placed in the first half of the XIX c., prevent from rotation the two stumps of the chord

The chord is connected with the rafters by two big wrought iron collars, equipped with regulation devices. These collars have the task to block the displacement at the bottom of the chord.

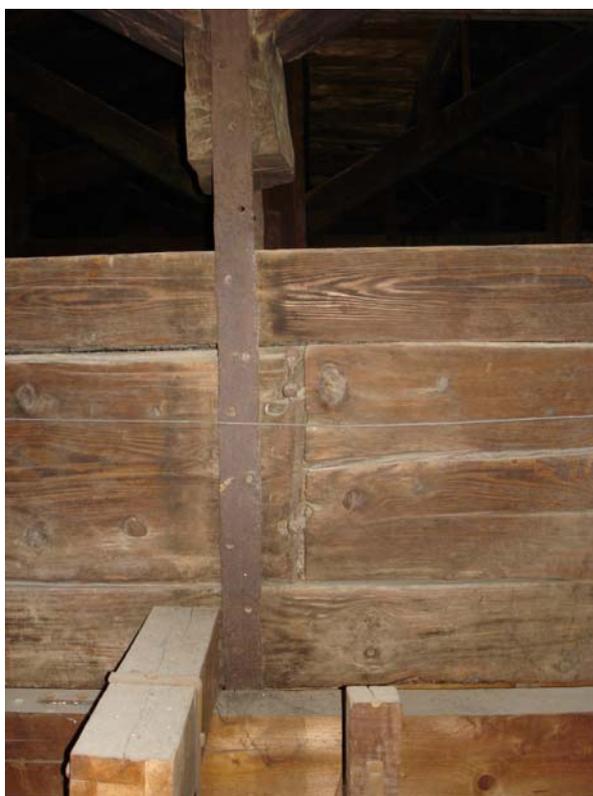
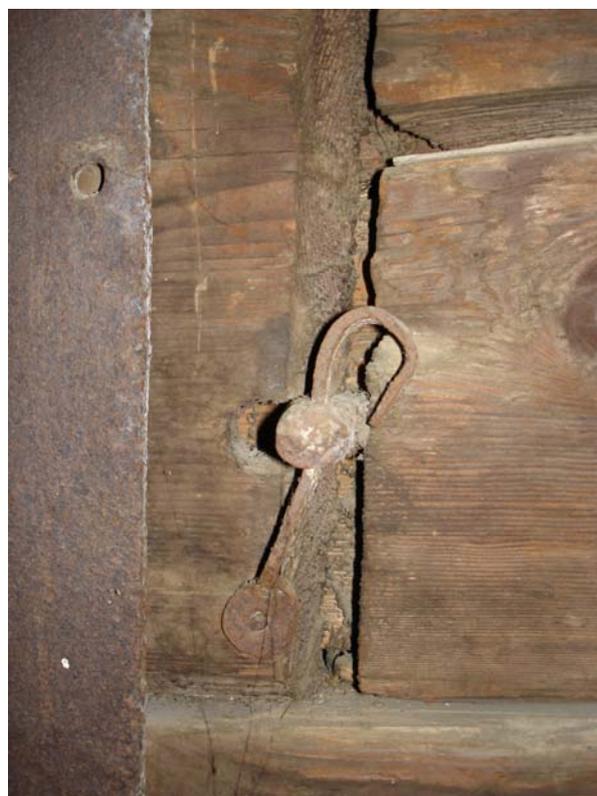
Figures 12,13. Wrong position of the metallic keys that should have connected rigidly the two components of the chord. The photo on the right shows the break of the abutments

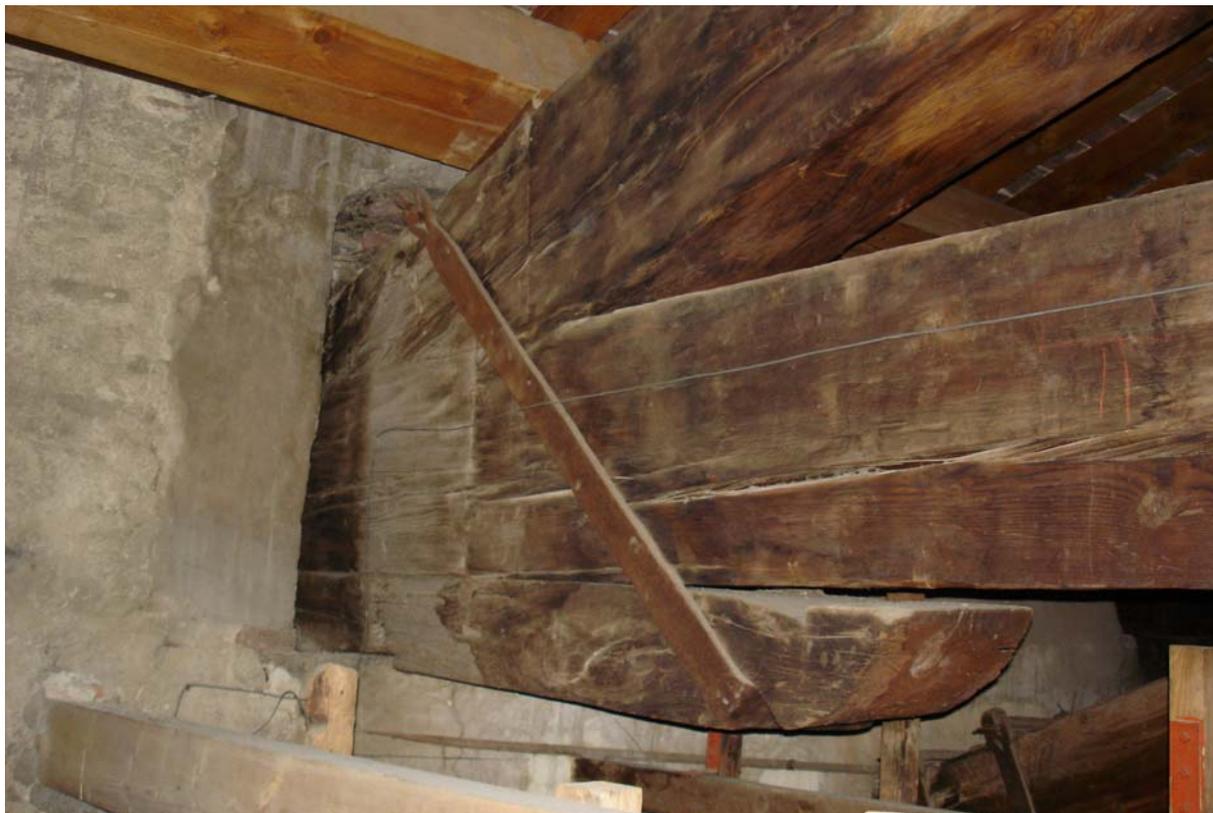
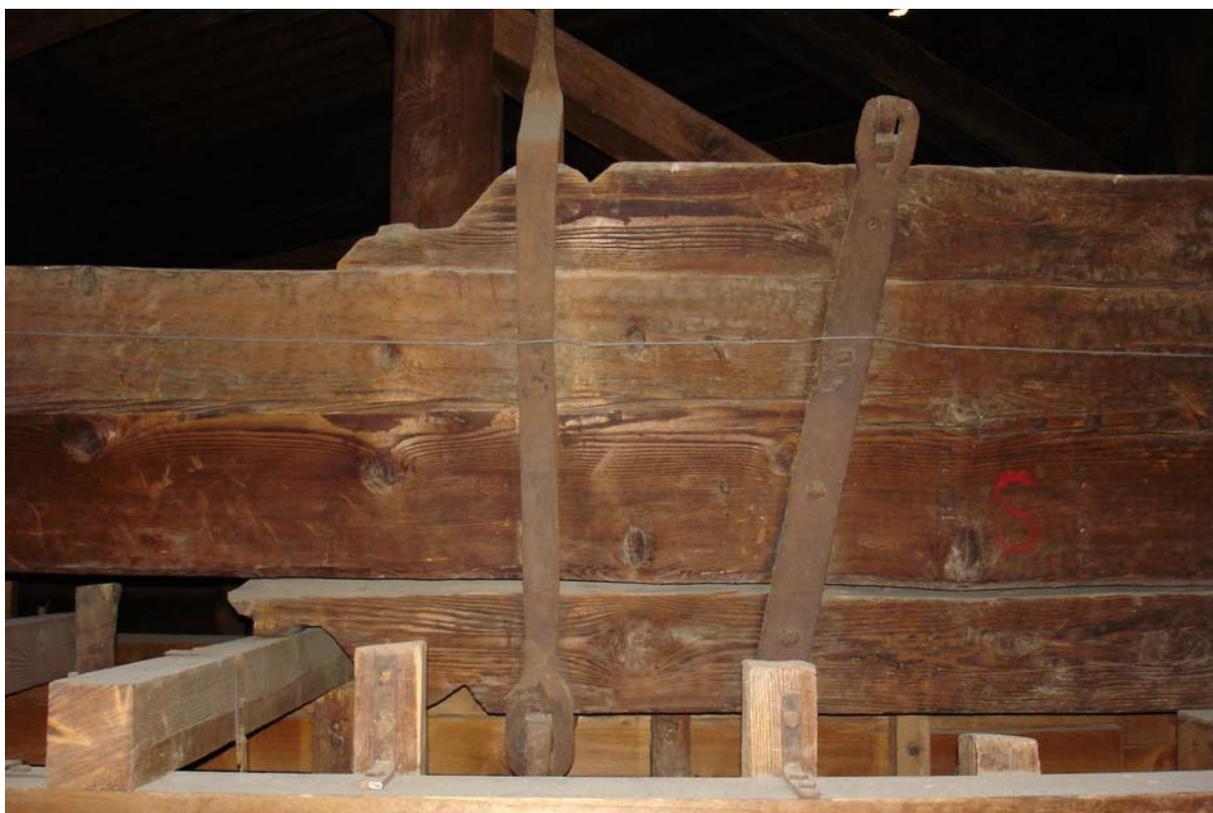
Figures 14,15. The Vasari's truss. The mutual rotation of the chord and of the ancon
