Assessment and Analysis of the Breeding Barn at Shelburne Farms

David C. Fischetti^{*}, Douglas W. Porter^{}, Ronald W. Anthony^{***}**

President, DCF Engineering, Inc.^{*}, School of Engineering, University of Vermont^{**}, President and Wood Scientist,
Anthony & Associates, Inc.^{***}

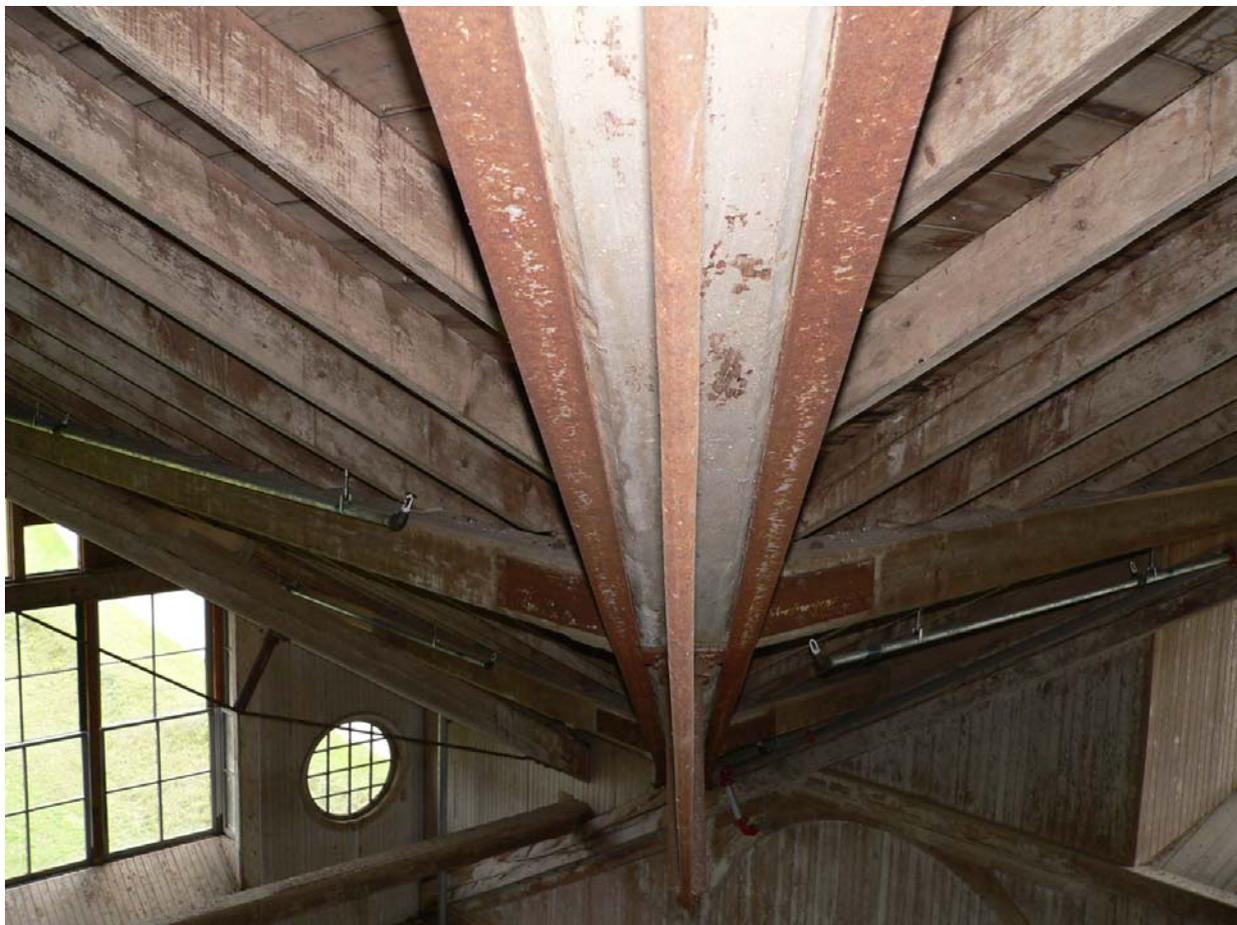
The timbers that make up the valley rafters were found to be generally in good to excellent condition. There were some exceptions. Each of the rafters was subjected to resistance drilling along its length to generate a schematic of the location and approximate extent of deterioration. Some of the rafters have deterioration on the upper face of the timber that penetrates to various depths, a condition called channelizing. Two of the valley rafters have severe deterioration of the heel where they bear on the interior wall.

Figure 5. Valley Rafter 17 South viewed from the apex.

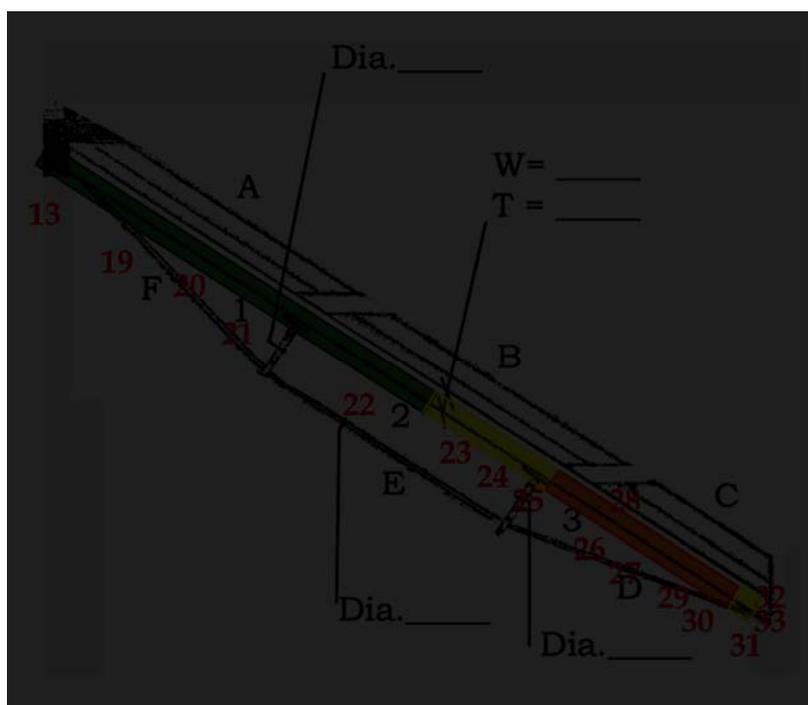
locations are marked by the drilling number on the schematic. As shown in Figure 6, this rafter has a varying extent of channelizing along the lower length of the rafter. Resistance drilling and probing revealed minor channelizing between the queen posts that progressively increased to the heel of the rafter. The upper length of the timber was found to be in good condition and is indicated as such by the green color.

Figure 6. Resistance drilling results for Valley Rafter 17 South. Numbers in red indicate drilling locations.

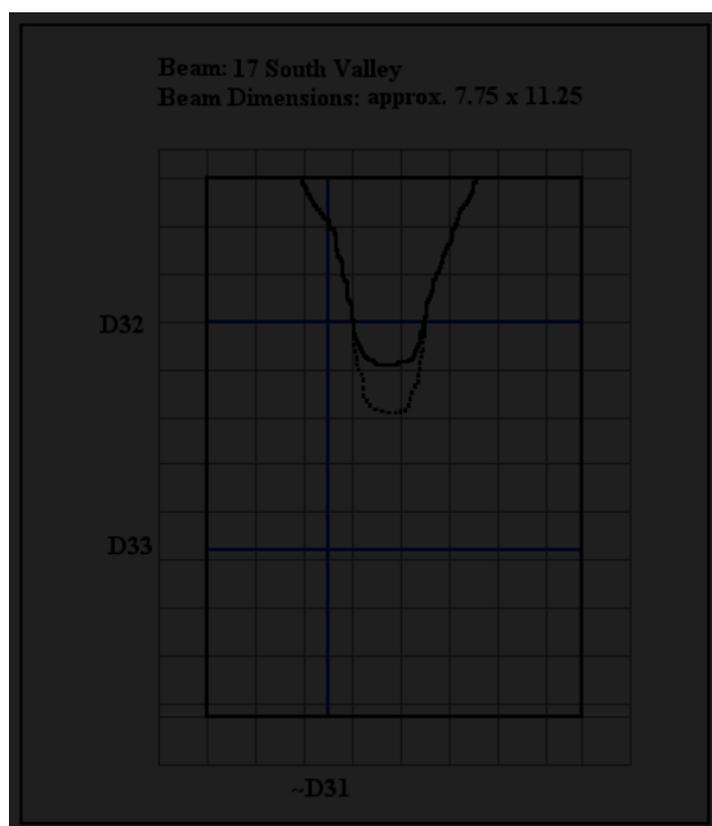
Figure 7 is a diagram of the drilling results from drillings 31, 32, and 33 (which are shown on the schematic in Figure 6). The diagram is an approximation of the width and depth of the channel due to decay as indicated by the three drillings. A decay pocket of this depth was referred to as deep channelization.

Figure 7. Diagram showing channelization pattern in Valley Rafter 17 South. Dotted line indicates likely pattern of the decay pocket, since only three drillings were conducted.

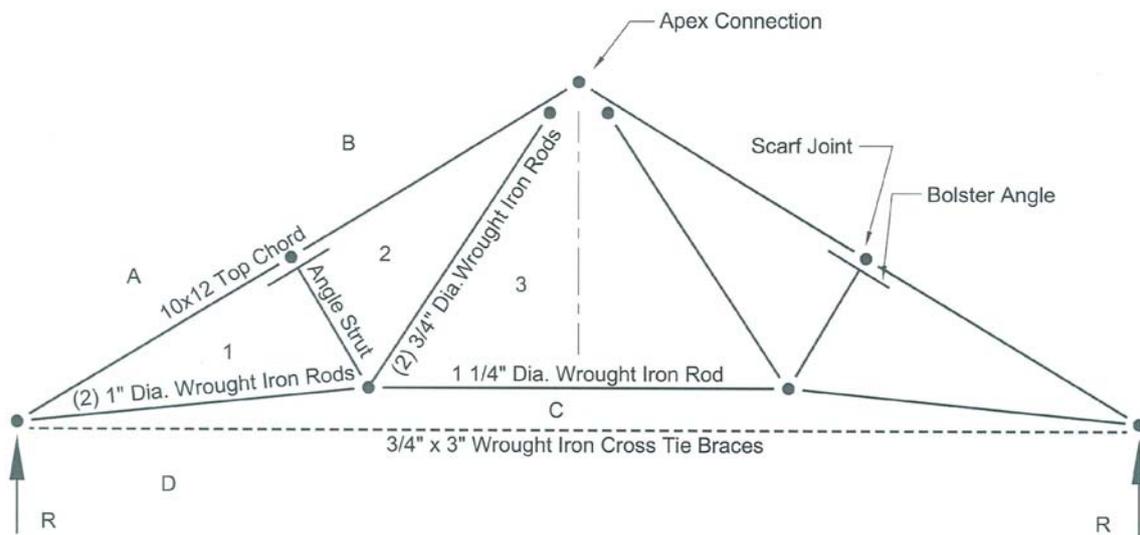
The preliminary analysis of the primary truss was performed with a 146.5 kg/m² snow load and 73.2 kg/m² dead load. The analysis indicated that there are overstresses in the top chord as well as the rods which extend from the heel supports to the queenpost struts. It is possible that the overstress in the 0.254 m x 0.305 m top chord is a result of the original designer analyzing the truss using graphical means (force diagram and string polygon) first developed in the United States by Col. Stephen H. Long in the 1840's.

Figure 8. This image shows the location of the bolster angles and the connection arrangement at the apex.

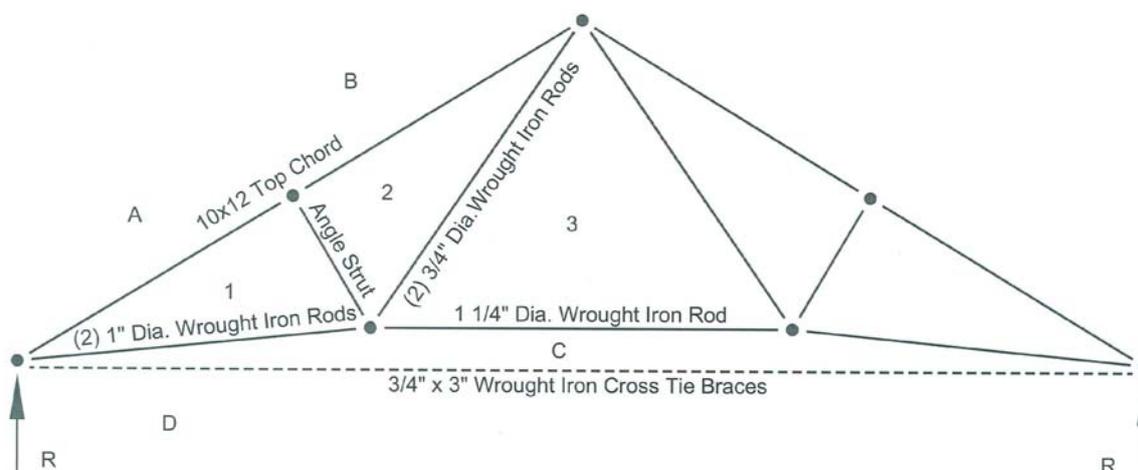
Figure 11. Analysis of the truss with the cross braces included, causes member C3 to revert to compression.

The addition of 1.91cm thick by 7.62cm high cross-brace tie rods to the building, apparently during construction, provides another path for the tensile force to be resisted. By including the tie rods in the analysis of the building cross section, the center tie bar of the truss becomes a zero force member (Figure 11). Analysis of the roof truss by the computer using the appropriate section properties and material stiffness shows that immediate horizontal deflection under dead load only would have been a total of five centimeters. This deflection of the trusses would have manifested itself in bending of the 25.4cm x 25.4cm post from a point at the horizontal chord of the roof trussed above the side aisle to the 20.32cm x 25.4cm girt (sill) at the heel of the truss, a distance of almost two and a half meters. Certainly, a horizontal movement of two and a half centimeters would have been observed in the post for a distance of only two and a half meters in height. If the annex had already been built or partially framed, it would have provided some restraint, pushing most of the deflection towards the posts along the north side of the building which certainly would have been observed by workmen.

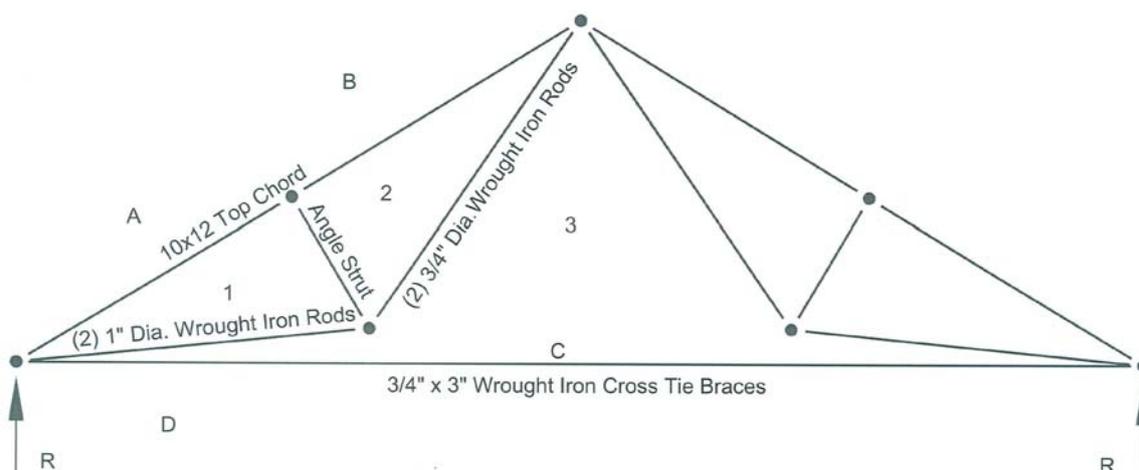
Figure 12. Testing and analysis indicates that the roof system acts as an A-frame with trussed rafters.

The answer was to provide additional ties to limit the movement which is natural to a truss with a raised bottom chord. In providing these ties R. H. Robertson transformed the building cross section into a tied A-frame with trussed rafters (Figure 12).
