"From Material to Structure" MECHANICAL BEHAVIOUR AND FAILURES OF THE TIMBER STRUCTURES

Examination of corroded wood by ammonium phosphate and sulphate-based fire retardants – The results of the Prague Castle roof timber examination

Irena Kučerová, Martina Ohlidalová, Miroslava Novotná*

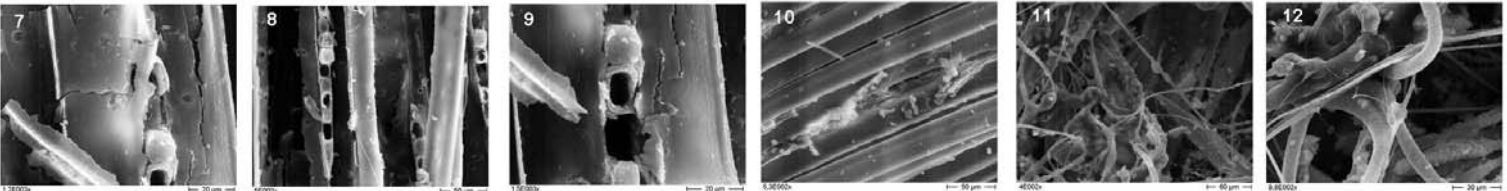
Figure 7,8,9 – A splinter from the House attic. Figure 10 – A splinter from the Vladislav Hall attic Figure 11,12 – Fibers sample from the All Saints Church attic.

Figures 7-12 show the observation of wooden samples by electron microscopy. On the anatomical structure level, some cells of the wood exhibited breakdown of the central lamella, which is predominantly formed by lignin (Fig. 8,9,10), while other cells exhibited breakdown of the cell wall, primarily composed of cellulose (Fig. 7,9). Figures 11 and 12 image the structure of fibers which originate from the wood surface corrosion (fig. 6). Indicates that the cell walls have disintegrated into the fibrous tangle. Microscopical research says that both of the main polymers are corroded – in some cases both of them and in other cases either cellulose or lignin only. Damage of the cell walls by mechanical agent can be considered as well.

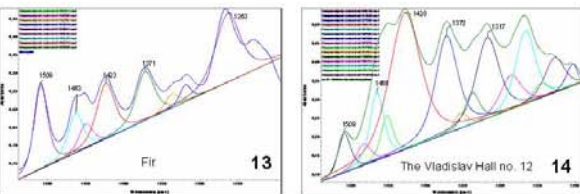
Figure 13,14 – Examples of bands isolation in absorption area 1200-1600 cm⁻¹

Analysis of wood samples was performed with FTIR spectrometer Bruker ISF 66v/S (Bruker, BDR) connected to a microscope Hyperion connected with Cassergrain lens for measuring transmittance spectra, detector MCT, beam splitter KBr. Measured parameters were: spectral range 4000-650 cm⁻¹, resolution 4 cm⁻¹, number of spectra accumulations 1028, apodisation Happ-Ganzel. The measured spectra were processed by a program Omnic 6.1 (Omnics Instruments Co., USA). Evaluation of changes in chemical structure was performed after bands isolation in absorption area 1200-1600 cm⁻¹ (fig. 13,14) and after relative comparison with areas of selected absorption bands of cellulose and lignin, which was calculated according to Gauss and Lorentz function. Table 2 gives information about the selected bands, which were used for the study of changes in chemical structure of wood. The relative changes in cellulose and lignin content are presented in table 3.

The results given there show there is a decrease of the lignin content in the samples which were taken from the wood surface (fibrous samples). Shifting of band position of CH₂ group bending vibration in cellulose to a higher wave number (from 1424 to 1430 cm⁻¹), is likely to indicate a relative increase of cellulose crystalline part as a consequence of a decrease of amount cellulose amorphous part. Creation of new bands was observed in the spectrum of sample no. 9 from the Vladislav Hall. The phenomenon may be related to oxidation of hydroxyl groups to carboxyl groups which are presented in the sample as a salt form.

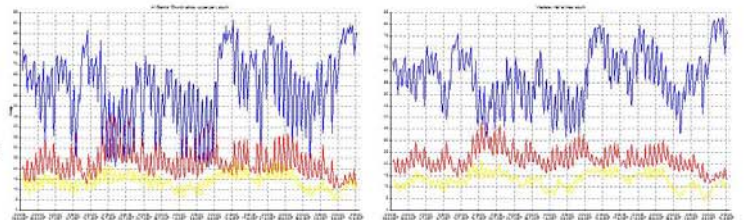
Figure 15,16 – Records of climatic condition measurements

The highest temperature approx. 47 °C was measured in the upper part of the attic that was close to southern tiles. In this part of the attic the temperature arose to 40 °C 9 times in summer 2007. Maximal temperature was lower in the bottom part of the attics. This indicates that the temperature is not one of the main corrosion agents (fig. 15,15).
