Structural Failures of the Timber Structures in Arctic Climate

Johan Mattsson
Mycoteam AS, Norway

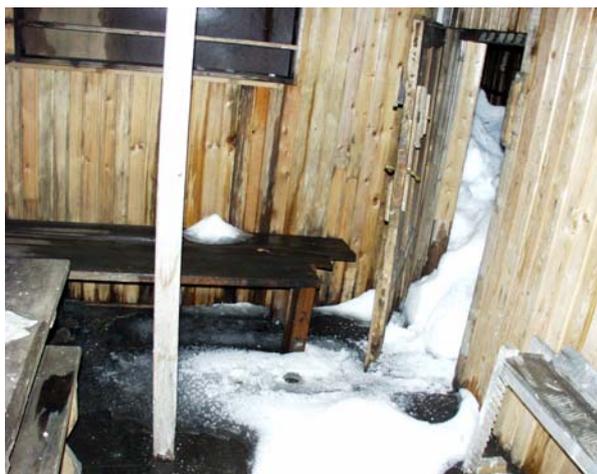
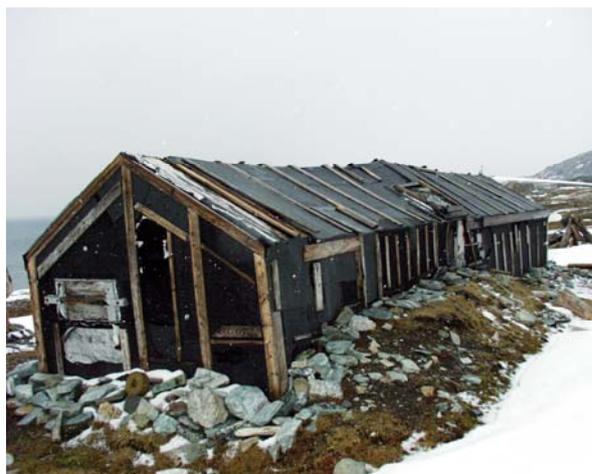
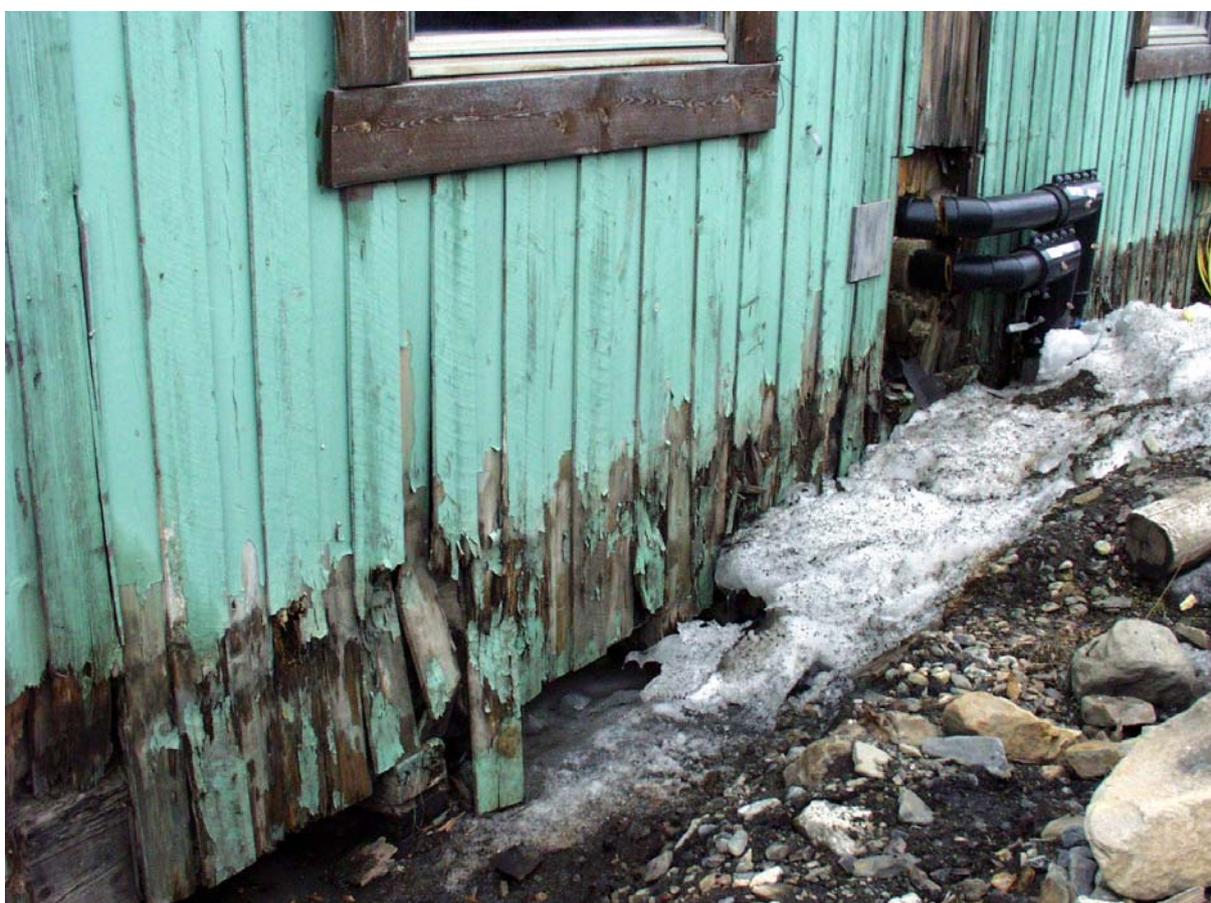
The traditional cabins at Svalbard were constructed by simple materials. The walls are normally without insulation, either by timber or a wooden frame. It is often an external bitumen layer in order to achieve an air tight construction. Some cases, where soil was shovelled up against the lower part of the walls were observed.

The floor is placed directly on the ground without any preparation. This is possible because a combination of relative stable ground conditions due to permafrost and a light, flexible building "floating" on the surface.

Our suggestion it therefore that during the repair work, the buildings should be permanently lifted somewhat up from the ground in order to ensure a better future service life of the building. This remedial action is of extra importance in case of a future global warming because such change could prolong the periods of favourable growth conditions due to increased temperature and access of water from the thawing permafrost.

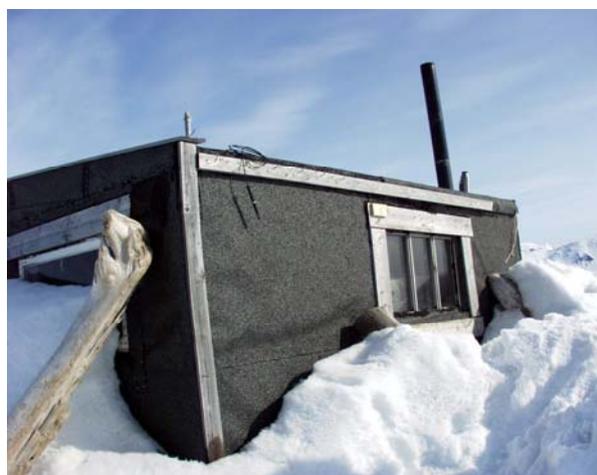
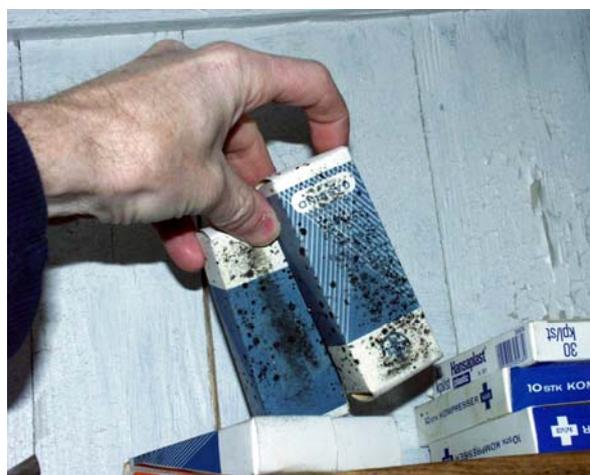
Decay fungi were generally found along the floor construction and lower part of external walls. Furthermore, all external wood had a grey discoloration, mainly caused by the blue-stain fungi *Aurobasidium pullulans*. External wood with horizontal exposure were also in several cases attacked by wood-decaying fungi, mainly *Leucogyrophana mollis*, but also occurring was *Gloeophyllum sepiarium*.

Several of the decayed materials were seriously damaged. The results of this were a severe technical failure of the timber structure. Due to continued climatic and humidity exposure, the rate of decay will increase in the future.
