## **Failure is not always what it seems to be Timber Roof Trusses Behaving Badly**

**Richard I. Ortega, PE, AIA, FAPT**

Senior Associate and Director of Preservation Technology, RMJM Hillier, Philadelphia, Pennsylvania, USA

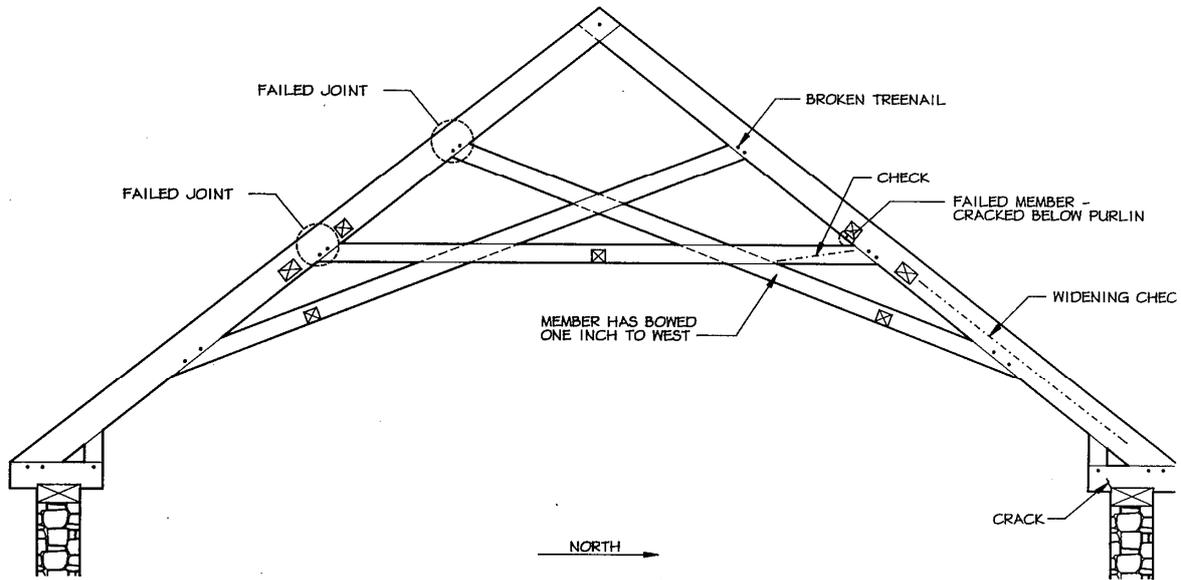
- All the trusses exhibited numerous failed pegged joints. In addition to the failed pegs, a few of the joints where the pegs were intact exhibited failure of the tenons.
- All the lapped joints of the trusses had rotated to some extent producing gaps at the far ends of the laps and localized crushing at the near ends of the joints.
- All of the top chords had failed.
- Several of the joints connecting the horizontal tie to the top chord had failed in tension.

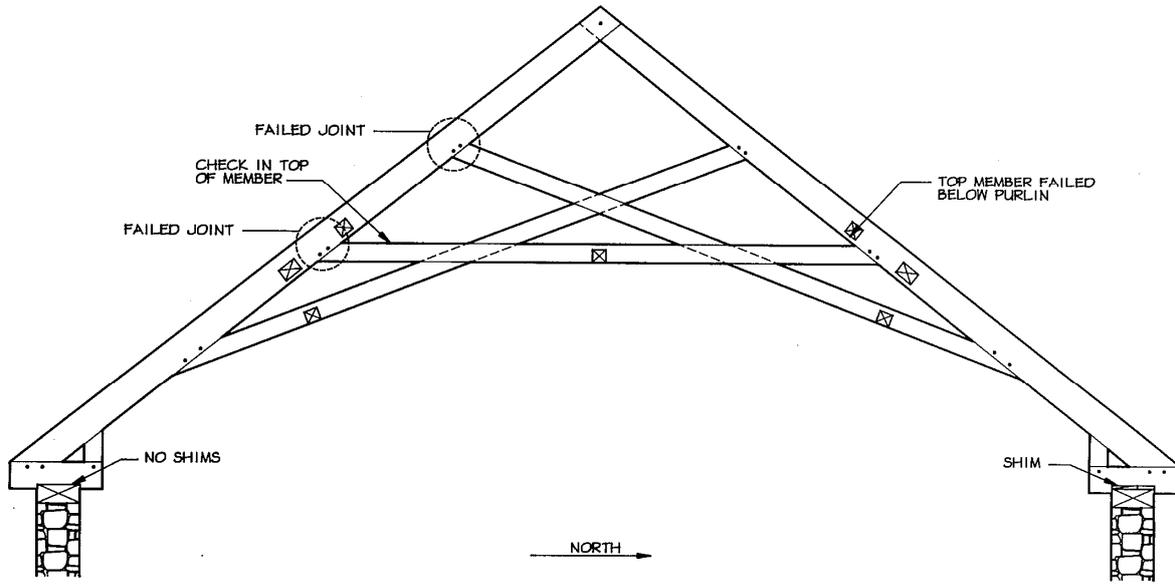
DRAWING No: <b>I</b>	<b>ORTEGA CONSULTING</b> Post Office Box 428 Media, PA 19063 (215) 565-1131	DRAWING TITLE: <b>TRUSS #3 EAST ELEVATION</b>	SCALE: 1/4" = 1'-0" DATE: 3/12/92 DRAWN BY: RDN APPROVED BY: PROJECT #: 92-03B
-------------------------	---	--	--

NOTE:  
UNLESS OTHERWISE NOTED, JOINTS NOTED AS "FAILED" ARE DUE TO BROKEN TREENAILS &/OR TENON.

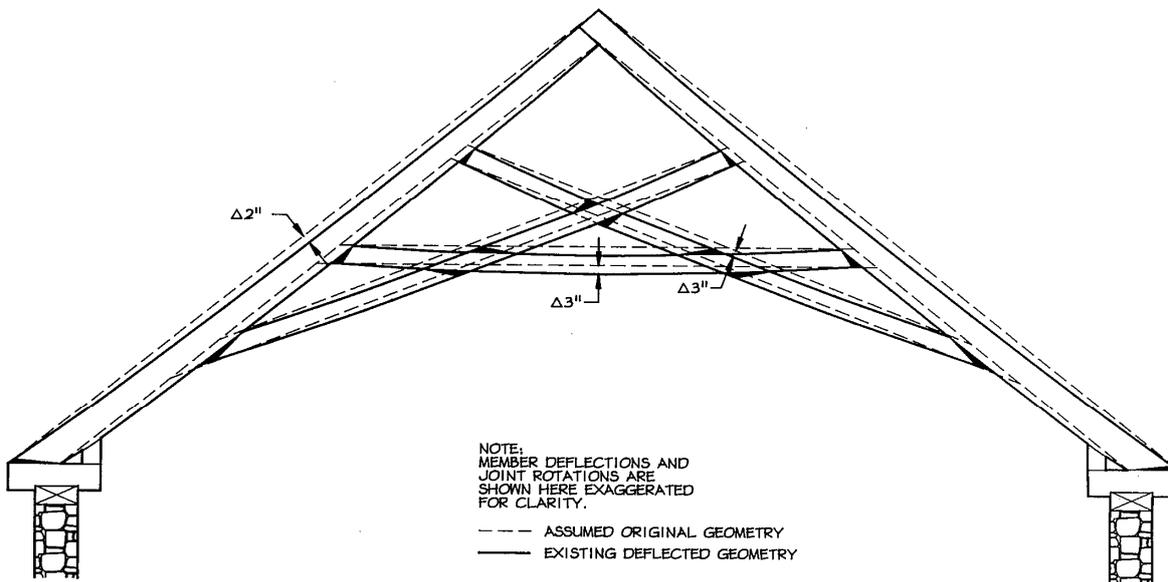
DRAWING No: <b>J</b>	<b>ORTEGA CONSULTING</b> Post Office Box 428 Media, PA 19063 (215) 565-1131	DRAWING TITLE: <b>DEFLECTIONS &amp; JOINT ROTATIONS</b>	SCALE: 1/4" = 1'-0" DATE: 2/14/92 DRAWN BY: RDN APPROVED BY: PROJECT #: 92-03B
-------------------------	---	--	--

Using string lines we also found that the member of the trusses exhibited significant deflections:

- The top chords had deflected approximately 2 inches.
- The diagonal scissor chord had deflected 2-1/2 to 3 inches.
- The horizontal tie had deflected about 3 inches.

We also closely examined the 20" thick masonry walls supporting the trusses and found that the tops of both walls had bowed outward as much as 6". This observation meant that our initial assumption that the masonry walls provided unyielding support for the trusses was not realistic. Thus, the same truss geometry was re-analyzed with one bearing end modeled as a roller so that spreading of the truss was theoretically permitted. The results of this analysis were consistent with the observed failures in the truss: the diagonal scissor chords go into tension to resist the spreading of the truss, and many of the truss members become overstressed.

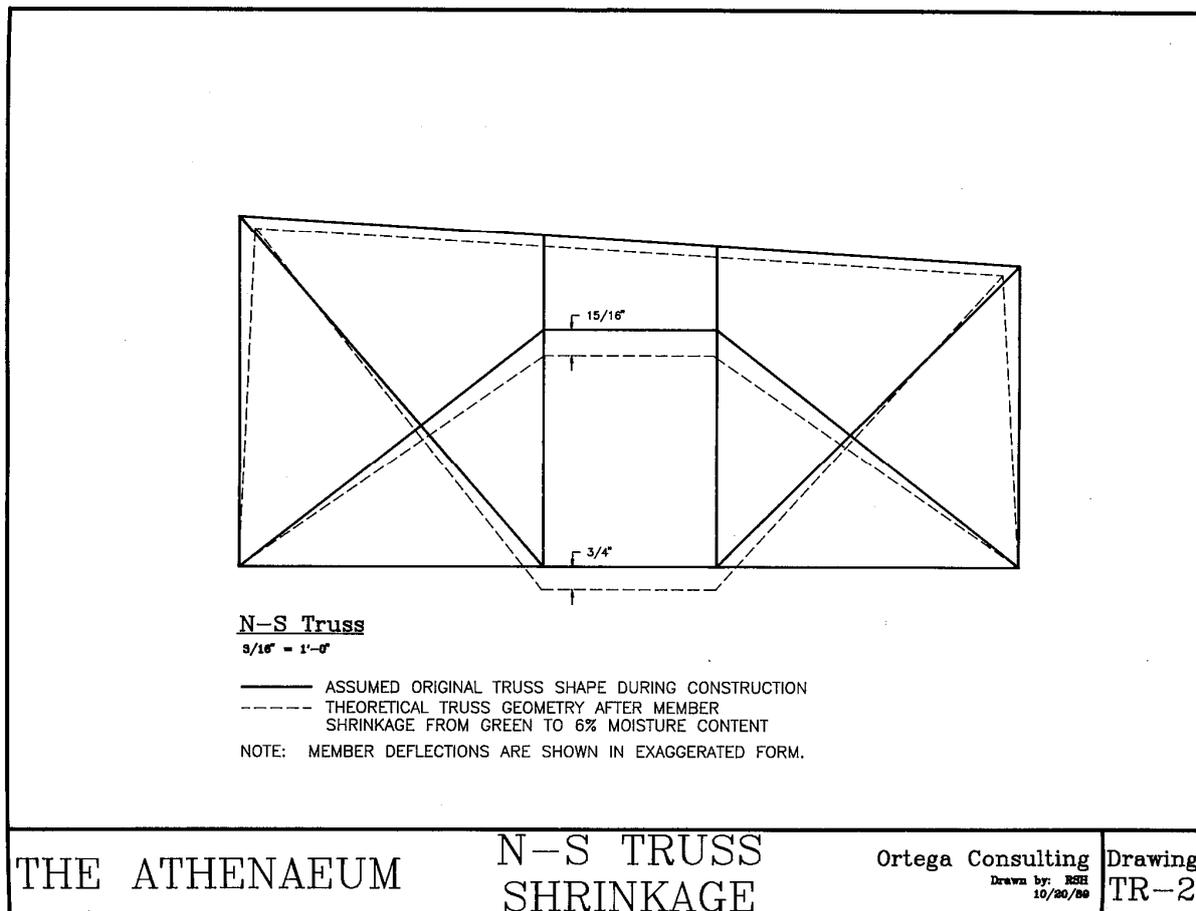
As part of our assessment we surveyed the floor levels throughout the building. For the most part the deflection patterns conformed closely to those anticipated for the deflection of joists. And except for the third floor, the magnitudes of the measured deflections were neither excessive nor substantially different from the calculated deflections. The glaring exception, however, was the deflection of the third-floor trusses. While deflection calculations of spanning wood members are notoriously approximate, the measured deflection of the trusses, at slightly more than one inch was well in excess of the calculated theoretical deflection of no more than 0.28 inches.

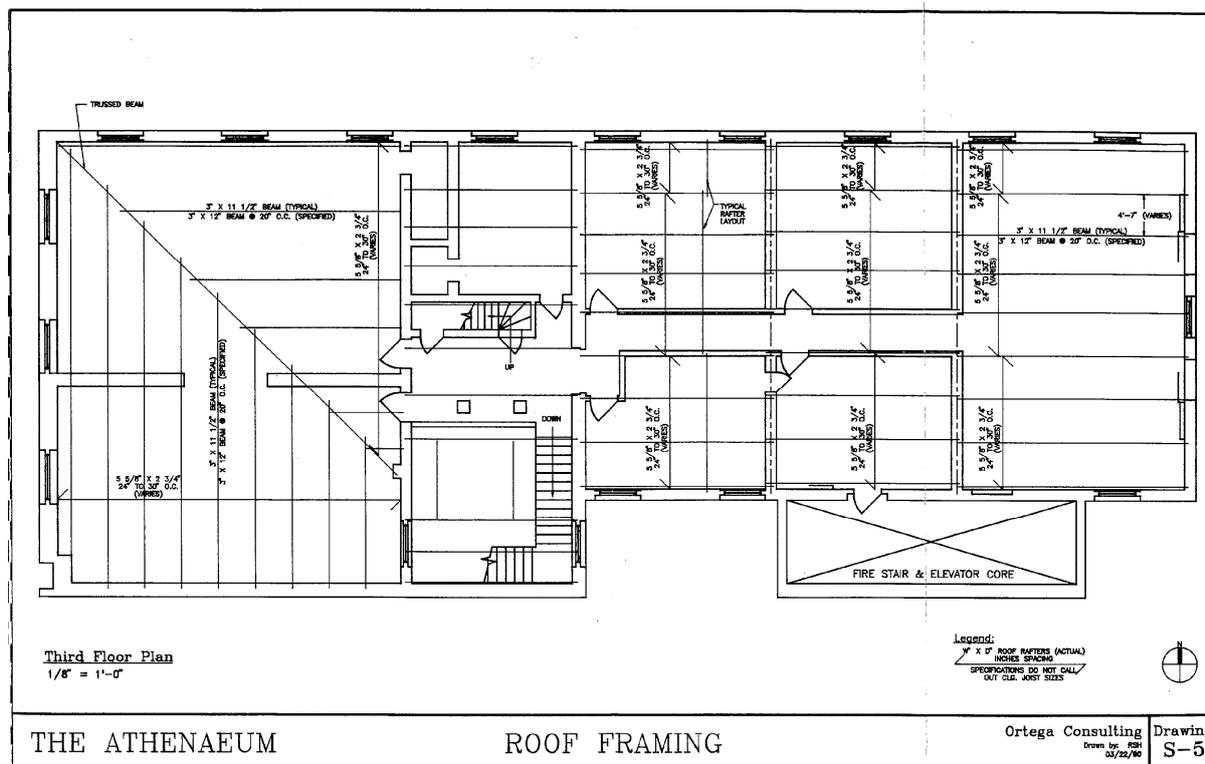
This sent us back to re-examine the trusses more carefully for damage which could have caused the excessive deflections. The joints appeared tight and there were no apparent failures of the connections. We had limited access to the heel joints, but saw no evidence of movement or shear block failure. The rods seemed reasonably tight. We found checking in most of the members, but no signs of failure. There seemed to be no mechanism to account for the excessive deflections.

While mapping the checking of the timbers we realized that they must have gone through a considerable change in moisture content since the time of original construction. Considering the sizes of the timbers, and assuming that it was unlikely that the timber was aged for several years before use, we concluded that they were probably green when the trusses were built – i.e. the wood had a moisture content approaching 30%. From readings taken during our survey we knew that the moisture content was about 6%.

With that much drying, we decided to explore the effects of drying-induced shrinkage on the trusses, especially whether it could account for the extra deflections. Using the lumber species cited in the specifications and shrinkage coefficients listed in the *Wood Handbook*, published by the Forest Products Laboratory, we calculated longitudinal shrinkage for all the members based on a 24% decrease in moisture content. We ignored the transverse shrinkage as being inconsequential for the truss geometry, even though we recognized it as the principal source of the checking.

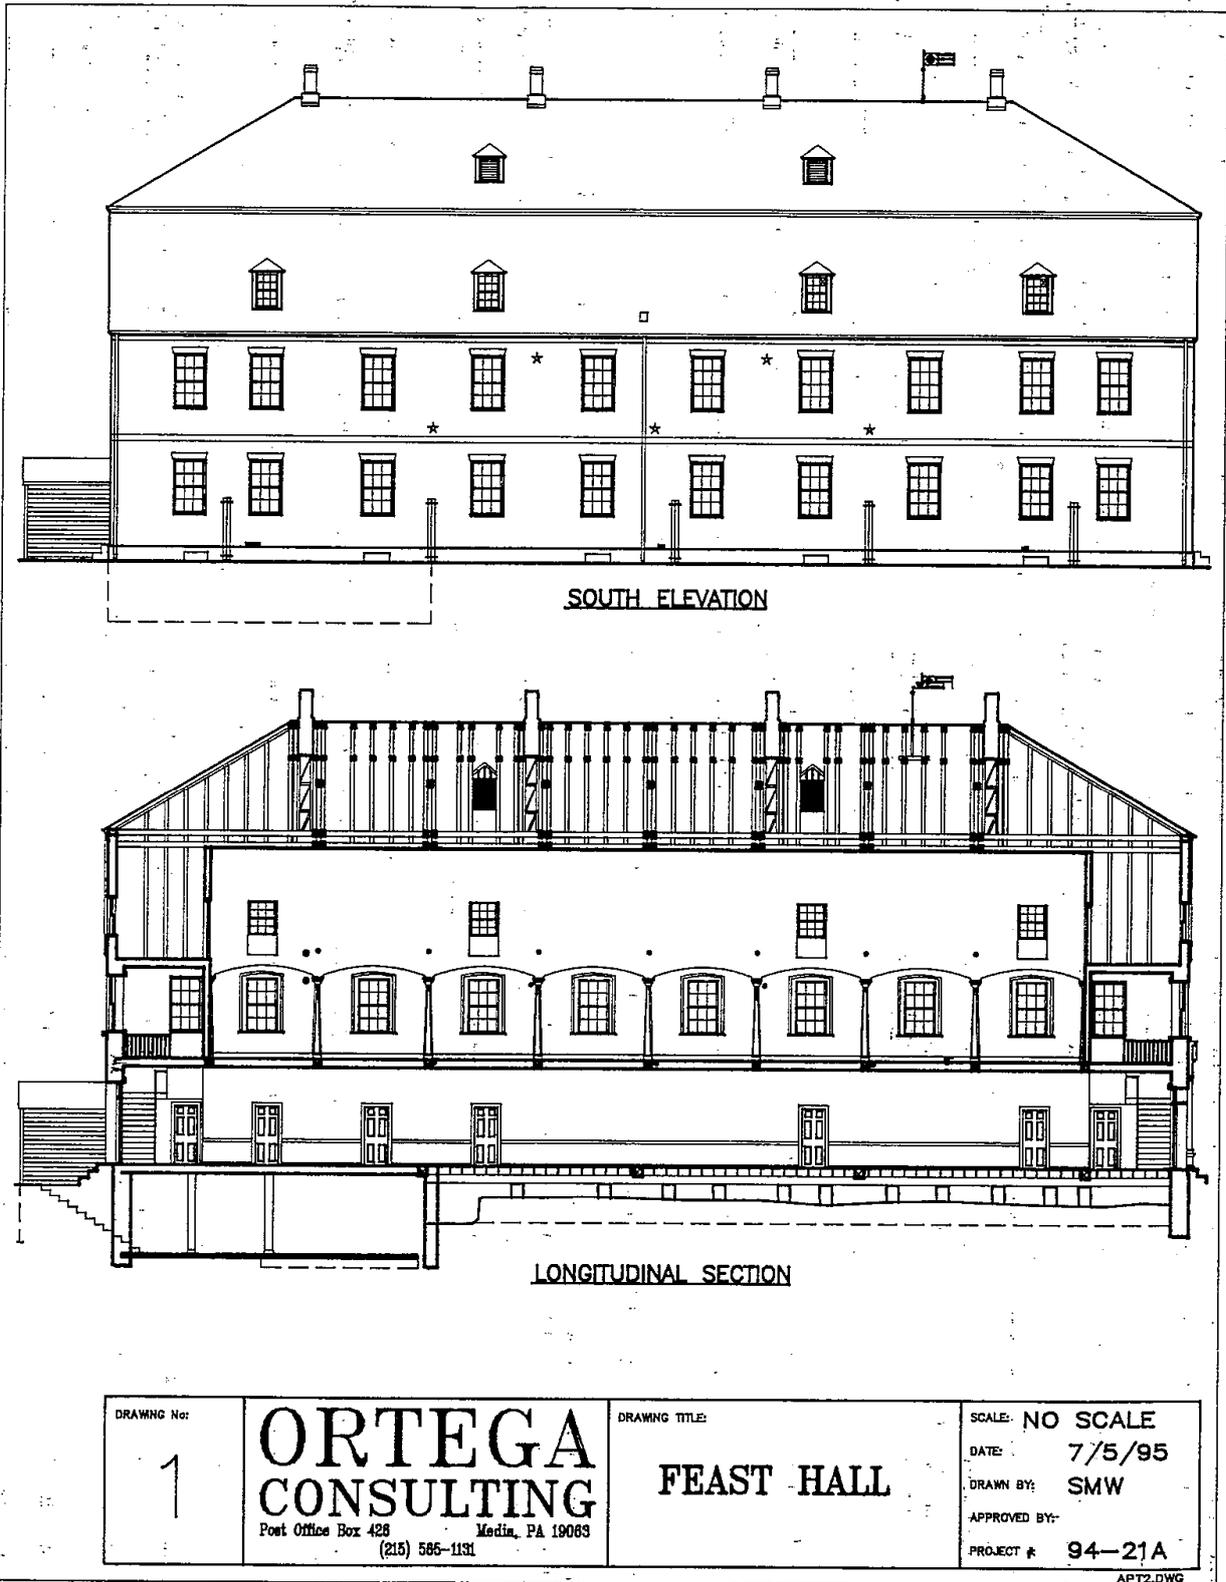
- The king-rod top chords were generally checked their entire length; for the most part the checking was more pronounced near the joints, such as at the apex of the 30° chords and at the intersection with the upper and lower horizontal ties.

- The joints between the king-rod chord and the horizontal ties have rotated. Where the rabbeted members intersect there are gaps between the chord and upper tie at the exterior shoulder and between the chord and the lower tie at the interior shoulder. At the opposite shoulder of each joint the intersecting members are tight against each other and in most cases exhibit localized crushing of the wood.

- Similar rotation was noted at the joint between the king-rod chord and the bearing member of the frame. In this joint the chord is shouldered to fit between the two frame members. At the upper face of the connection there are gaps between the members whereas the joint was tight at the bottom edge; but not generally to tight as to cause crushing of the fibers.

- At the connection between the knee brace and the bearing member there is a gap at the bottom of the mortised joint. At the opposite end of the brace, where it is morticed into the lower horizontal tie there is a similar gap. In both cases the opposing edge of the joint was tight. This situation also indicates rotation of the joints.

- There is a gap between the faces of the lower tie and the bearing member at the upper face of the joint where the former is morticed into the latter; the lower edge was tight, though not crushing.

- The maximum deflection of the upper tie, as measured at the mid-point of the top face relative to a string line between the two ends of the tie, was 2-5/8".

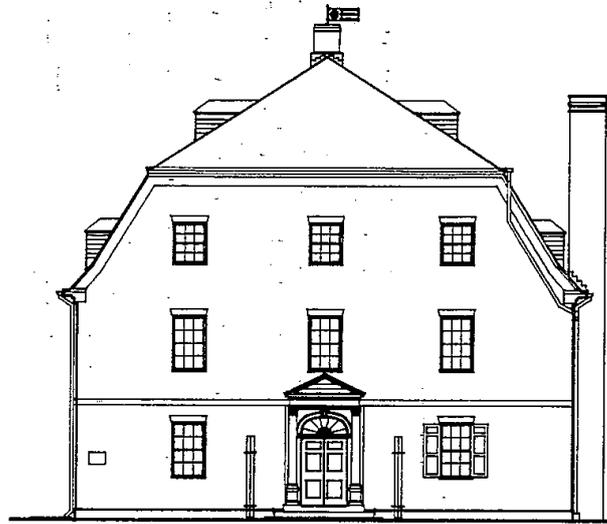
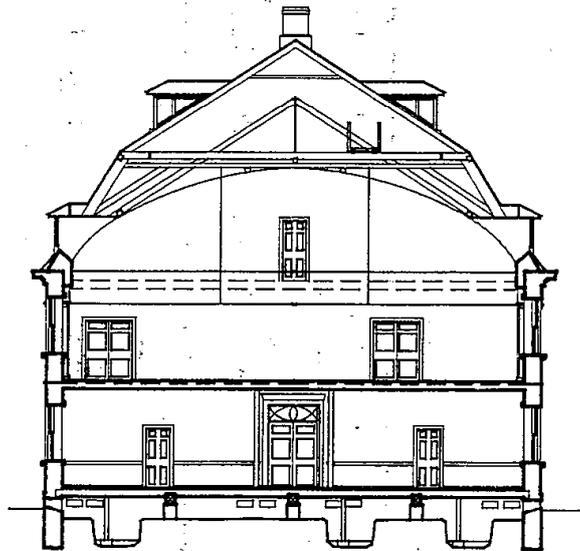
Inspection and sounding of the ties-rods yielded the surprising finding that they were slack – i.e. were not loaded.

These observations were at variance with the results of our analyses and modeling of the trusses, which, among other findings, could not replicate the 6" displacement of the truss bearings (the calculated amount was 1-1/2"), and resulted in a 12 Kip tensile load on the tie-rod.
