## Structural Failure Analysis of timber Floors and Roofs in Ancient Buildings at Valencia (Spain)

**Liliana Palaia**

Polytechnic University At Valencia-Icomos Spanish National Committee

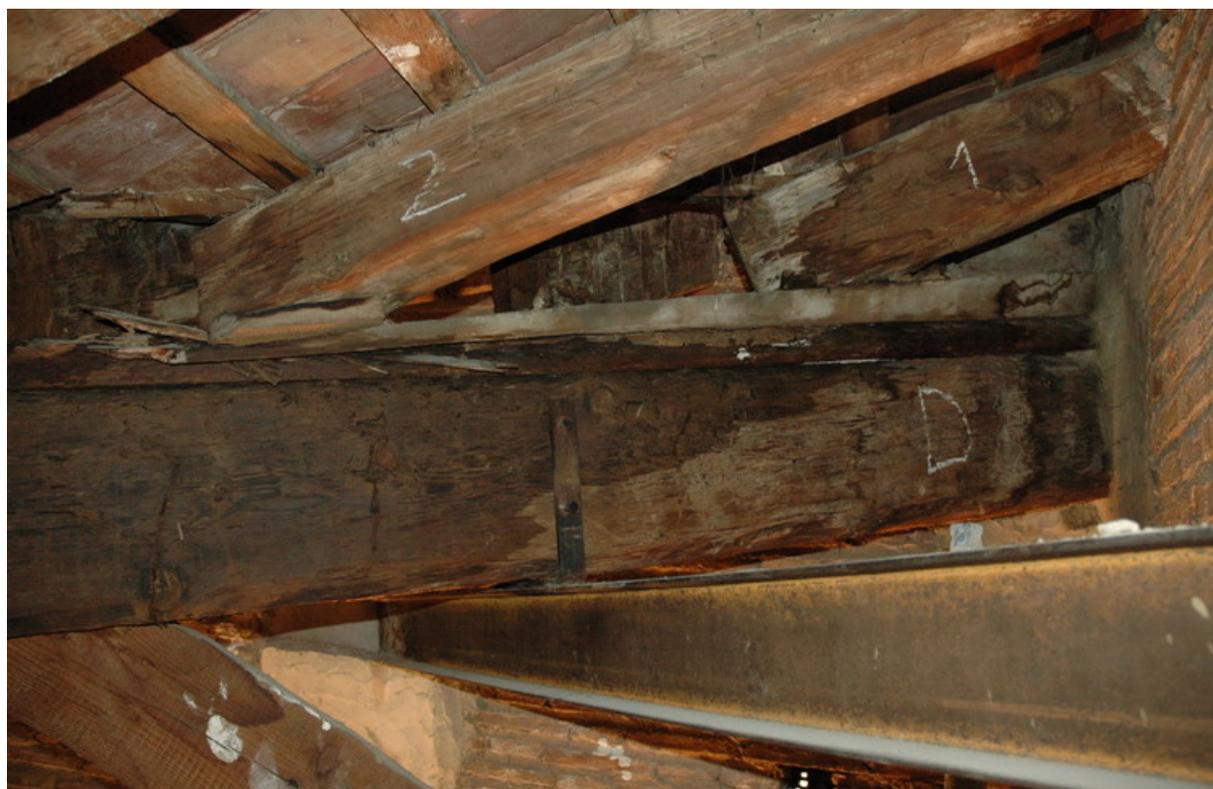
**Figure 1.** General view of a timber roof structure. Gran Asociación Valenciana de la Caridad. Valencia.

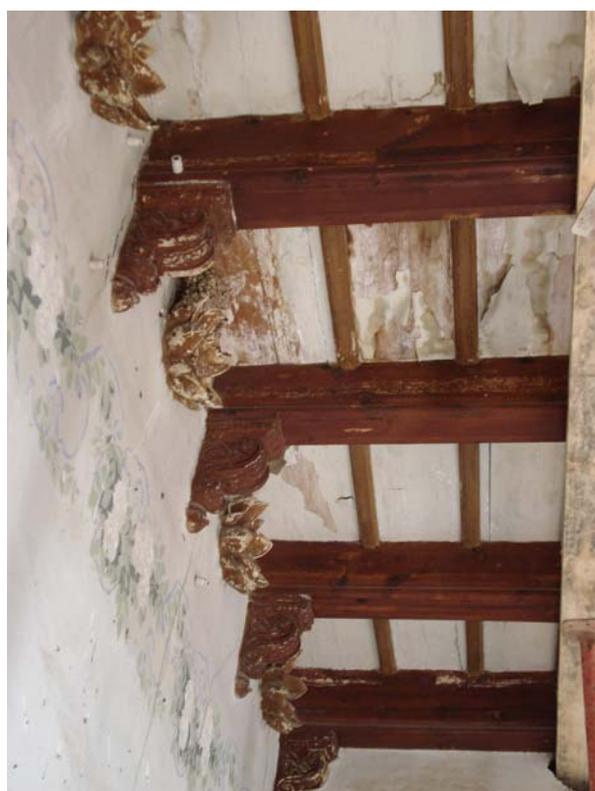
**Figure 2.** Timber floor built with very small joists, positioned quite close to each other, around 0,45 m. Villa Ivonne, Meliana.

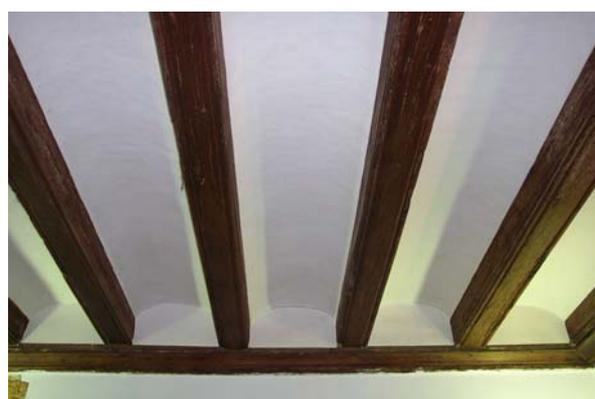
**Figure 3.** Timber floor structure built with joists of important cross section, positioned quite separate, around 1,00 m. Alaquàs Castle.

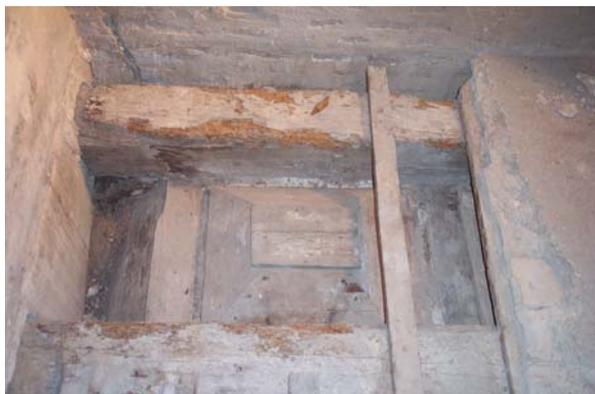
Damage produced by rot is more frequently localised at the timber element endings, that may be coincident with insect attack as that produced by termites, or it may be extended

**Figure 4.** Long horn beetle attack in timber joists.  
Alaquàs Castle.

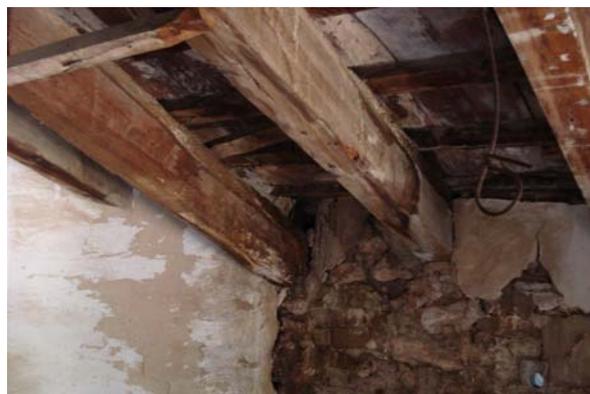
**Figure 5.** Brown rot in a timber roof element.  
Villa Ivonne, Meliana

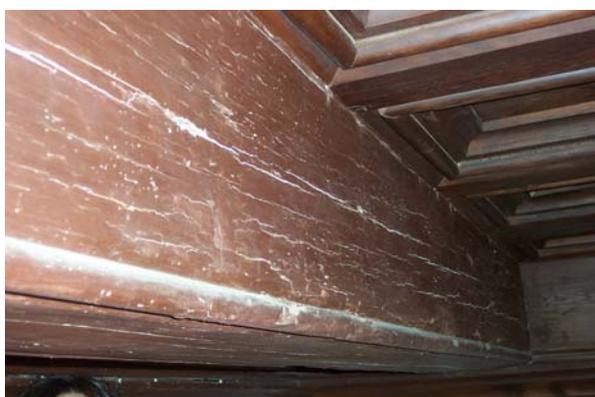
**Figure 6.** Coffered ceiling joist repaired with gypsum mortar, and then painted to simulate timber.

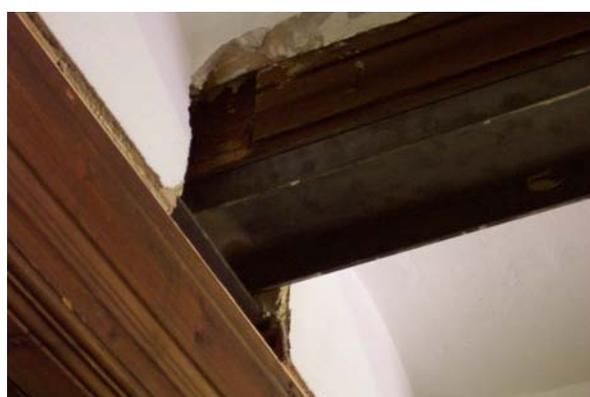
**Figure 7.** Floor joist wrongly reinforced in a previous repair. The metallic element is inversely orientated, being useless.

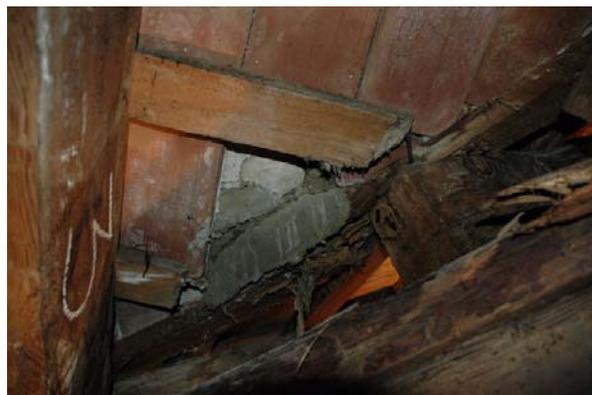
**Figure 9.** Roof rafter ending showing its rotten ending.

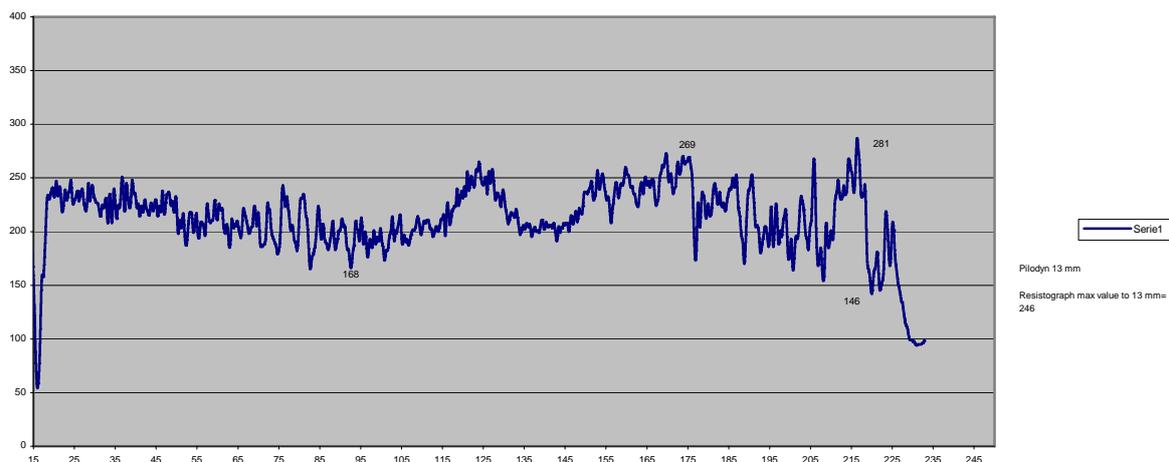
GRAN ASOCIACIÓN. TIMBER ROOF. SOUTH EAST CLASSROOM. RAFTER Nº 9. SOUTHERN END

Figure 16. Resistograph xls graphic of an individual element.

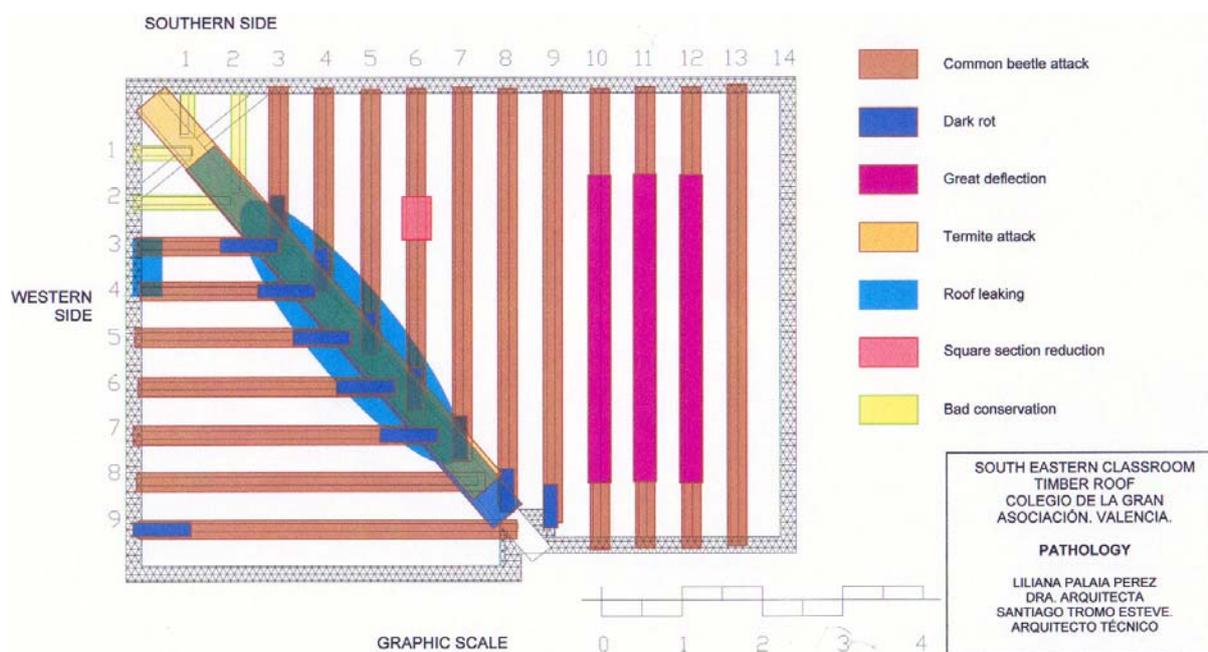
Wood is, generally, in good state of conservation, except some elements. Those are identified in drawings, indicating position and extension of the damage (Fig.18). According to that resume, repair measures are designed as a conclusion.

**Figure 18.** Graphic resume of pathology. Diagnosis of a timber roof at the “Gran Asociación Valenciana de la Caridad”. Valencia.
