Mechanical Role of Roller Ends of Historical Timber Structures

Toshikazu Tsuchimoto

Shinshu University, Nagano, Japan

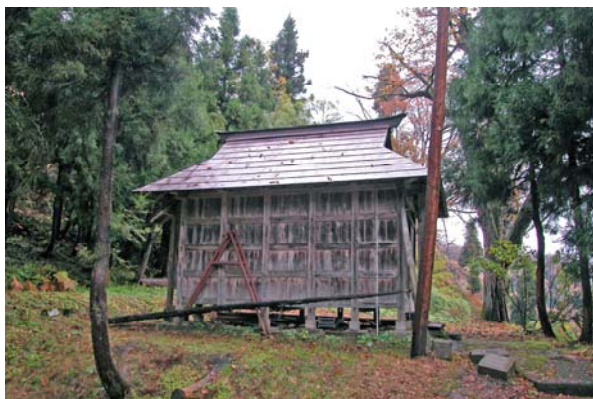
Figure 1-1. Juni-jinja shrine just after the earthquake in 2004

One is Juni-jinja shrine (Fig.1-1, 1-2). The very small shrine in the small village survived without any damage of the structure by the earthquake in 2004 (Fig.1-1). It moved 5 cm horizontally from the existing place (Fig.1-2). It had originally had posts on stones. It changed to have posts on concrete cubes on concrete plates on the earth. The new foundations did not fixed to the posts. In result the concrete cubes had 5 cm slide on the concrete plate and the post had a bit of slide on the concrete cube by the earthquake. The structure of no fixed joints at the ends of upper structures belongs to the traditional one while the material of concrete cubes and plates belongs to the modernized one. In the meaning the right integration of the traditional and the modernized caused less damage in Juni-jinja shrine.

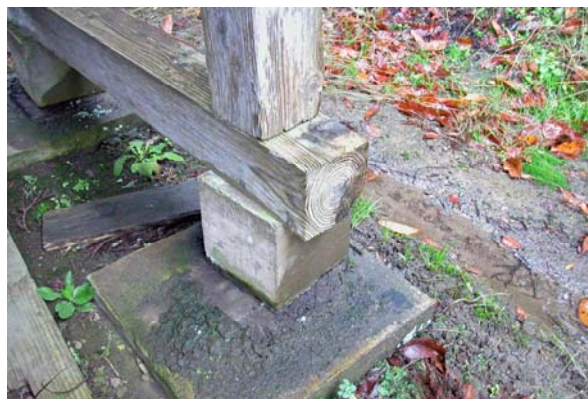
Figure 1-2. Slide of post in Juni-jinja shrine by the earthquake in 2004

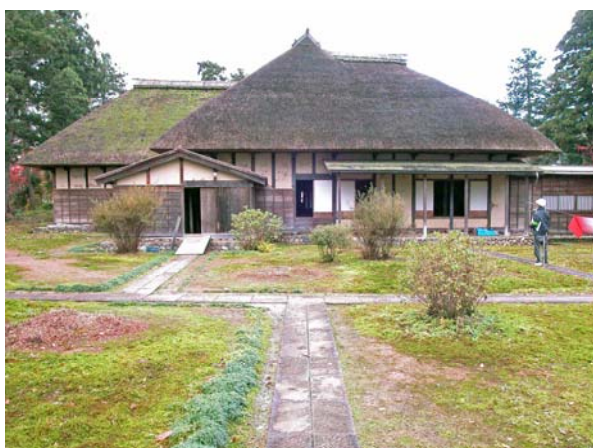
Figure 2-1. Hasegawa-family house just after the earthquake in 2004

Other is the Hasegawa-family house (Fig.2-1, 2-2). It is a big vernacular house and one of cultural assets of Japan. It survived by the earthquake (Fig.2-1). It had damage of its walls made of soils and it had partial damage of the timber frames. It moved vertically as well as horizontally (Fig.2-2). It had footplates on the stones. The footplates had some cuts on their bottom. These cuts geared into stones on the ground. Some cuts gearing into stones prevented the upper structure from making a horizontal move smoothly. On the other hand it move a bit vertically. In fact stones beneath footplates sank from the existing level. The vertical move seemed to reduce serious damage of the upper structure. It had been better for the Hasegawa-family house to have footplates with no cut Because cuts on the bottom of footplates prevented the structure from moving on stones horizontally. The house is a traditional one, but it have already loosed the original role of footplates. In the meaning the lack of original role of traditional structures caused damage in Hasegawa-family house.

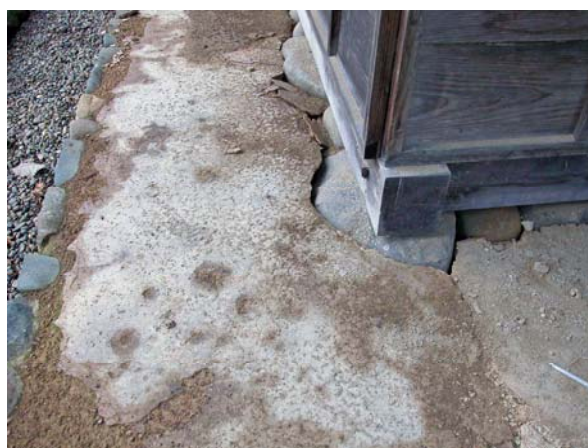
Figure 2-2. Subsidence of foundations in Hasegawa-family house by the earthquake in 2004

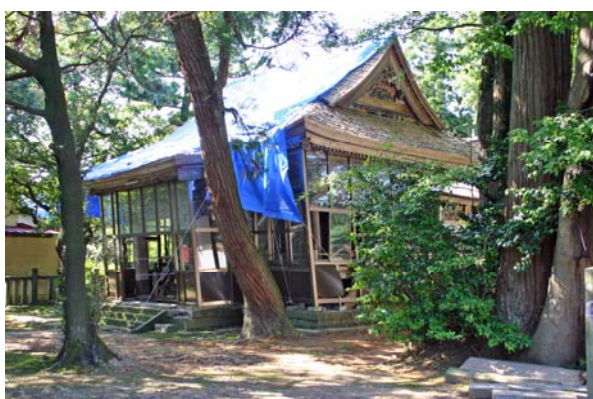
Figure 3-1. Tata-jinja shrine just after the earthquake in 2007

One is Tatajinja-shrine (Fig.3-1, 3-2). It is a small shrine and one of cultural assets of Japan. It had much damage that was caused by wrong repairs in the late twentieth century (Fig.3-1). It changed to have repaired feet-ends. A post had a newly replaced part in the end. Another post had fixed on the ground (Fig.3-2). It is suggested that the structure had originally had unfixed end. It is much wrong to have repaired post-

ends to be fixed on the ground. In the meaning the wrong repair during the modern period caused laege-scale damage in Tata-jinja shrine.

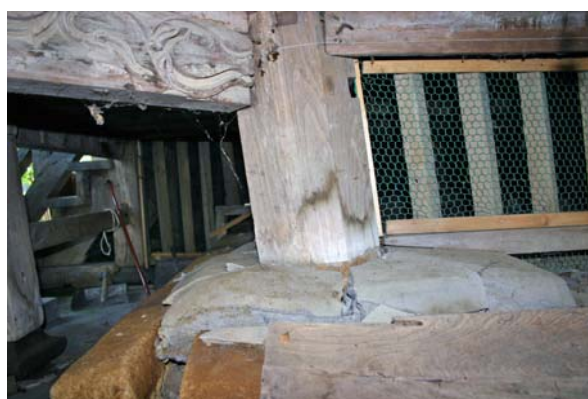
Figure 3-2. Inclination of the post in Tata-jinja shrine by the earthquake in 2007

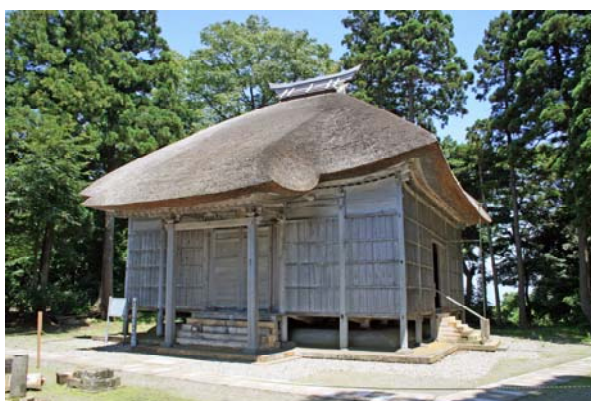
Other is Kannon-do in the Daisenji-temple precinct (Fig.4-1, 4-2). It had no damage of upper structure (Fig.4-1). The other structures in the same precinct had much damage of upper structures. Kannon-do is the oldest but had the least damage in the precinct. It had 5 cm move horizontally from the existing place (Fig.4-2). Only the stone-made staircases in front of the structure had small damage because the staircase had no move while the upper structure had 5 cm move. Yet, it is remarkable to have had no damage of the upper structure in spite of its age. It had completely unfixed ends on stones. In addition it is not so big and is not complicated plan. Its plan is square. Its structure is simple. Kannon-do is one of the most typical examples of horizontal move that reduced damage by big earthquake. In the meaning the traditional role caused no damage in Kannon-do.

Figure 4-1. Kannon-do in Daisenji-temple just after the earthquake in 2007

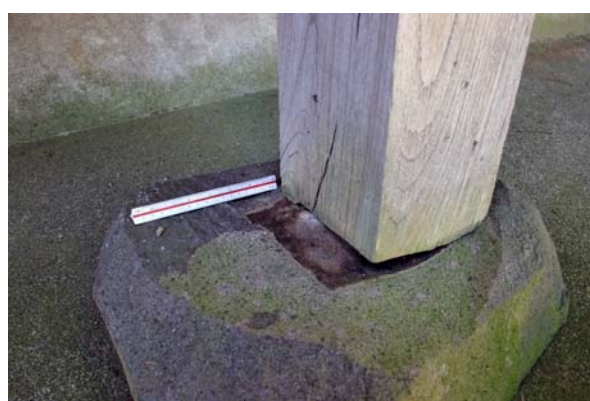
Figure 4-2. Slide of the post in Kannon-do by the earthquake in 2007
