Roof structures in Swedish churches: preservation challenges and solutions

Ylva Sandin

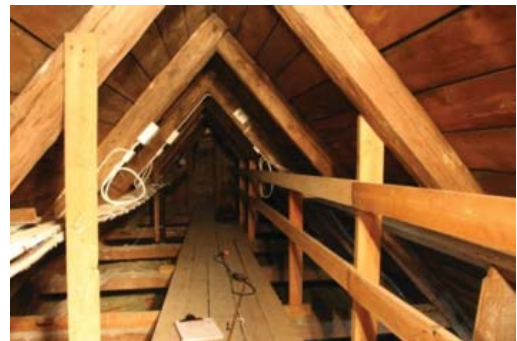
Figure 1 Threats to historic church roof trusses. a) Insidious, successive changes that transform the attic as a historic setting. b) Structural problems (the picture shows a material failure in a rafter). The dominating problem is the one where the trusses have lost their horizontal support. This leads to large stresses in rafters. c) Rot. d) Trusses are covered in insulation and become difficult to inspect.

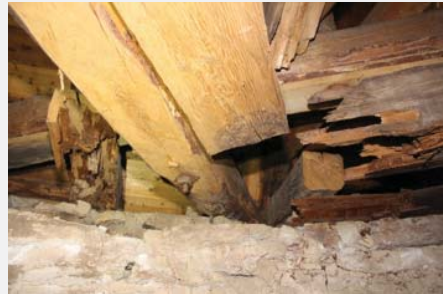
existence of damage by rot. Some of the beam ends and wall plates were entirely destroyed by real-rot fungus as well as some of the lower rafter ends. The central beam in the beam system was rotten in the middle and was leaning against the vault. There was a system of partially inefficient repair measures. These were at least a few decades old, suggesting that some of the damages had been there for a long time

Figure 3 Skörstorp church. a) Rot damages. b) Some of the old repair measures. c) Wall plates were found to be more damaged than first assumed. d) Part of the beam system damaged by rot. Photo a, b and d: Carl Thelin. Photo c: author.

Rafter ends were repaired with new timber of the same dimension as the original, using scarf joints. Two beams in the horizontal beam system were changed for new ones. The entire spire had to be carefully raised with a large number of jacks and lifting bags in order for the middle beam to be changed.

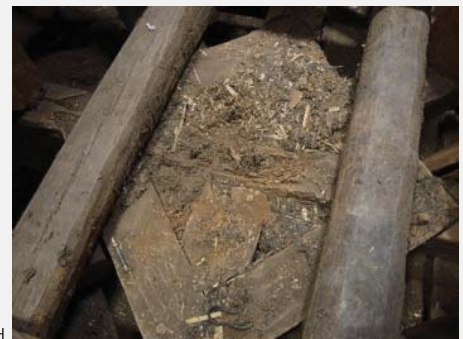
d

The system of beams have an important role in keeping the lower ends of rafters in place and preventing their slipping. When beams are severely damaged there is a risk that (larger) horizontal forces come to act on the walls of the church. The walls of Skörstorp church are cracked in a way that suggest that they might have been pushed outwards by the roof structure - or by the vault. The question was raised whether the spire had come to lean on vault.

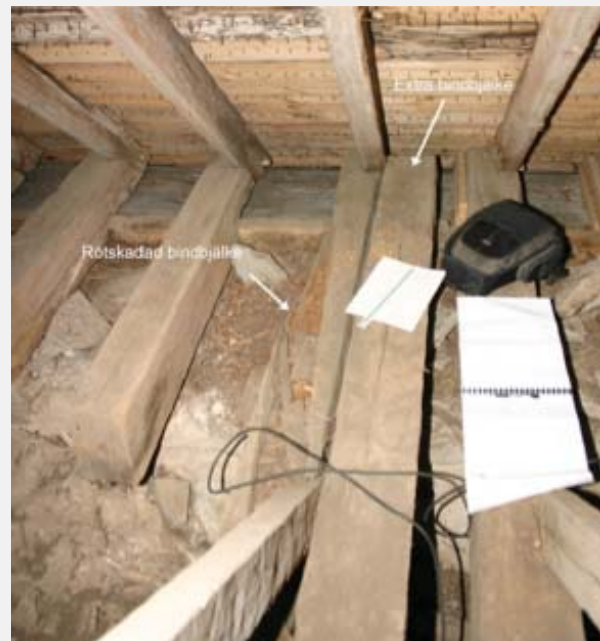
Today, a number of damages weaken the structures. Many of the roof trusses are partially damaged by rot. Large parts of the wall plates are rotten. A sample has shown that in at least one position there is real-rot fungus. Additional parts, tie beams and others, have been built in in order to strengthen the structure.

Figure 6 Marka church. a) and b) Rot damages. c) Tie beams have been cut off and struts removed where vaults are built in. Extra parts have been added to compensate for lost ones. Photos: Carl Thelin.

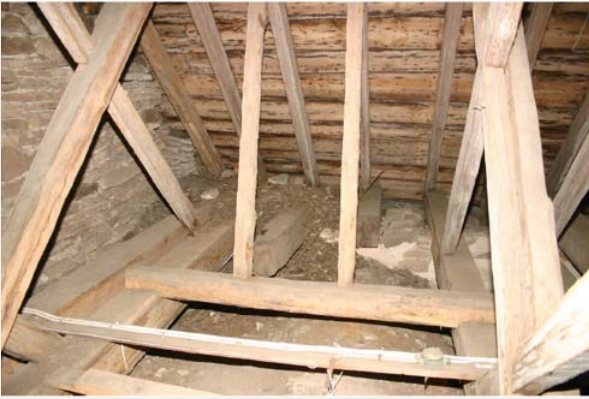
The medieval church of Marka still has a large number of original roof trusses. Dendrochronological analysis has shown that the timbers in the roof trusses above the nave were felled in 1155/1156.¹ The roof trusses were originally visible from the church room but are now hidden by vaults. When these vaults were built (probably in the 15th century) some of the tie beams in the roof trusses above the nave, as well as all of the tie beams in the roof trusses above the chancel, were cut off. Additional parts have been built in at some point to compensate for the removed ones.
