Timber-Frame Buildings in Scandinavia: High Deformation Prevent the System from Collapse

Pietro Copani

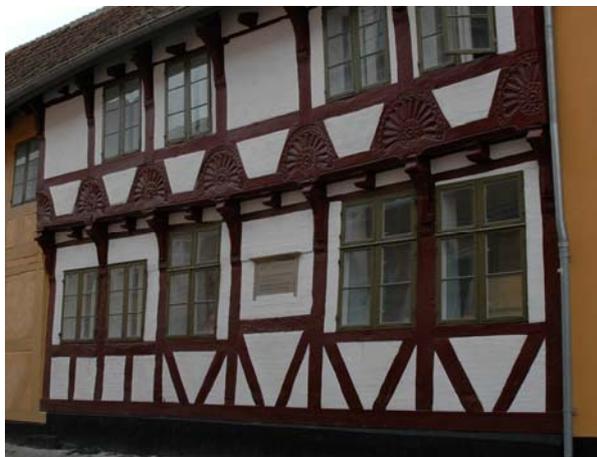
Figure 1. A timber-frame house in Odense (Denmark), where the carved wooden "corners" take a great part in the decorative power of the building.

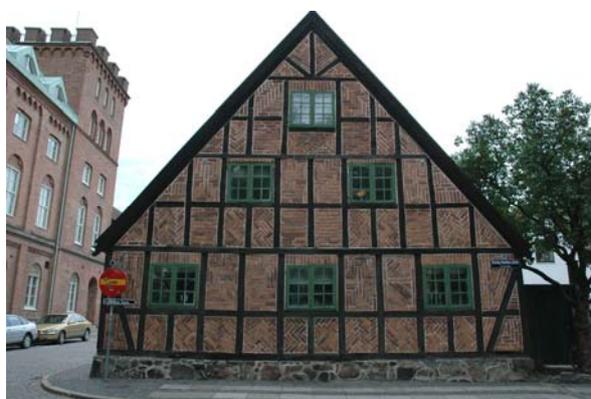
Figure 2. In this XVIII century house in Lund (Sweden) we can see several way of posing the infill-bricks.

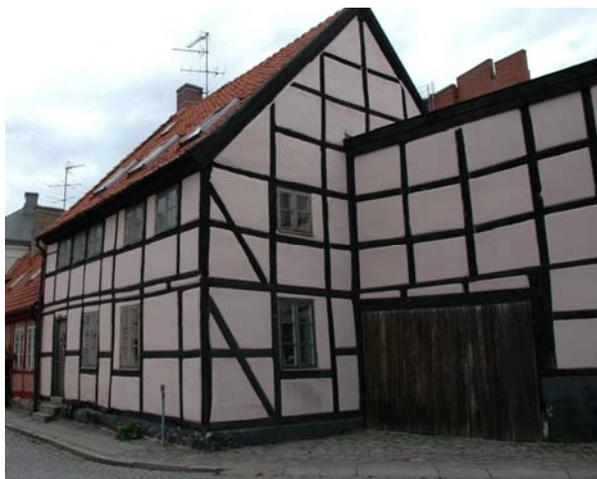
Figure 3. A traditional house in Lund.

part of the storey-wall, separated from the lower one by an horizontal joist. The position of the wooden floors is shown over the outer walls' surface by the main beams: the two beams concluding the floor take part in the wall's design, and sometimes the other beams' end is laid out of the wall's external surface, between two beams perpendicular to the main ones (figure 3).

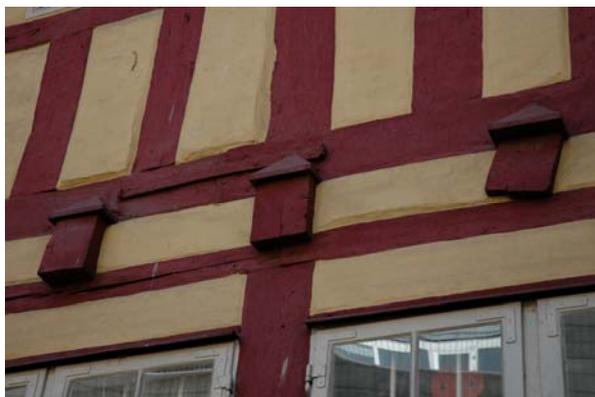
Figure 4. Detail of a house in Aarhus (Denmark): the floor beam on right is still in position in spite of its great deformation.

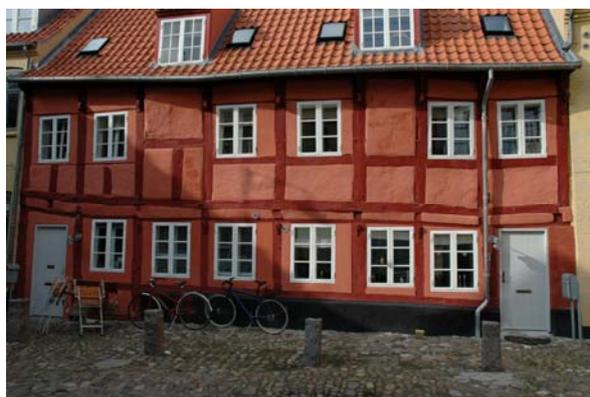
Figure 5. This façade in Aarhus shows clearly a rough design, but the stability of the whole system doesn't seem to be compromised.

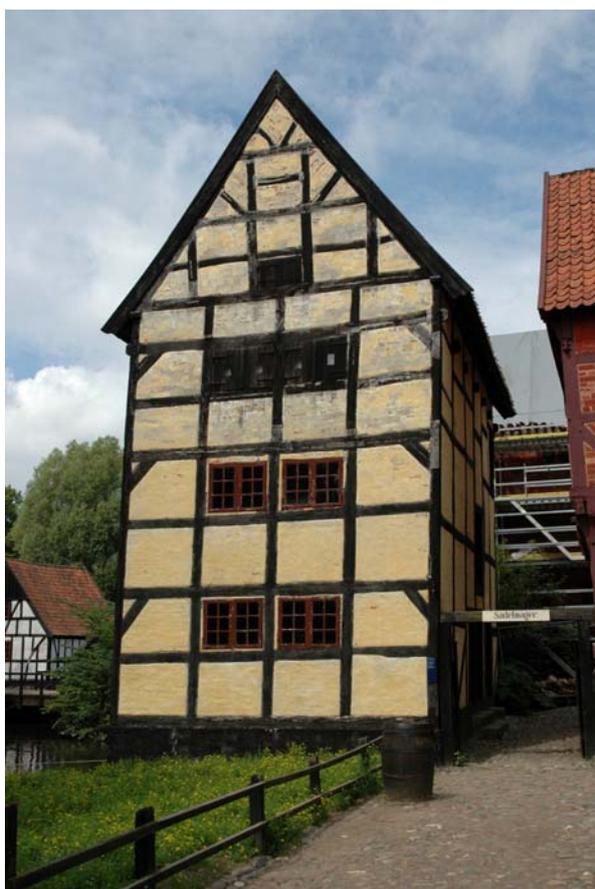
Figure 6. In this building in Aarhus Folk Museum the deformation of the frame causes a great slope of the first three floors, that moves horizontally dragging the fourth one that maintain its shape because of the triangular frame.

Although the not great rigidity of the timber-frame houses is a formidable seismic-resistant system, it also make these buildings exposed to the deformations of some structural units, or of the whole frame. One of the traditional multi-storey houses in Aarhus Folk Museum shows a great deformation of its structure (figure 6); in this case the wooden squares that form the frame are not provided of diagonal rods, except for the

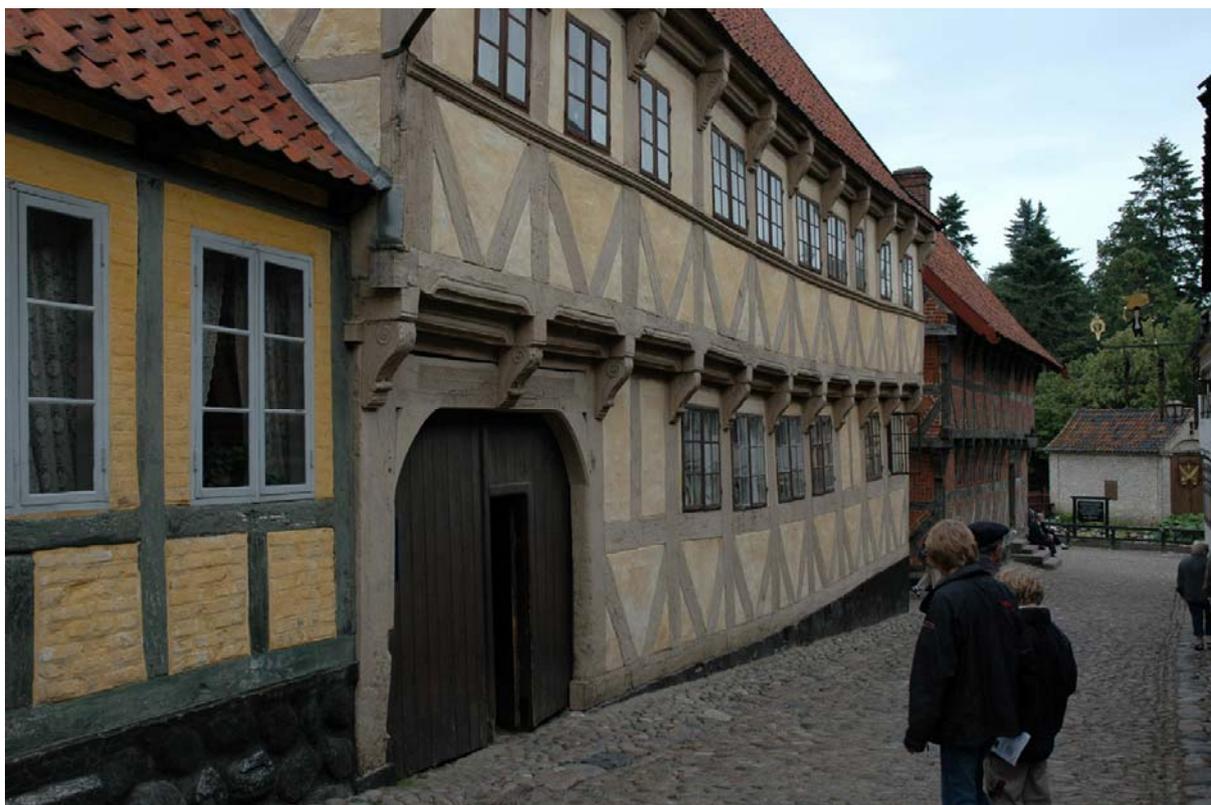
Figure 7. XVI century house in Aarhus Folk Museum.

One of the most common deformations of the infill-frame structures is the sinking of a part of the building, due to a foundation failure, or to a pillar failure, etc. In the building shown in figure 7, where we can notice the diagonal rods placed in each module of the lower part of the floor-wall, the beams related to the two floors are flexed in the same way: the sagging of the lower floor, caused by a foundation failure, drags the rest of the house deforming it in a significant way, but the rigidity of the whole building –

provided by the thickness of the timber elements, by the little dimension of the stitch modules, by the presence of so many rods – prevails despite of the failures.

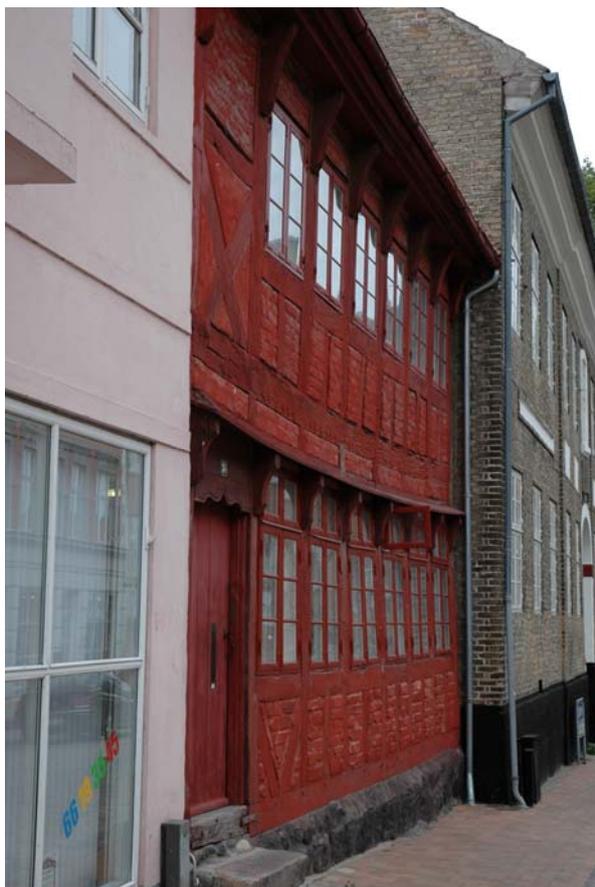
Figure 8. Significant deformation of the floor in this house in Odense (Denmark).

The same kind of deformation, caused by little failures of posts or connections, can be found in the two buildings shown in figures 8-10. The effects of deformation over the red house in Odense is very similar to the last one described above, but the origin of the failure is not to be found in the foundations: the flexion is caused by the load over the floor, not enough supported by the pillars. The long timber-frame house in the city centre of Aarhus shown in figures 9-10 is affected by a combination of failures: the sinking of the floor, in three different points, and the inclination of the walls' posts. This kind of situation is often caused by partly inadequate joints, that can't react effectively to excessive thrusts or unexpected saggings.

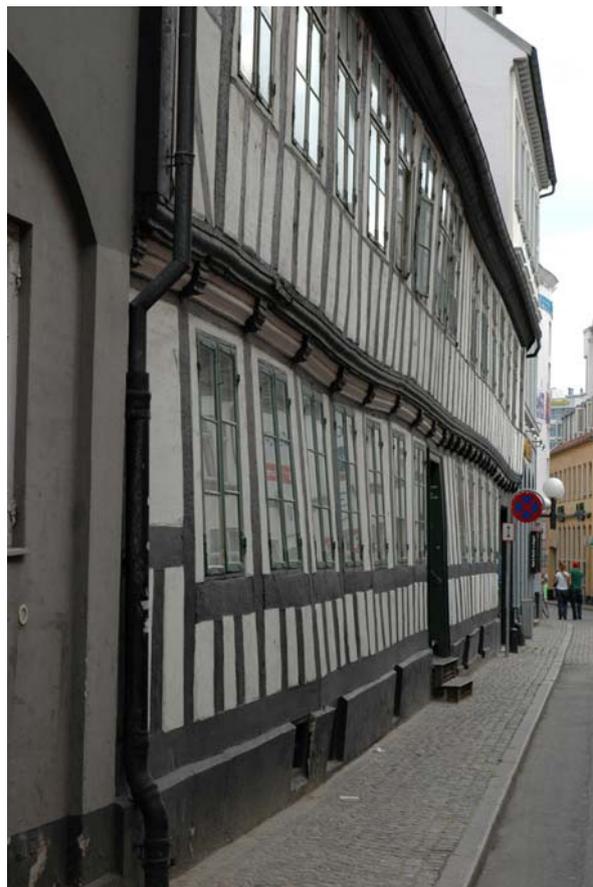
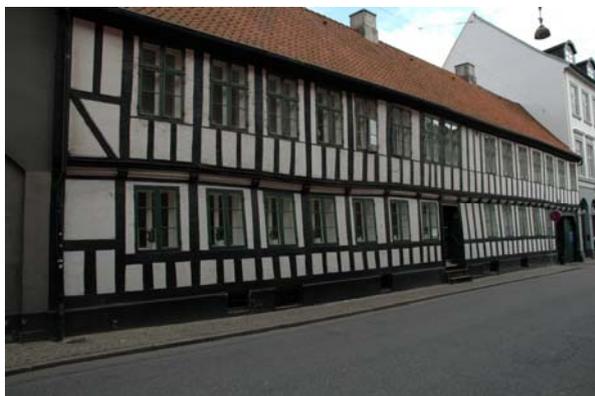
Figures 9-10. Traditional house in Aarhus city centre.

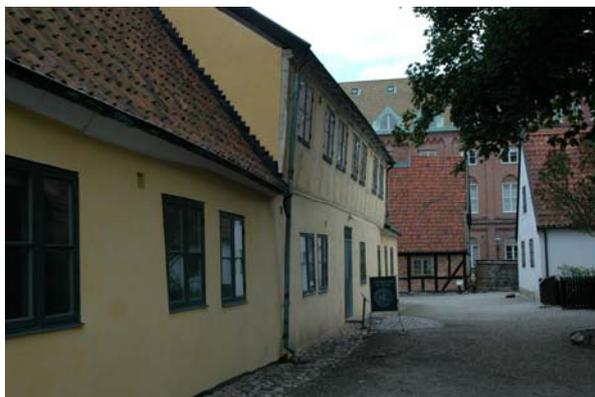
Figure 11. A timber-frame house in Odense with significant deformations of the floor-beam and of the upper wall.

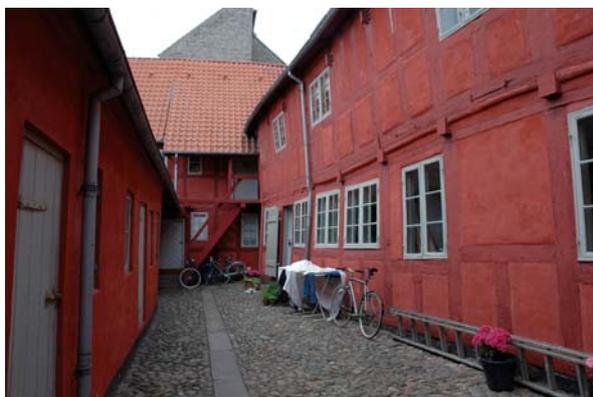
Figure 12. A typical inclined wall at the upper floor of the house (Lund).

The loss of the vertical position of a single pillar, or of a group of them, can be due to different failures (approximate location of the members, inadequate connections, excessive load, etc.); in some cases, the entire wall loses its position because of horizontal loads: often it happens at the upper floor, for the push of the roof trusses (figures 12, 13). The roof's beams are connected to the top of the walls' posts; under this joint, a slender tie-beam links the two main walls: the ends of this beam come out of the walls through little holes carved in the posts, and fixed to them by bolts. This kind of connection is not always efficient, and it needs to be replaced (figure 14), or to be reinforced by iron ties (figure 15).

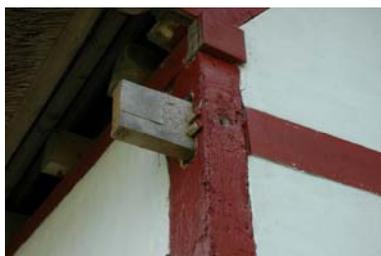
Figure 13. Another case of inclined wall, in Aarhus. The deformation is due to the push of the roof structures.

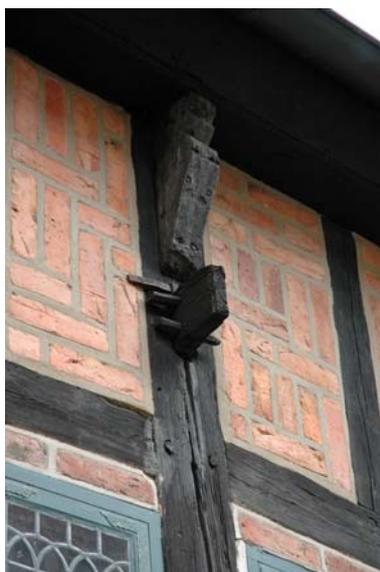
Figure 14. Wooden tie-beam replaced in a traditional farmhouse in Kertinge (Denmark).
