## The Wood Trusses of the “Red House” in Palermo’s Parco D’Orleans

**Antonio Cottone, Simona Bertorotta**

Dipartimento di Progetto e Costruzione Edilizia, Università degli Studi di Palermo

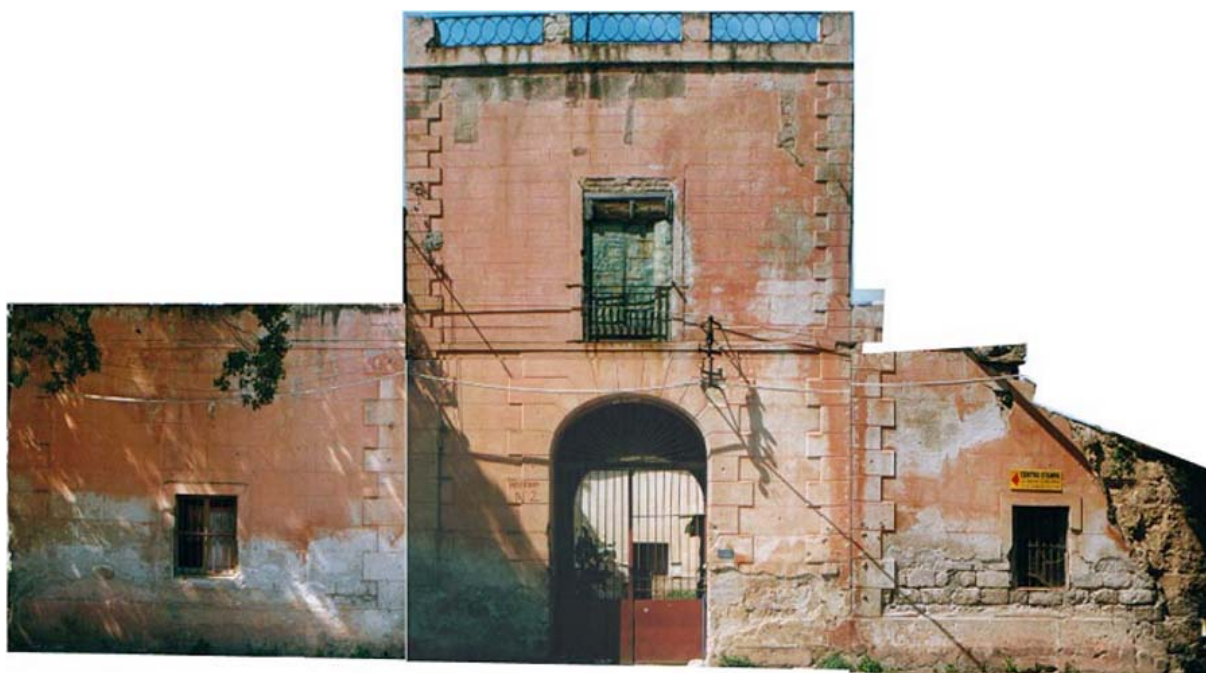
**Figure 2.** Photo-mosaic of the main façade following

The entity of the damage was such that even a plano-altimetric reading was difficult, as discovered in 1993 when the feasibility<sup>iii</sup> of the intervention was being studied. In fact, the building was to be turned into a "....nursery school for people (teaching and technical - administrative staff of the University of Palermo and students) who move within the Parco d'Orleans and who fill the insufficient public and private facilities of the area ..."iv. At that time, the only parts of the buildings still remaining, even though seriously damaged, were the front building and the big room behind it, originally used as a stable. Of the two adjoining wings, one had collapsed and had been rebuilt in a different way from the original with unauthorized structures that leant against the tower-like building, while the other had almost completely lost its roof covering (Fig. 2).

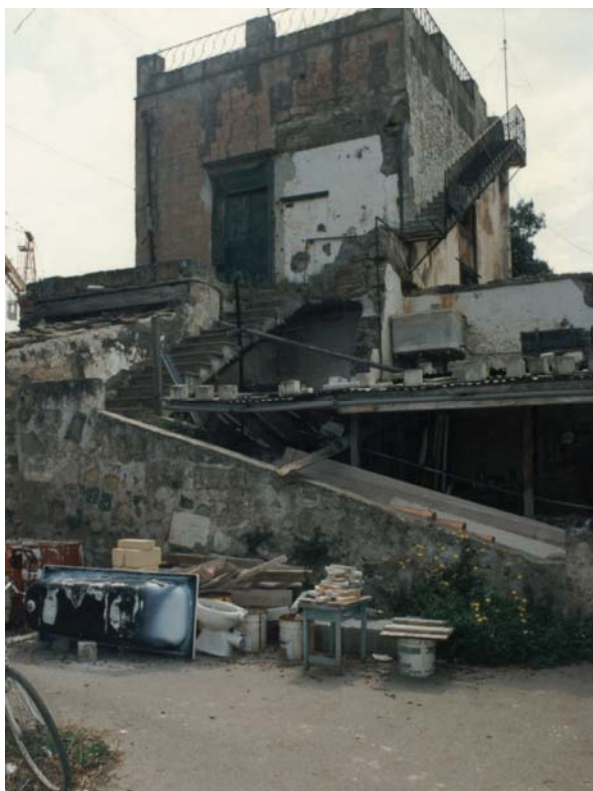
**Figure 4.** The north-west side of the building, that had crumbled

When restoration began, the building was in an extremely bad state of repair: of the two side buildings, only one remained standing, although a large amount of it had crumbled and most of the covering was missing, while the other, on the north-west side, had completely collapsed (Fig. 4). All the remaining wooden structures, due to the perishability of the material and because they had been exposed to the inclemency of the weather, were in a complete state of decay, and had almost totally collapsed. These wooden structures were the floor - ceiling of the small tower, the remaining trusses of the south-east (Fig. 5) wing that had almost completely collapsed, and the trusses of the large room that closed the courtyard (Fig. 6). Because the floors were in seriously bad condition, because there were no constraints and because false ceilings were to be fitted in the rooms, it was decided that the wood would be substituted with girders and hollow block floor. This was also a 19<sup>th</sup> century technique, but it was better suited to bear the loads that would be brought to bear on these structures by a nursery school, while still respecting the original plan of the structure. Only two of the supporting structures of the

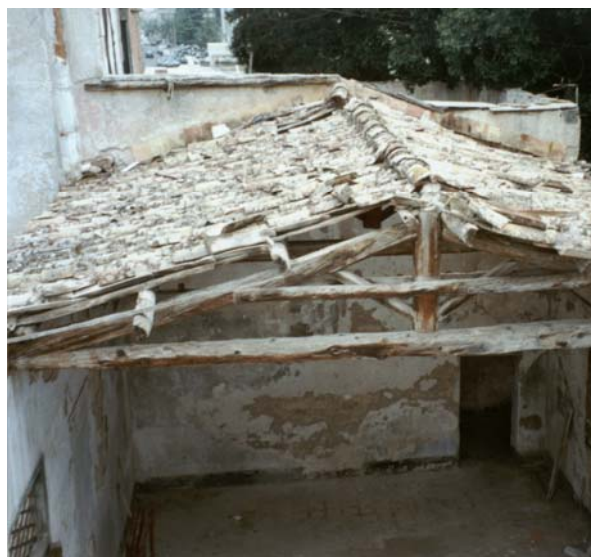
**Figure 5.** The remaining trusses on the south-east side of the building

pitched roof of the building on the south-east side remained intact, what's more in a bad state of repair. It was therefore decided that they would be substituted with steel trusses, which were constructed using tradition English lattice trusses made out of Fe 430 (Fig. 7).

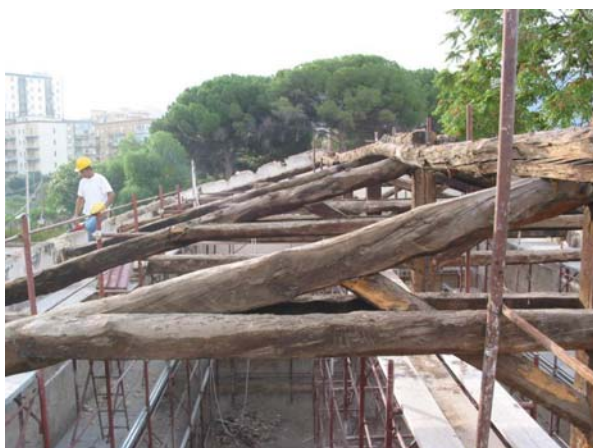
**Figure 6.** The trusses of the large room (i.e. former stable)

A special feature of the trusses of this room was that they had angle braces, knee rafters and double lower chords, probably due to the fact that they had to extend over quite a span; furthermore they supported a secondary beam layout on which the roof boarding and covering, made up of double layer Sicilian ridge tiles, rested<sup>vi</sup>.

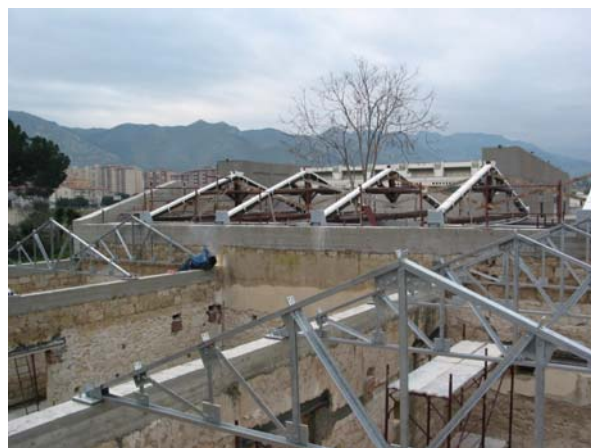
**Figure 7.** The new roof covering with steel trusses

This decision was also made not only because of the small number of remaining trusses and their insufficient load-bearing capacity, but also because it was necessary to use false ceilings in the rooms which, in the new structure would have been used for small children.

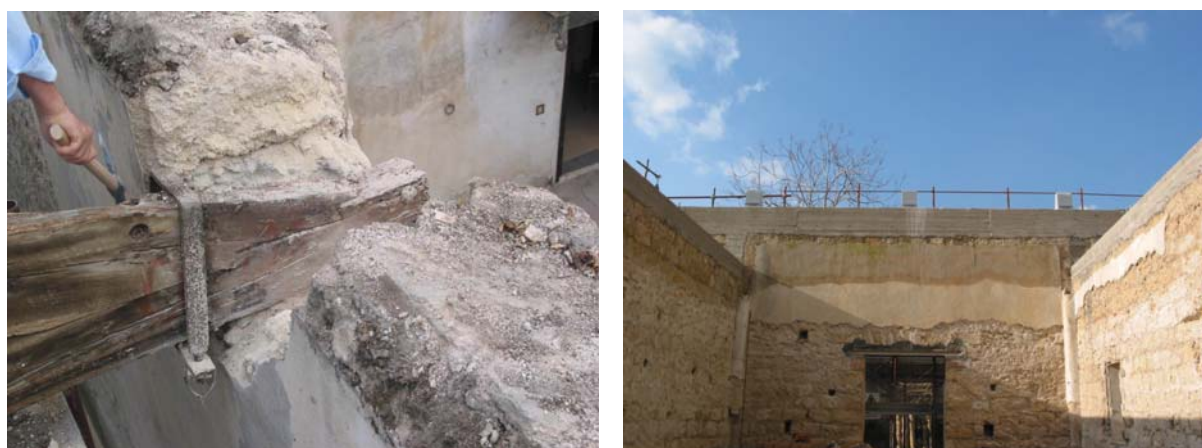
Figure 11. Dismantling of the head pieces from the masonry

Figure 12. The metal shoes anchored in the perimetral kerb

The new project intended to lighten their load bearing function by introducing a system of two rafters made with channel irons and two iron chains with large diameter round bars fixed to steel shoes anchored in the masonry. His intervention was effected in various phases. The first dismantling phase saw the freeing of the head pieces of the beam from the masonry (Fig. 11), which were then transported by a crane that stacked them on the ground. After the wood elements on the ground had been disinfected, an armoured concrete perimeter kerb was laid all around the perimeter of the room. Four stainless steel threaded bars (f 20) were sunk into the kerb, which were to serve as anchors for the steel shoes where the trusses would be subsequently lodged (Fig. 12). A *neoprene* sheet, 5cm thick, was placed between the steel shoes and the top kerb below, to avoid the transmission of torsional stress to the underlying masonry. A 10 cm channel iron was also welded to the back of each steel shoe, the purpose of which was to oppose the effect of the iron chains (Fig. 13) used to accomplish the task of the pre-existing wood lower chords, which were made of iron rods (30 cm in diameter).

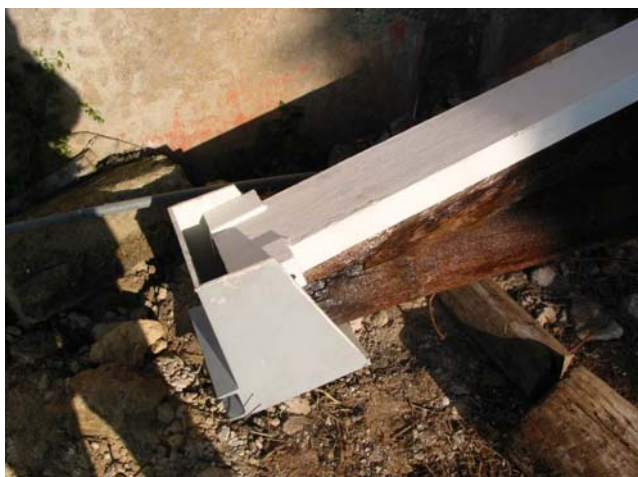
**Figure 13.** The steel shoe with the channel iron and the connection to the king post

There were iron rods for each truss which were anchored to the steel shoes by means of bolts that would have allowed them to be stretched. This operation was made easier by closing off the summit masonry behind the steel shoes. This was achieved by means of a

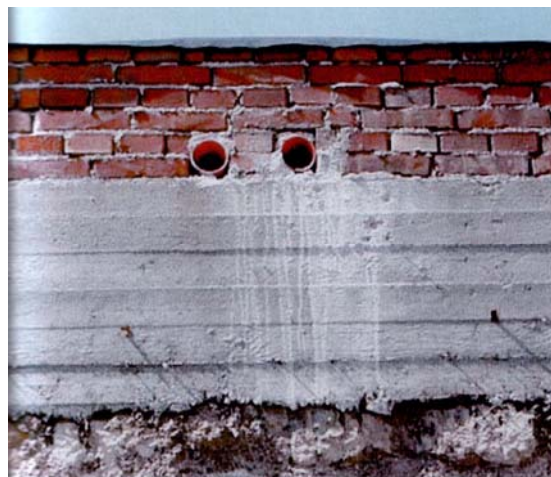
**Figure 14.** The birks on the summit masonry used to areate the head pieces of the beams

small wall built of bricks and hydraulic lime at the head, in which holes were bored to make the area easily accessible (Fig. 14). At the same time we applied the following structural aids, out of contract, to the trusses: channel irons were used to gird the upper part of the struts, which were fastened by means of a system of bolted brackets. A *neoprene* sheet was placed between the steel extrusions and the wood struts to avoid them coming into direct contact, considering their different reactions to thermal stress, and thereby avoiding subsequent condensation phenomena which would have made the wood an easy prey for biotic attacks (Fig. 15). The two new steel rafters were fastened to the steel shoes by means of two angle irons that were welded to the end parts, and that were connected to each other by means of a pair of gusset plates that were also bolted (Fig. 16).

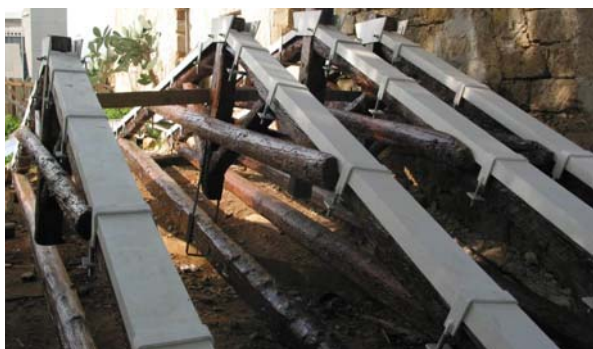
**Figure 16.** New metal structure connected to a pair of gusset plates

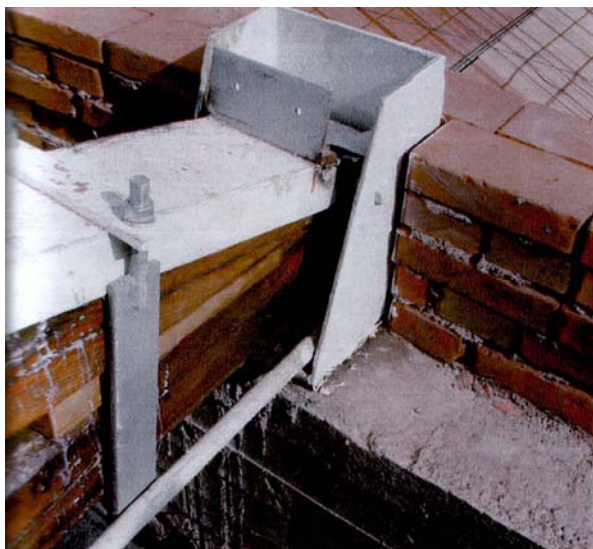
**Figure 17.** The head piece of the wood lower cords

These new trusses were then placed on the steel shoes, after a further sheet of *neoprene* had been placed between them. Thus the head pieces of the wood lower chords were never in direct contact with the steel, so that they could be ventilated appropriately (Fig. 17). The secondary beam layout was fastened to the extradoses of the channel irons by means of angle irons, which were used to hold the 10x10 wood rafters on which the 2cm wood floor planks rested (Fig. 18). A coat of waterproofing, a layer of insulating and Sicilian ridge tiles (the lower ones of which were new while the upper ones had been restored) completed the roof covering.

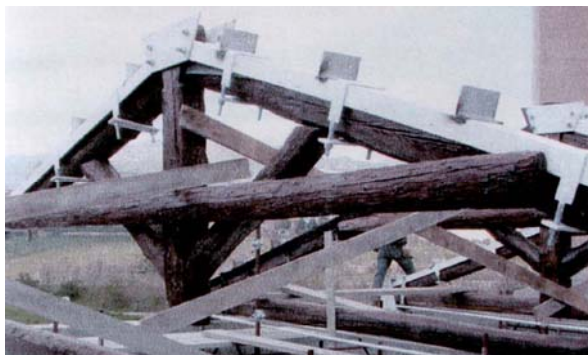
**Figure 18.** The angle braces on the channel irons used to haed secondary beam

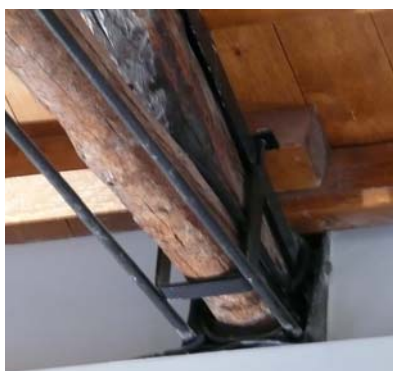
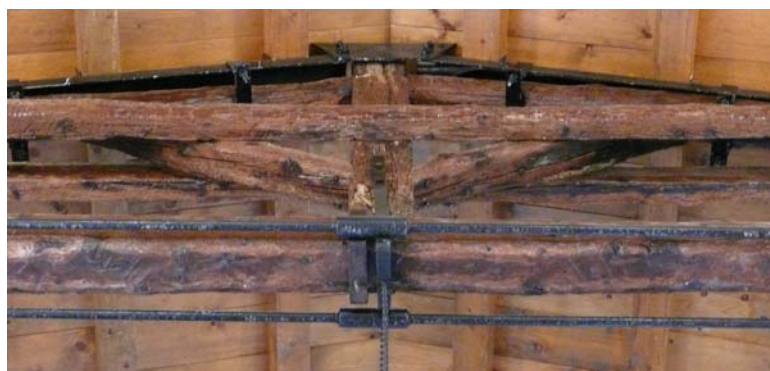
**Figures 19, 20, 21.** The covering following restoration

From an overall point of view, the intervention on the roofing structure, effected using perimeter kerbs, steel shoes and lower chords, put the big room in the position to resist seismic stress in compliance with the law, which otherwise would not have been possible in such a large room that completely lacked intermediate "wall shields", unless it had been substantially reduced in size (Figs. 19,20,21).
