## TIMBERED ROOFS AND CEILINGS OF THE *PALATINA CHAPEL* IN PALERMO

### 1. The history of monument and its timbered roofs and ceilings

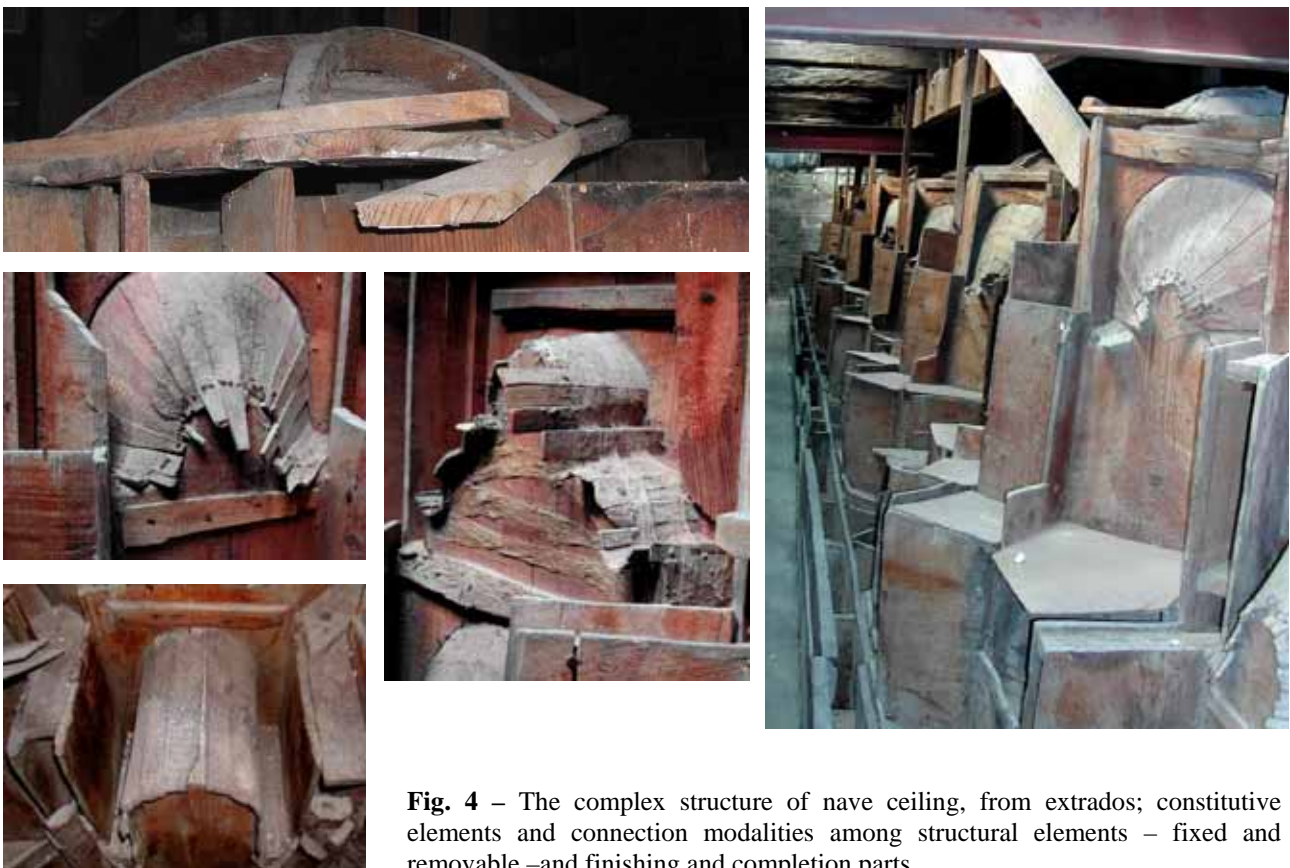
The ceiling today is supported by a system of 22 hemi-squared wooden beams (having each one approximately a section of 10,5x13cm); these beams are sustained by 2 wooden beams (*rompitratte*), constituted everyone by a couple of beams (about 20x5,5cm), mutually connected with filleted bar and bolts, that are supported once more by 4 steel beam (*NP16*, presenting an **I** section). The two wooden and the four steel beams are datable to the reinforcing intervention effected in 1939 by F. Valenti assisted by M. Guiotto, represented by G. Pignato in 1941. The hemi-squared wooden beams, set into perimetric masonries, they look more ancient; vertical wooden boards are connected with nails to these beams (wooden tie beam, called from the XVI century “*appenditori*”) and to the structures of *muqarnas* Norman ceiling above described, having the function to support the heaviest or damaged parts. The evident constructive difference between the ceiling system and these vertical wooden boards of support, the use of not medieval nails, together with the considerations already exposed about the translation of

coverage beam-floor, all these conditions show that the *muqarnas* ceiling constructive system was originally a self-carried structure and that only after numerous and stratified interventions some auxiliary elements of reinforcement were added, with the consequent translation of coverage beam-floor level.

**Fig. 4** – The complex structure of nave ceiling, from extrados; constitutive elements and connection modalities among structural elements – fixed and removable –and finishing and completion parts.
