Chiiori: Survey and Analysis of Structural Problems Facing a Traditional Japanese Farmhouse

Conway Carter

University of Hawaii at Manoa, School of Architecture

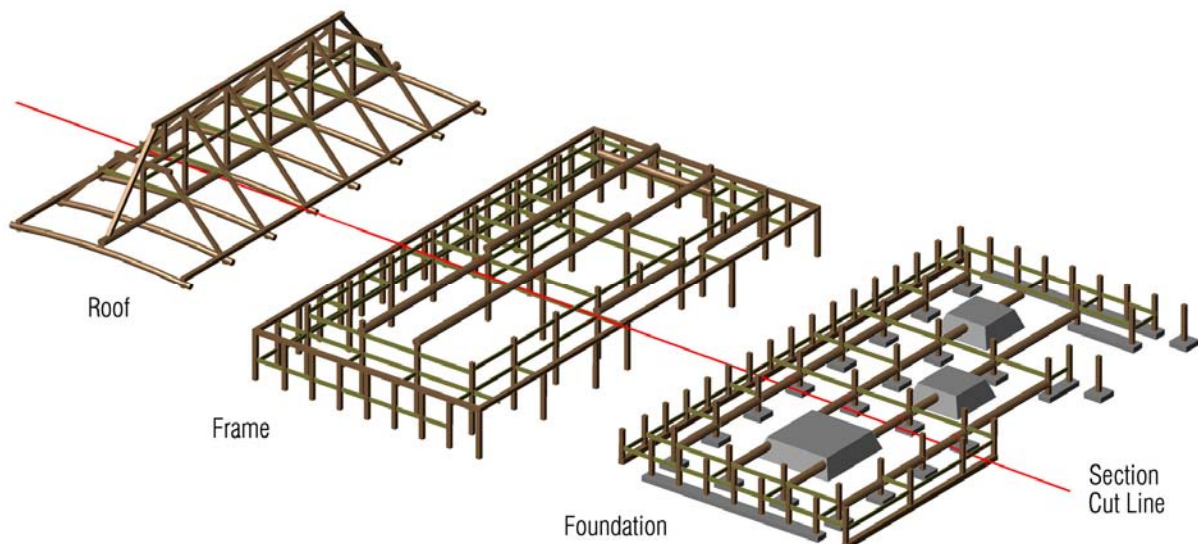
Figure 5. Overview of structural problems

The most noticeable structural defect of the house is the lean of almost all major structural columns by an average of two degrees towards the south. Some columns lean but remain straight while others bend while leaning. Those that bend tend to exhibit a convex curvature in the direction of the lean, with greater bending at the base of the column and less towards the top. Most also lean slightly in an east-west direction, generally leaning in toward the center of the house. The floors of the house generally follow this lean towards the south, but in a less uniform way than the columns. Some sections of the floor centered along the east west axis of the house are perfectly level, while the lean of others varies to more than twice the angle of the columns without any discernable pattern.
