Assessment and Analysis of the Breeding Barn at Shelburne Farms

David C. Fischetti^{*}, Douglas W. Porter^{}, Ronald W. Anthony^{***}**

President, DCF Engineering, Inc.^{*}, School of Engineering, University of Vermont^{**}, President and Wood Scientist,
Anthony & Associates, Inc.^{***}

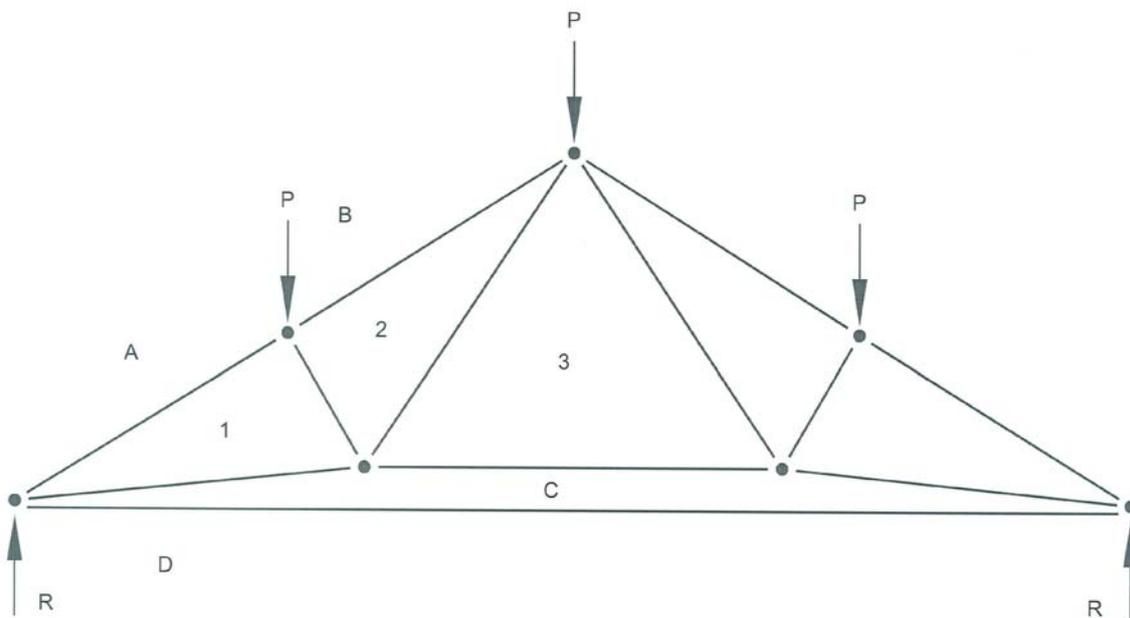
1. The truss members are connected together with frictionless pins.
2. Truss members are straight and the axis of the members intersect at joints.
3. Deformations under load do not excessively change the basic truss geometry.
4. Loads and reactions are applied only at joints (Figure 9).
- 5.

Figure 9. This shows the placement of the unit loads for the load test with the loads located at joints.

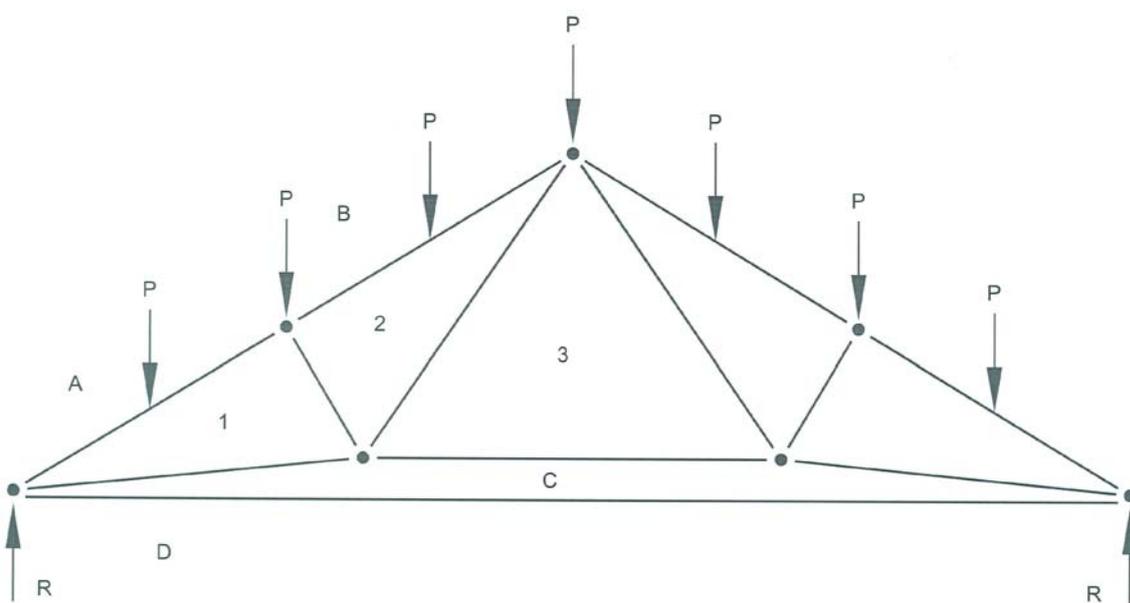
Apparently, the truss in the riding ring evolved from a simple truss analyzed by graphical means, to one with purlins located between joints (Figure 10), to a system combining a truss with a horizontal tie (Figure 11). The wrought iron angles used to bolster the spliced top chord is an interesting detail. These may have been added as an afterthought,

Figure 10. This shows the placement of the unit loads for the load test with the loads located at purlins.
