## **Failure is not always what it seems to be Timber Roof Trusses Behaving Badly**

**Richard I. Ortega, PE, AIA, FAPT**

Senior Associate and Director of Preservation Technology, RMJM Hillier, Philadelphia, Pennsylvania, USA

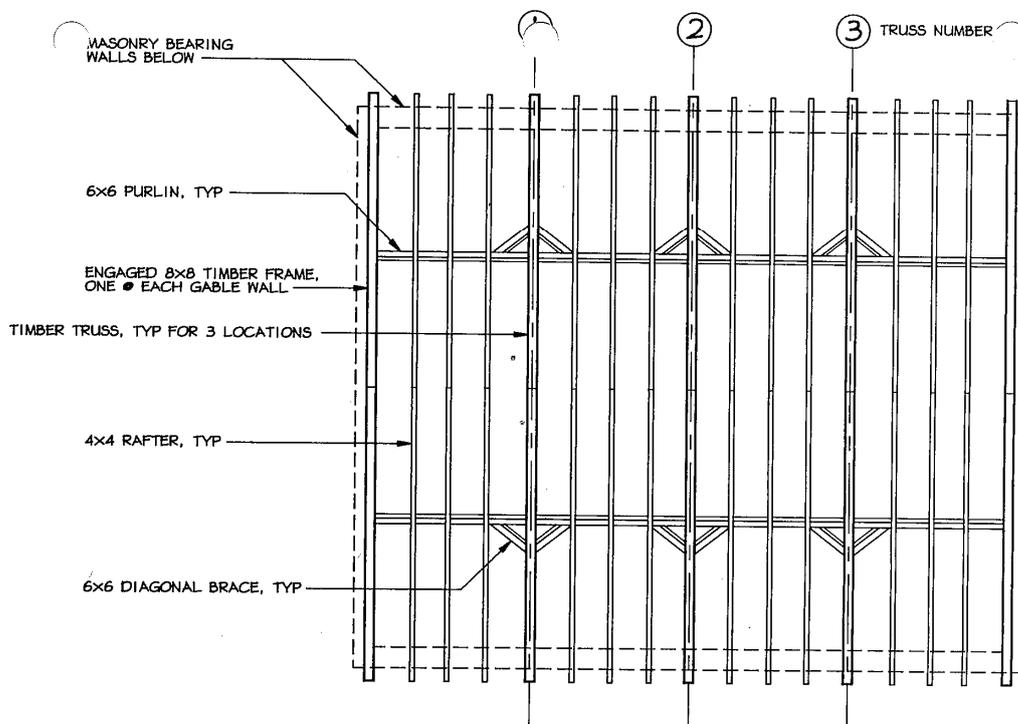
<b>B</b>	<b>ORTEGA</b>	DRAWING TITLE:	SCALE: 1/8" = 1'-0"
	CONSULTING	<b>ROOF FRAMING PLAN</b>	DATE: 3/12/92
Post Office Box 428 (215) 585-1131	Media, PA 19063		DRAWN BY: RDN
			APPROVED BY:
			PROJECT #: 92-03B

At variance with the analyses, our survey of the trusses found numerous failures:

- All the trusses exhibited numerous failed pegged joints. In addition to the failed pegs, a few of the joints where the pegs were intact exhibited failure of the tenons.
- All the lapped joints of the trusses had rotated to some extent producing gaps at the far ends of the laps and localized crushing at the near ends of the joints.
- All of the top chords had failed.
- Several of the joints connecting the horizontal tie to the top chord had failed in tension.

Using string lines we also found that the member of the trusses exhibited significant deflections:

We also closely examined the 20" thick masonry walls supporting the trusses and found that the tops of both walls had bowed outward as much as 6". This observation meant that our initial assumption that the masonry walls provided unyielding support for the trusses was not realistic. Thus, the same truss geometry was re-analyzed with one bearing end modeled as a roller so that spreading of the truss was theoretically permitted. The results of this analysis were consistent with the observed failures in the truss: the diagonal scissor chords go into tension to resist the spreading of the truss, and many of the truss members become overstressed.

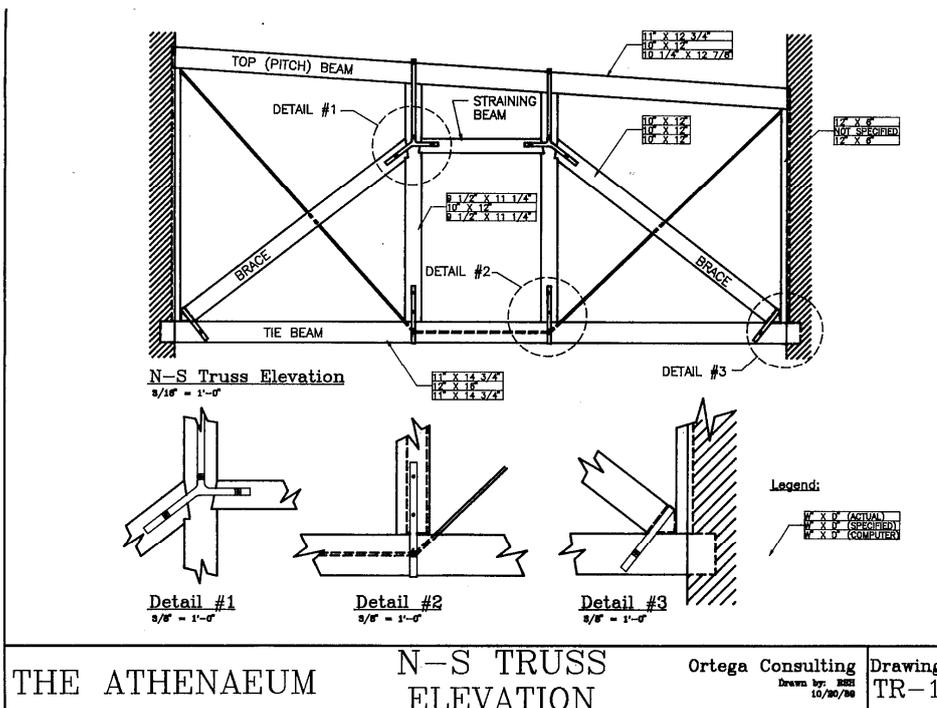
A survey of the framing found it to be generally as specified. Aside from some minor dimensional variations, the queen posts, straining beams, braces, pitch beams, iron straps, and rod conform to the specifications (see Drawing TR-1). The bottom chord, or tie beams, is smaller than specified, using two 5-1/2 by 14-3/4 inch timbers with a gap in between for the suspension rod. Likewise, the bolt below the queen posts, under which the suspension rod passes, appears to be only 7/8 inch in diameter instead of the 2 inches specified. The end posts, which are not mentioned at all in the specifications, are partially concealed in chases in the exterior masonry walls, but appear to be 6 by 12 inch pine timbers. We were not able to confirm the existence of the cast iron collars at the ends of the pitch beams and the rod connections to them as they were inaccessible.

This sent us back to re-examine the trusses more carefully for damage which could have caused the excessive deflections. The joints appeared tight and there were no apparent failures of the connections. We had limited access to the heel joints, but saw no evidence of movement or shear block failure. The rods seemed reasonably tight. We found checking in most of the members, but no signs of failure. There seemed to be no mechanism to account for the excessive deflections.

While mapping the checking of the timbers we realized that they must have gone through a considerable change in moisture content since the time of original construction. Considering the sizes of the timbers, and assuming that it was unlikely that the timber was aged for several years before use, we concluded that they were probably green when the trusses were built – i.e. the wood had a moisture content approaching 30%. From readings taken during our survey we knew that the moisture content was about 6%.

With that much drying, we decided to explore the effects of drying-induced shrinkage on the trusses, especially whether it could account for the extra deflections. Using the lumber species cited in the specifications and shrinkage coefficients listed in the *Wood Handbook*, published by the Forest Products Laboratory, we calculated longitudinal shrinkage for all the members based on a 24% decrease in moisture content. We ignored the transverse shrinkage as being inconsequential for the truss geometry, even though we recognized it as the principal source of the checking.

When we graphically reconstructed the truss using just the timber centerlines and with the shortened member lengths, we found that the iron rod, which would not shrink, would become slack unless the truss deflected between  $\frac{3}{4}$  and 1 inch to re-engage it. (see drawing TR-2).

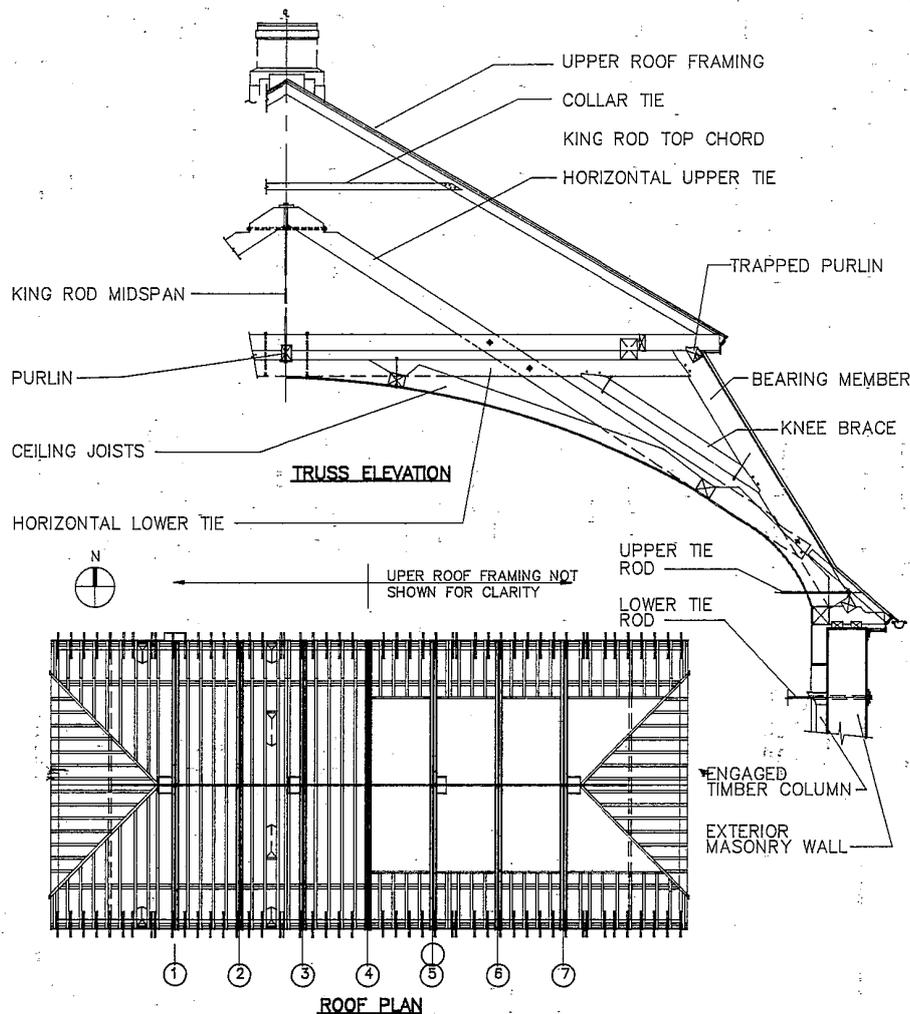
- At least half the scribe marks on the braced frames are on the concealed faces of the pairs of frames – i.e on the surface facing the other braced frame in pair rather than on the face toward the next truss.

- All the treenails of the mortise-and-tenon joints were driven from the concealed face.

These new observations led us to reach some startling conclusions regarding the sequence of the timber framing and the source of the truss and wall distortions.
