## Structural Failure Analysis of timber Floors and Roofs in Ancient Buildings at Valencia (Spain)

**Liliana Palaia**

Polytechnic University At Valencia-Icomos Spanish National Committee

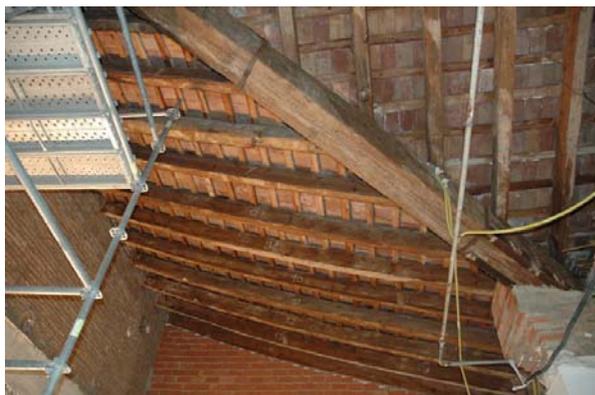
Before starting the inspection, all timber elements are identified with chalk, when possible, and taken photographs of all element endings and jointing. (Figures 8, 9)

**Figure 8.** Complete identification of all timber elements of the structure.

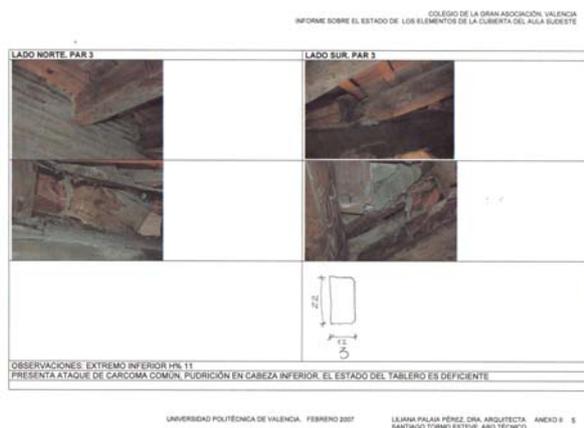
**Fig. 10.** Individual timber elements data chart. Diagnosis of a timber roof at the Gran Asociación Valenciana de la Caridad. Valencia.

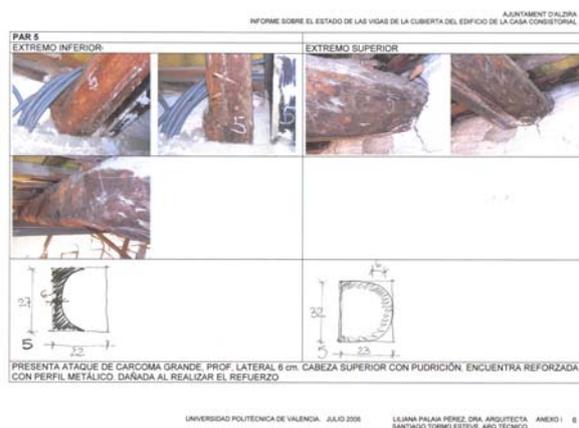
**Figure 11.** Individual timber elements data chart. Diagnosis of a timber roof at the main house building. Ajuntament d'Alzira.

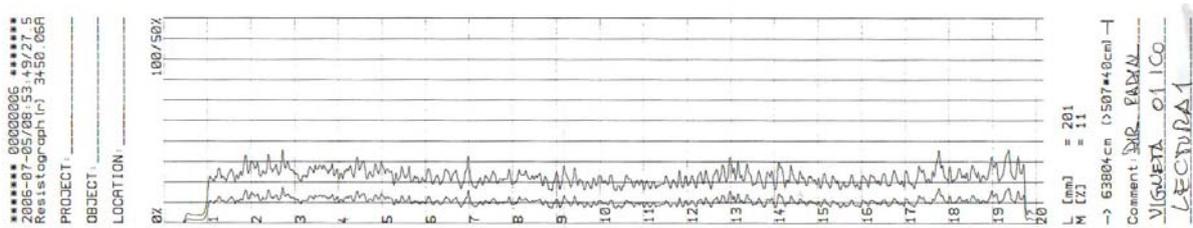
Figure 15. Print out Resistograph test

This technique not only is capable of accurately measuring the severity and extent of decay, the ratio of sound to decayed timber remaining, and its position within the cross-section, but also give a reference of its density. As this parameter is in relation with its mechanical resistance, some of these characteristics can be estimated. The data obtained is recorded by a computer and print out, being possible to observe at the x axis the progress of the depth penetration. The y axis indicates the relative magnitude of the torque required by the bit moving at a constant speed. (Figure 15)
