Roof structures in Swedish churches: preservation challenges and solutions

Ylva Sandin

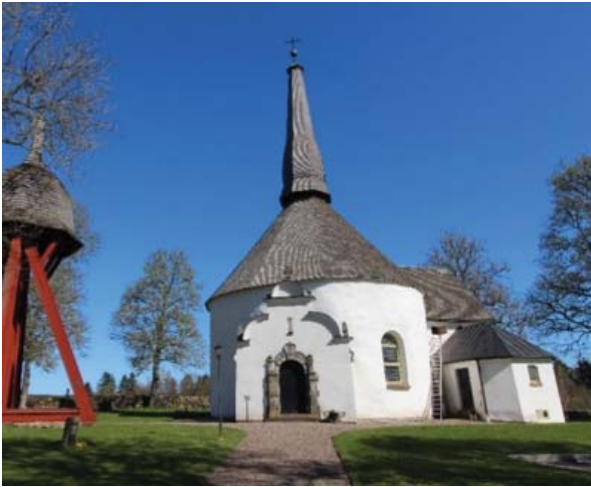
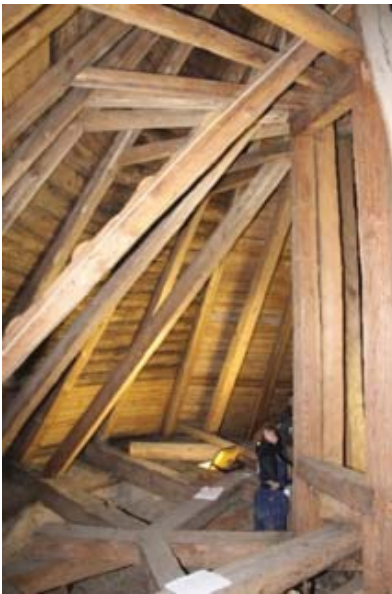
Figure 2 a) Skörstorp church, exterior. b) The attic above the round nave and the 17th century spire. Photos: Carl Thelin.

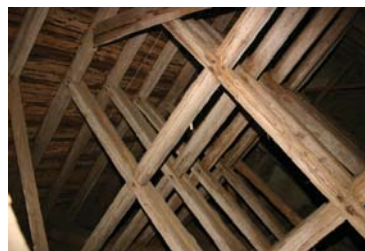
The medieval church of Marka still has a large number of original roof trusses. Dendrochronological analysis has shown that the timbers in the roof trusses above the nave were felled in 1155/1156.¹ The roof trusses were originally visible from the church room but are now hidden by vaults. When these vaults were built (probably in the 15th century) some of the tie beams in the roof trusses above the nave, as well as all of the tie beams in the roof trusses above the chancel, were cut off. Additional parts have been built in at some point to compensate for the removed ones.

Figure 5 Marka church, roof trusses above the nave. Photo: Carl Thelin.

Today, a number of damages weaken the structures. Many of the roof trusses are partially damaged by rot. Large parts of the wall plates are rotten. A sample has shown that in at least one position there is real-rot fungus. Additional parts, tie beams and others, have been built in in order to strengthen the structure.
