"From Material to Structure" MECHANICAL BEHAVIOUR AND FAILURES OF THE TIMBER STRUCTURES

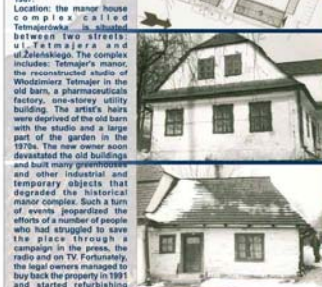
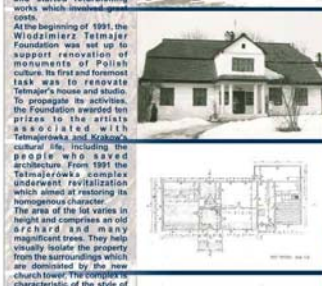
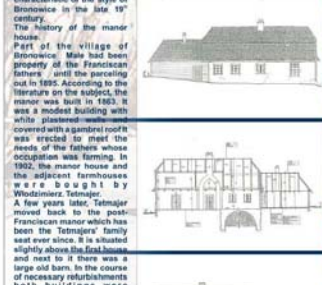
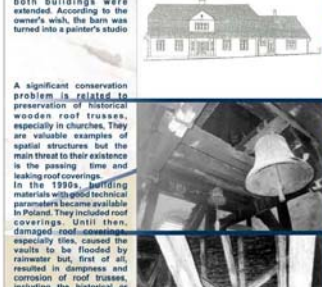
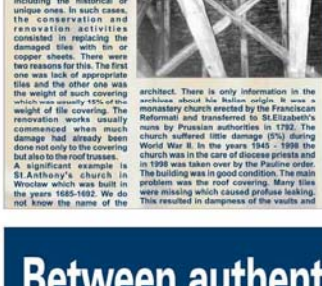
Therefore the problem of preserving the authentic structure of the walls proved quite complex. When plaster was removed and detailed inventory taken, it turned out that every wall had its unique structure. On the whole, there were two types of wall structure. The rooms in the eastern part of the main building had a (sumikowo-takowa) construction while the rest of the walls consisted of a post and frame filled with bricks, stones, wood, brushwood, all joined by means of clay-based mortar. Significant

fragments of inside walls were made of brick. A variety of structure and detailed inventory taken, it turned out that every wall had its unique structure. On the whole, there were two types of wall structure. The rooms in the eastern part of the main building had a (sumikowo-takowa) construction while the rest of the walls consisted of a post and frame filled with bricks, stones, wood, brushwood, all joined by means of clay-based mortar. Significant
