The Current Principles for the Preservation of Historic Wooden Monuments in Japan

Alejandro Martínez

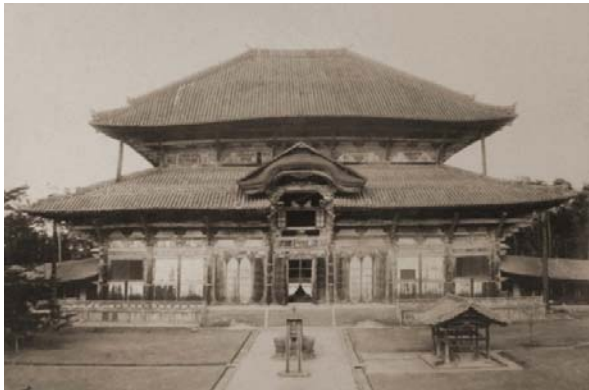
Fig.1 Main Hall of Todaiji Temple, condition before the repair works in 1891.

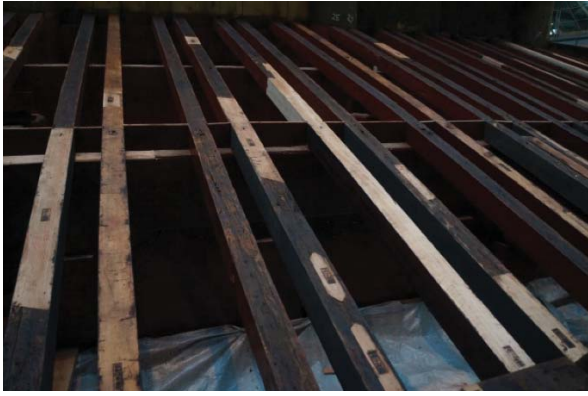
Fig.4 Different kinds of repairs of rafters made by splicing damaged timber with new wood, Rin'oji Temple, 2015. The date of the repair is burnt into the new.

material is reused. Damaged members are repaired by splicing decayed parts with new timber. Small section timbers and heavily damaged elements, which traditionally would be replaced, are also repaired through this method, and complete replacement is limited to extremely damaged members. This kind of repair is possible thanks to specialized carpentry techniques, used in combination with modern technologies such as epoxy resins. In addition, elements that had to be replaced are stored if they have documental value, and discarded timbers are usually stored in the roof.

that they can be identified later” also matches the standard Japanese practice, where new elements are identified with a mark burnt into the wood with the date of the repair.

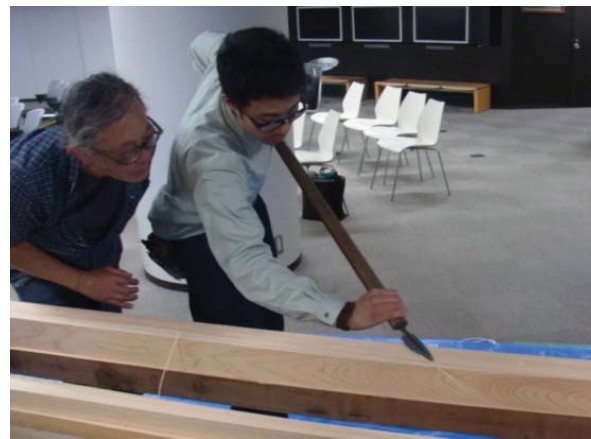
Fig.5 Training young carpenters in the use of traditional tools.
